**THE GOVERNMENT OF THE
HONG KONG SPECIAL ADMINISTRATIVE REGION**

Highways Department

Deformation of road surfaces on bridges

**Audit Commission
Hong Kong
31 March 2003**

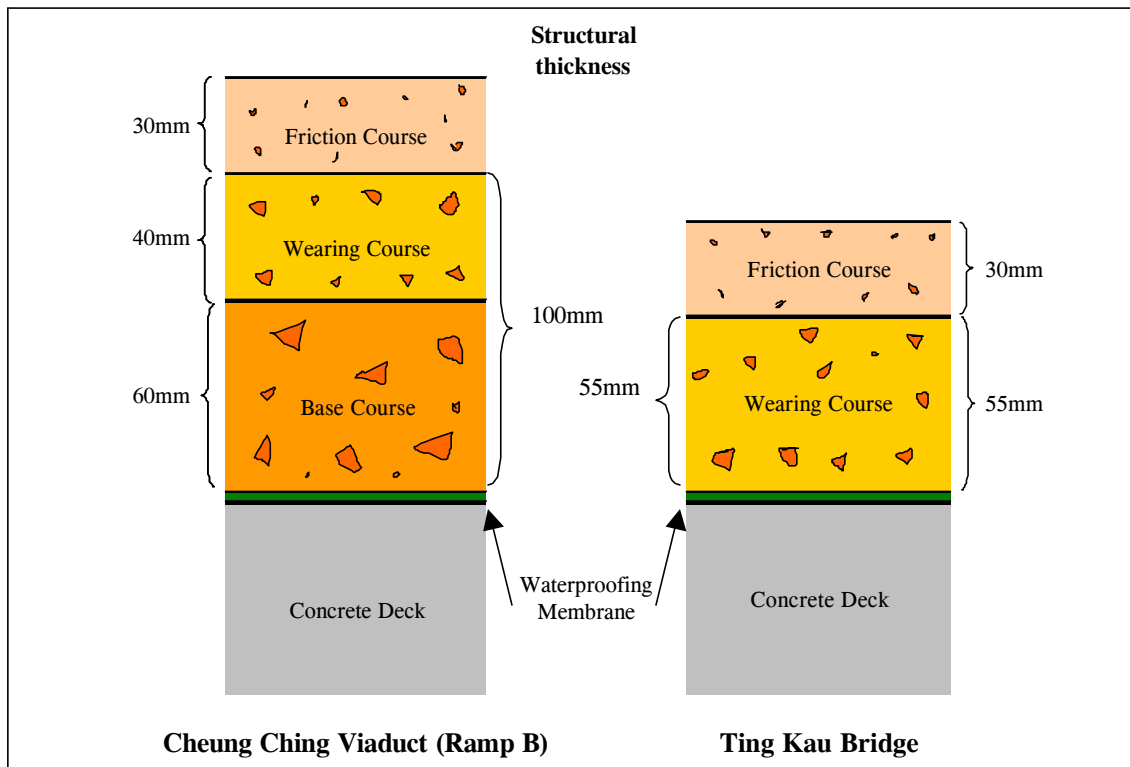
Figure 4
Thickness of the bituminous pavements of
Cheung Ching Viaduct (Ramp B) and Ting Kau Bridge
(para. 4.13 refers)

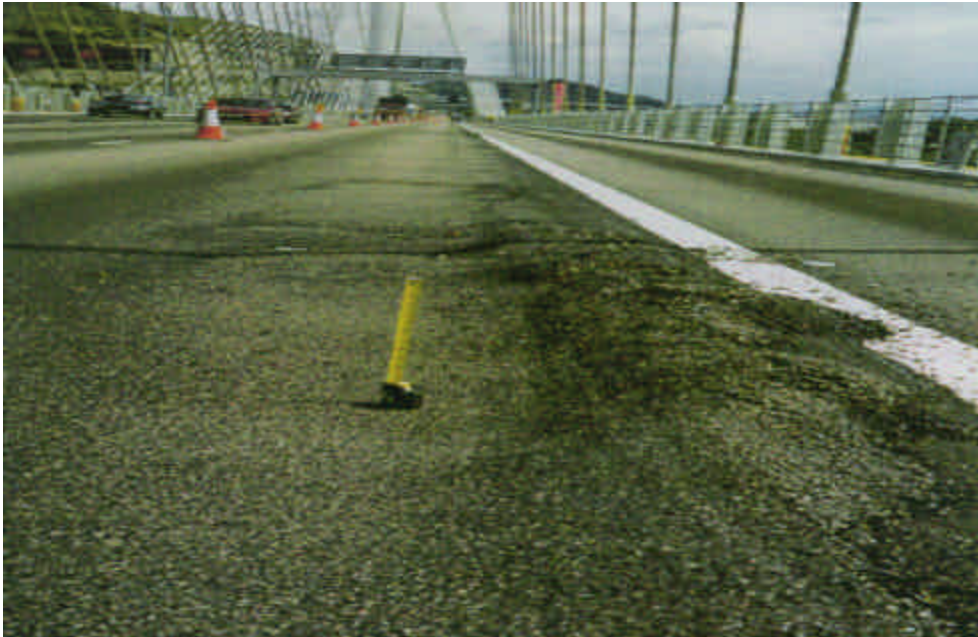
Bridge	Date opened to traffic	First defects noted on	Particulars
TKB	5 May 1998	2 July 1998	Two months after road opening, severe movement and blistering of bituminous surfacing were found on the slow lane.
WKEV	20 February 1997	8 August 1997	Six months after road opening, serious rutting and movement of bituminous surfacing were found.
KSMB	22 May 1997	20 July 1998	14 months after road opening and shortly after opening of the new airport, rutting on the slow lane was found.
MWV	22 May 1997	20 July 1998	14 months after road opening and shortly after opening of the new airport, rutting on the slow lane was found.

As shown in Table 1 above, the deformation of the road surfaces of the four bridges occurred not long after they were opened to traffic. In the case of the TKB, the defects were noted just two months after it was opened to traffic in May 1998. Subsequently, there were further reports of deterioration of the road surfaces. Photographs 1 and 2 on the centre pages show the defects on the road surfaces of the TKB and WKEV respectively.

Photograph 1
An example of a defect on the road surface of the Ting Kau Bridge
(para. 2.5 refers)

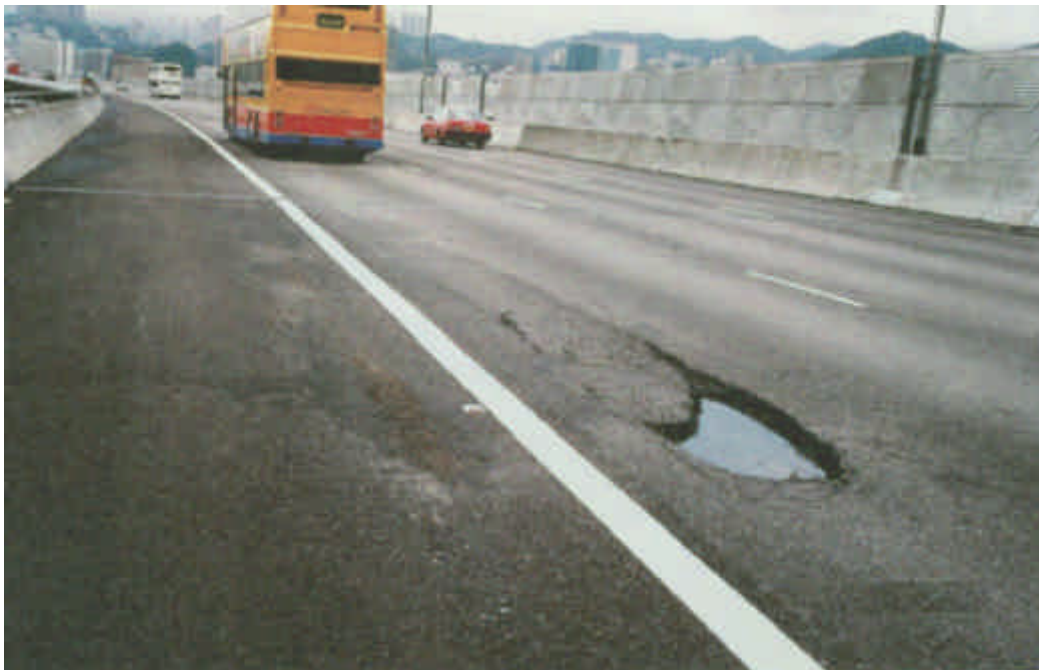
Photograph 2
An example of a defect on the road surface of the West Kowloon Expressway Viaduct
(para. 2.5 refers)
