Civil Engineering and Development Department

<h3>Reprovisioning of public piers</h3>
--

**Audit Commission
Hong Kong
March 2005**

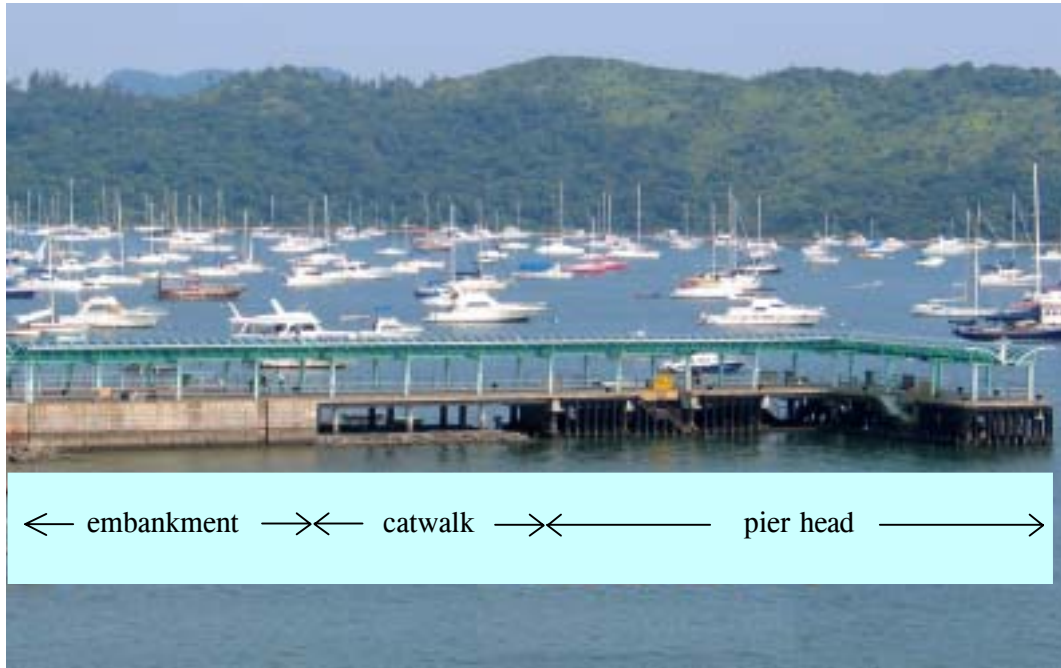
Photograph 1

**Example of a pier with a catwalk and an embankment
(Pak Sha Wan Public Pier)**

2.13 The Pak Sha Wan Public Pier in Sai Kung, built in 1974, was a notable example of a “relatively young” pier with severe deterioration. It was ranked by the consultants in 1995 as the second most deteriorated pier when it was then only 21 years old. Urgent structural repairs were carried out to ensure its operational safety. However, the pier was considered to have deteriorated beyond economic repair. The Pak Sha Wan Public Pier was subsequently reconstructed in 2001 at a cost of \$33.1 million.

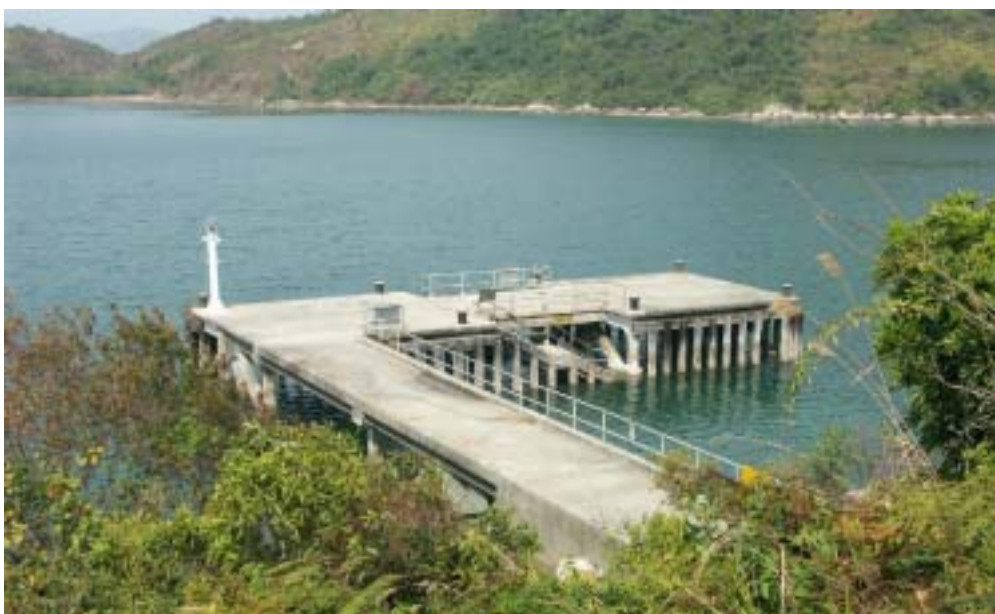
Photograph 3

Sham Chung Public Pier

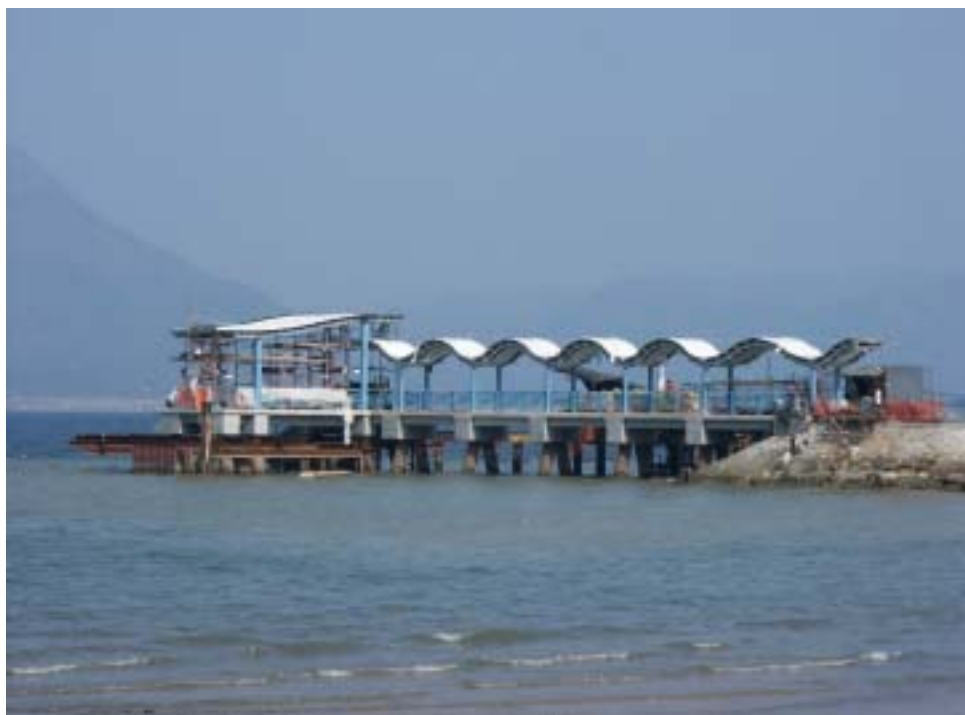
Photograph 5

Wu Kai Sha Public Pier

5.14 In the PWSC submission, the CEDD said that the Wu Kai Sha Public Pier was used by fishermen and government departments but did not mention the low utilisation of the pier. Audit conducted several field inspections (from October to December 2004) of the pier and observed that:

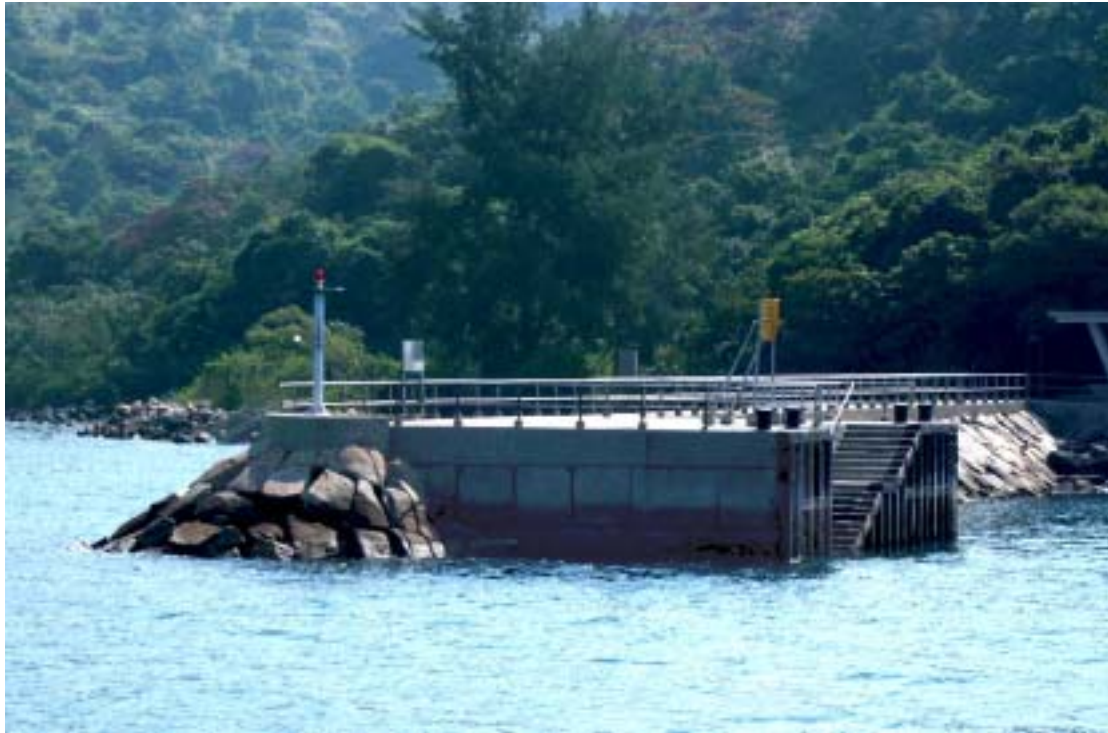
Photograph 8

An example of a solid pier (Chek Keng Public Pier)

6.27 There are several disadvantages associated with solid piers. Firstly, in areas with strong waves, incident waves and waves reflected from the solid piers may make berthing difficult. Secondly, solid structures do not allow the passage of currents. If there are strong currents, local eddies induced by the solid structures also make berthing more difficult.
