Maintenance of public marine facilities

**Audit Commission
Hong Kong
31 March 2006**

MAINTENANCE OF PUBLIC MARINE FACILITIES

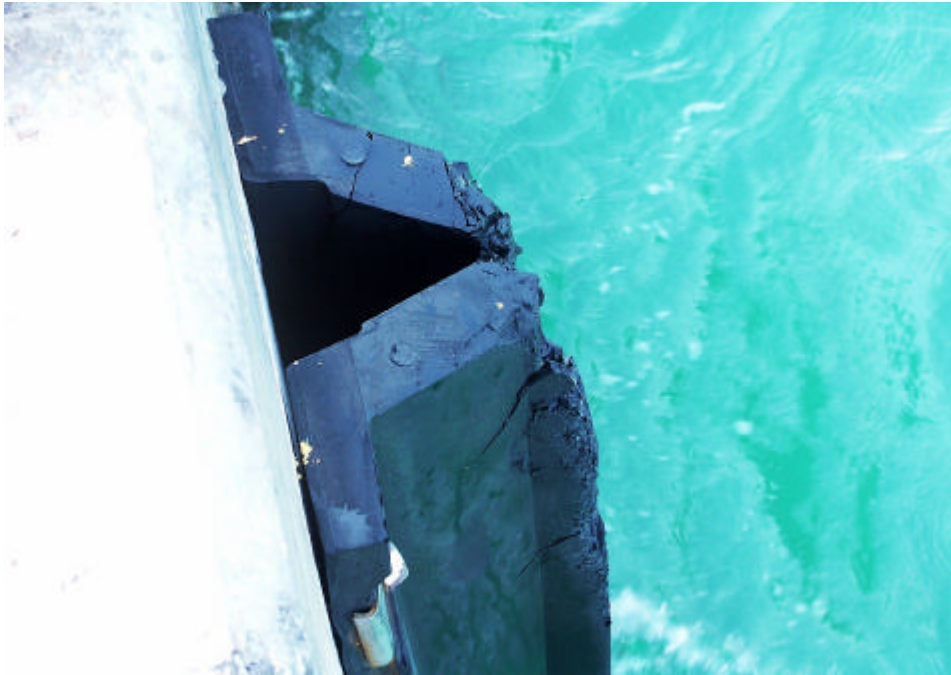
Photograph 4

A damaged rubber fender at Tung Lung Chau (North) Pier

4.36 **Audit considers that the CEDD needs to closely liaise with ferry operators and take into account their views in assessing the performance and durability of the new fenders. The berthing practice of ferry operators may also affect the durability of fenders. It is important that the CEDD should liaise with the ferry operators to ascertain if they have adopted an appropriate berthing practice, having regard to the physical properties of the new fenders.**

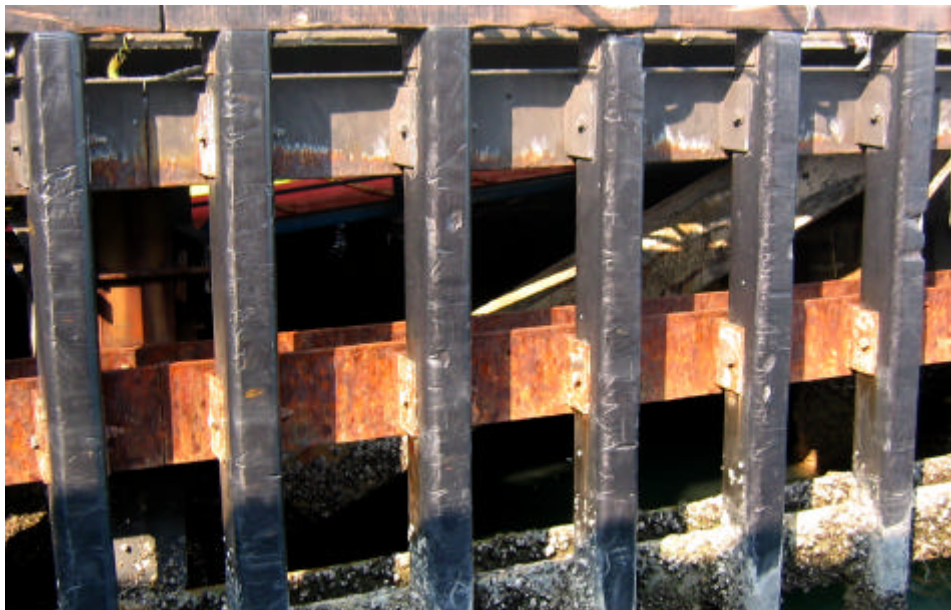
Photograph 5

Plastic fenders at North Point (West) Ferry Pier with scratch marks

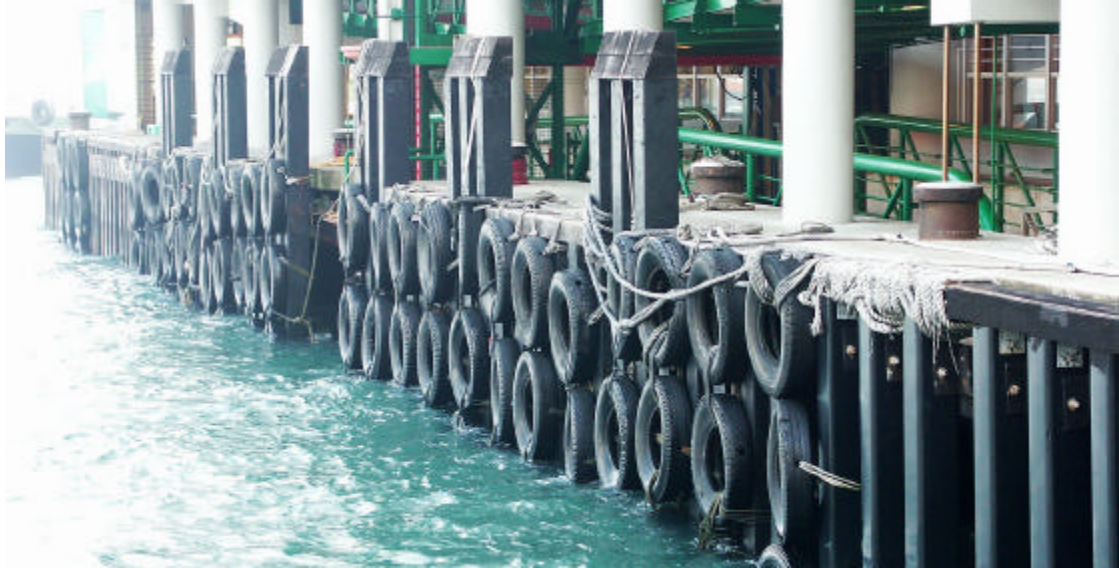
Photograph 6

Plastic fenders at Central Pier No. 4 covered with rubber tyres

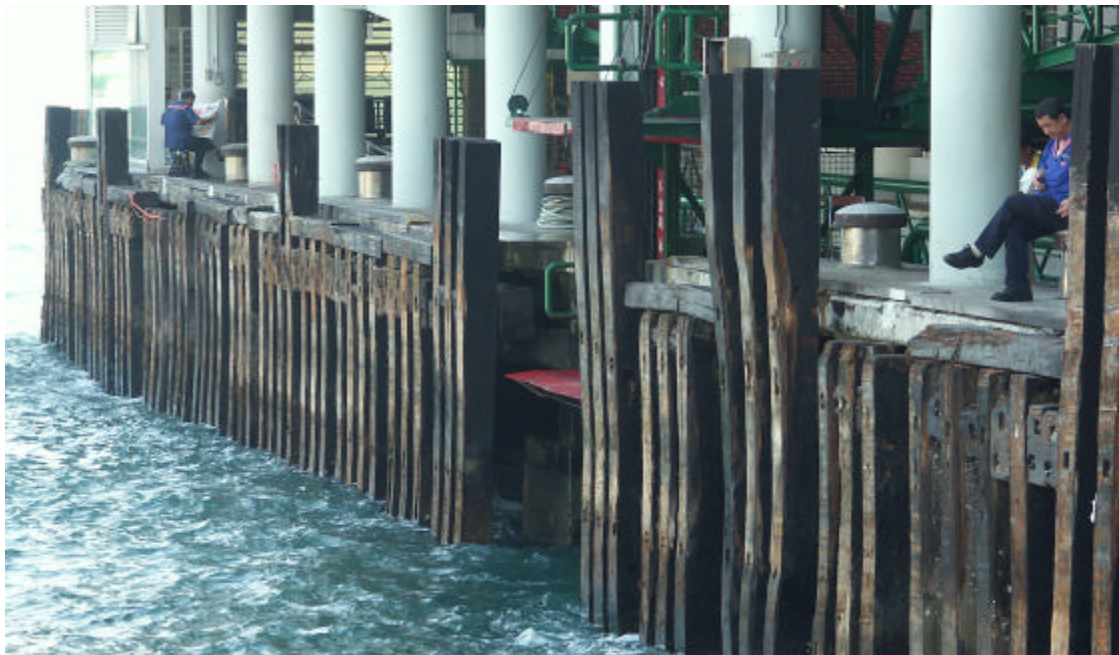
Photograph 7

Timber fenders at Central Pier No. 5 without rubber tyres
