Home Affairs Department

**Implementation of minor works projects
by the Home Affairs Department**

**Audit Commission
Hong Kong
23 October 2006**

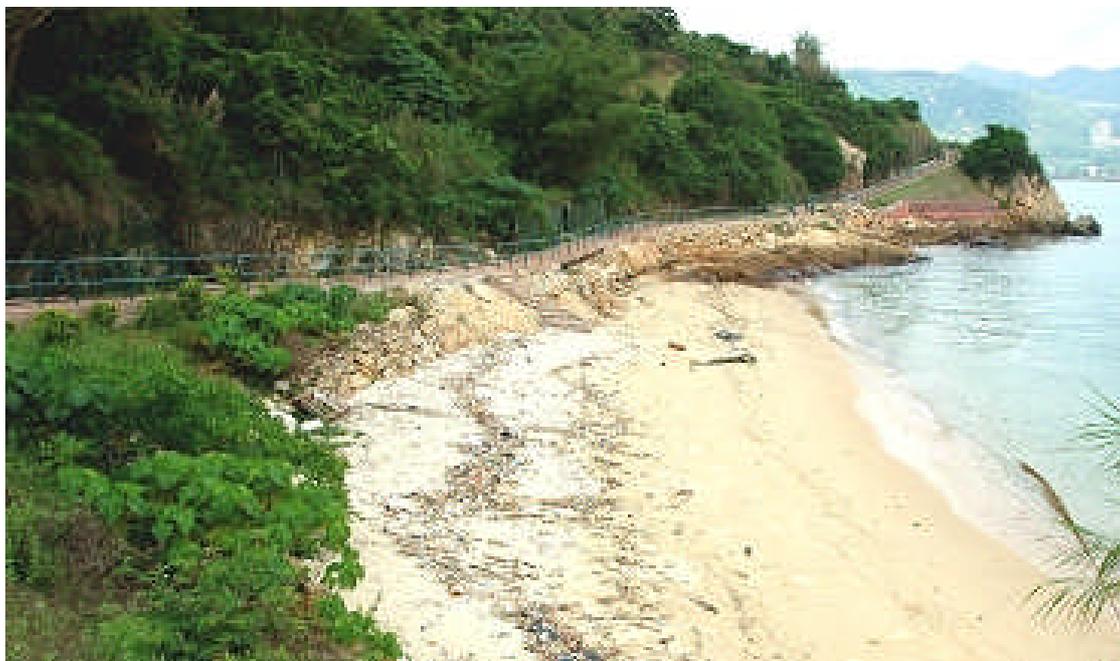
A section of the new footpath on Peng Chau

- (a) ***Condition of the beaches.*** The three beaches were unattended and covered with debris (see Photograph 1 in para. 2.10);
- (b) ***Condition of the pier.*** The pier was in a dilapidated state (see Photograph 2); and
- (c) ***Alternative access.*** There was an existing footpath on the hilltop in the area providing access to the pier (see Figure 1 in para. 2.4), and to two of the three beaches.

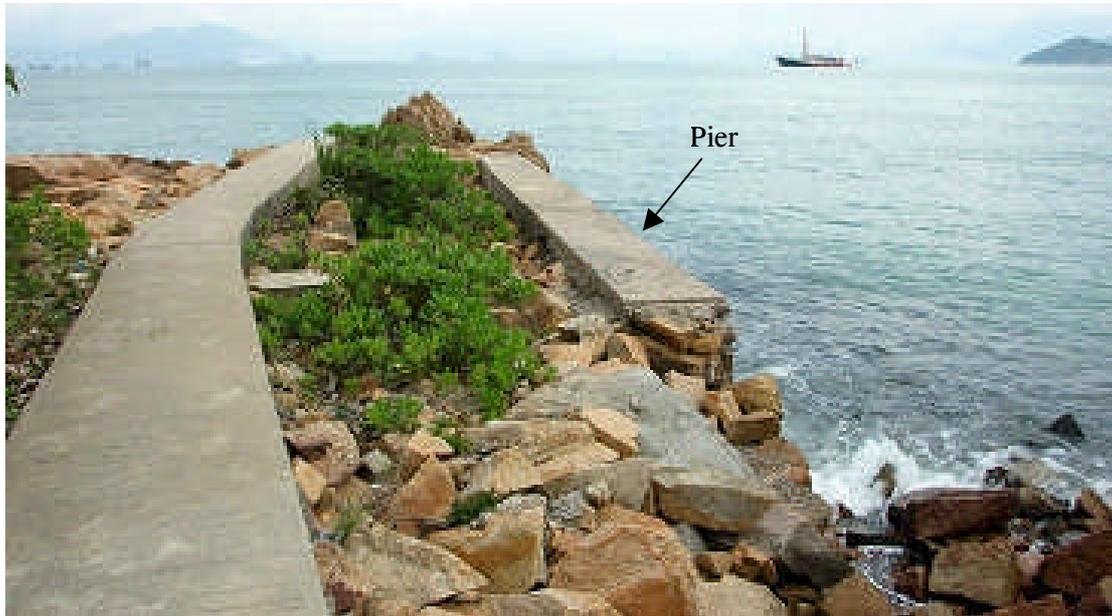
Photograph 2

The dilapidated pier

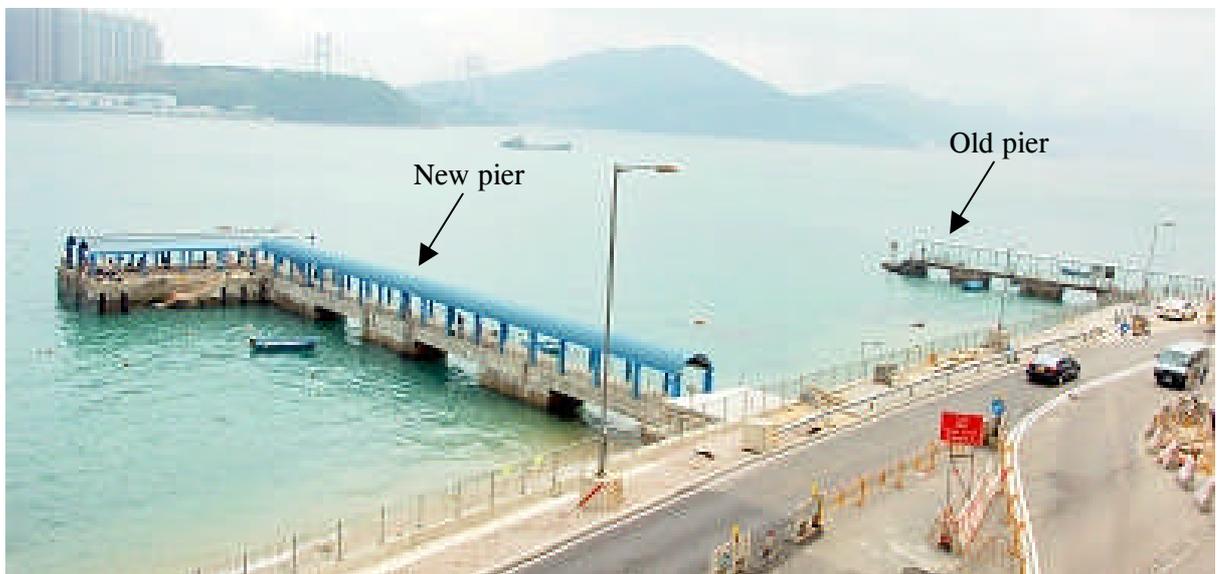
Photograph 3

Two piers at Anglers’ Beach, Sham Tseng

- (a) had severely deteriorated and was approaching the end of its design life; and
- (b) was beyond economic repair and strong justifications were required for continuing its maintenance.

- (a) the old pier was over 40 years old and was beyond economic repair;
- (b) as a temporary maintenance measure, the pier was supported by steel beams to maintain its structural stability;
- (c) there would be safety hazards to continue using the old pier;
- (d) further maintenance would be very costly; and
- (e) demolition of the old pier should be carried out when the new pier could serve its functions.

3.23 Audit noted that, in the four years from 2001-02 to 2004-05, the CEDD incurred \$320,000 in maintaining the old pier. In June 2005, the CEDD estimated that repairs costing \$360,000 would be required to ensure the safety and stability of the old pier, if it were to continue in service. **Audit considers that the HAD should, in consultation with the relevant departments, critically review the need to maintain both piers at Anglers' Beach.**

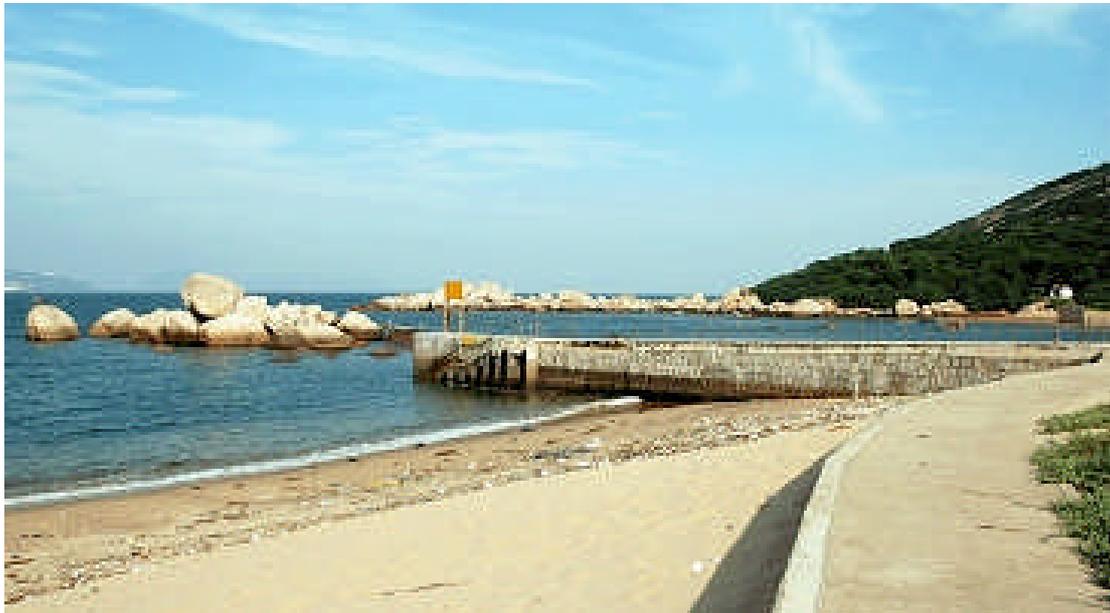
Photograph 5

Loading platform at Shek Pai Wan

- (a) they did not use the loading platform at Shek Pai Wan for refuse collection because they found it not convenient to do so;
- (b) they preferred using a sampan going ashore on the beach to using the loading platform for refuse collection; and
- (c) they adopted this practice at other bays, such as Mo Tat Wan, on Lamma Island even when a pier was provided.

4.20 **Audit has also recommended that the Director of Food and Environmental Hygiene should, in consultation with the Director of Home Affairs, review whether the loading platform is required for refuse collection by the FEHD (see para. 4.16).**

4.21 **Audit has also recommended that the Director of Civil Engineering and Development should delete the loading platform at Shek Pai Wan from the CEDD's inventory of public piers (see para. 4.18).**

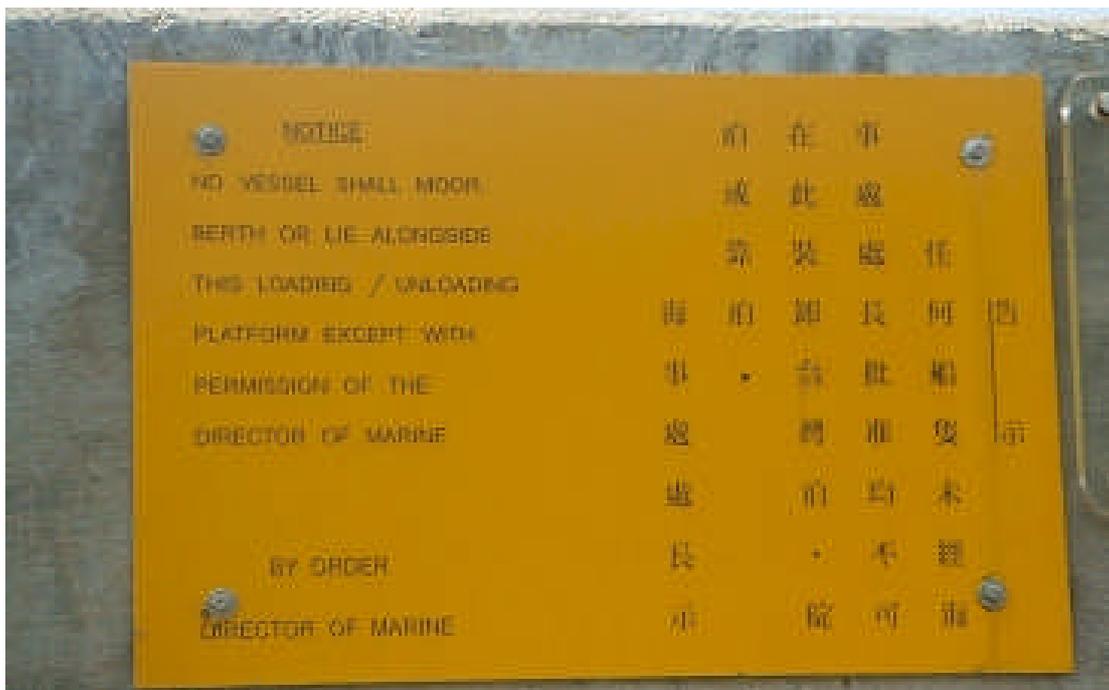
Photograph 6

Warning sign posted on the loading platform

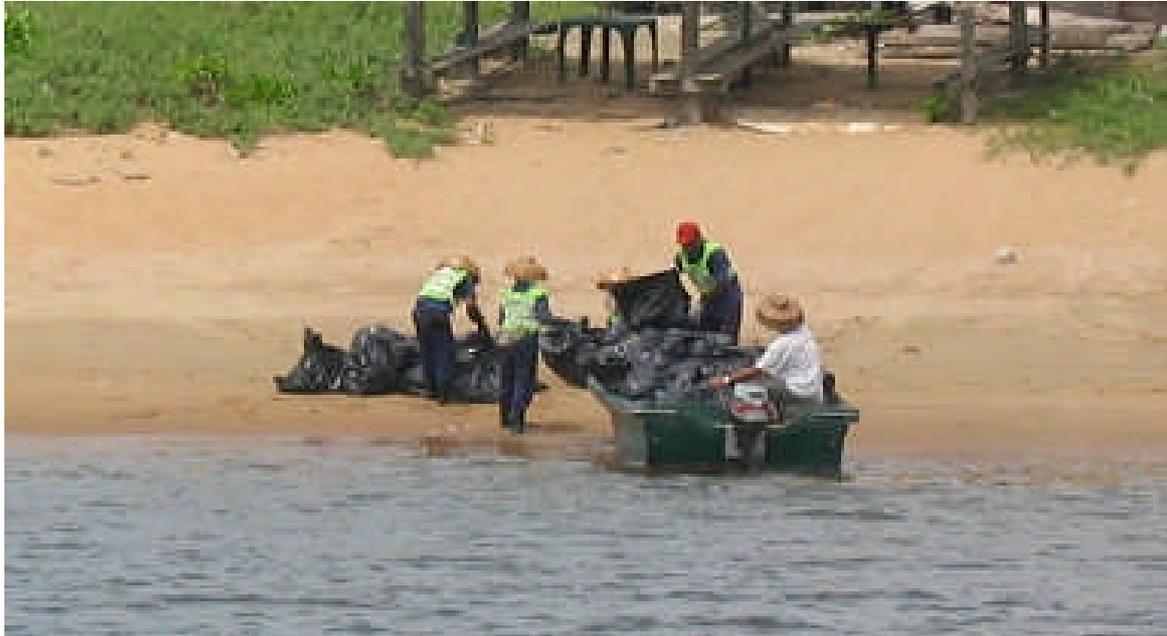
Photograph 7

Refuse collection at Shek Pai Wan

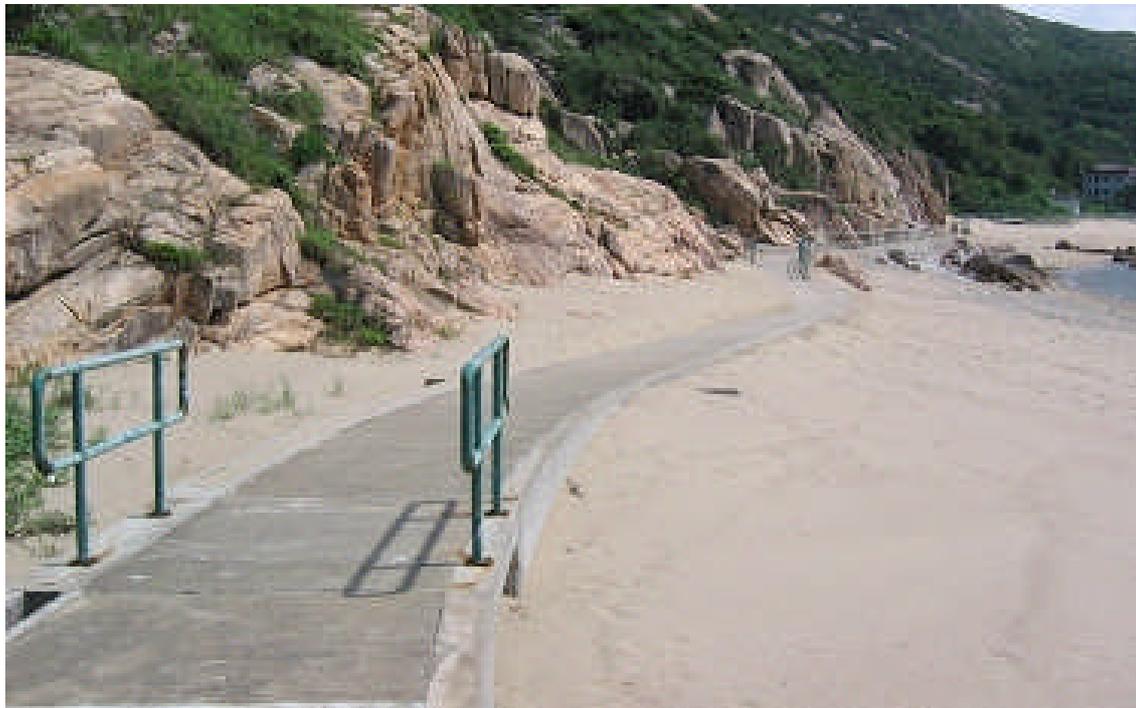
Photograph 8

5.4 In March 1999, a contractor (Contractor D) commenced the works. During a typhoon in October 1999, the footpath foundation was severely damaged by strong waves. The HAD's review of the damage revealed that:

- (a) the footpath design had not taken into account the impact of waves on its foundation; and

- (b) as the footpath was constructed near a beach and very close to the sea, the foundation design was not strong enough to withstand the waves during a typhoon or at high tides.

Footpath at Shek Pai Wan

In the light of the findings, the HAD implemented measures to strengthen the footpath foundation and installed protection structures.

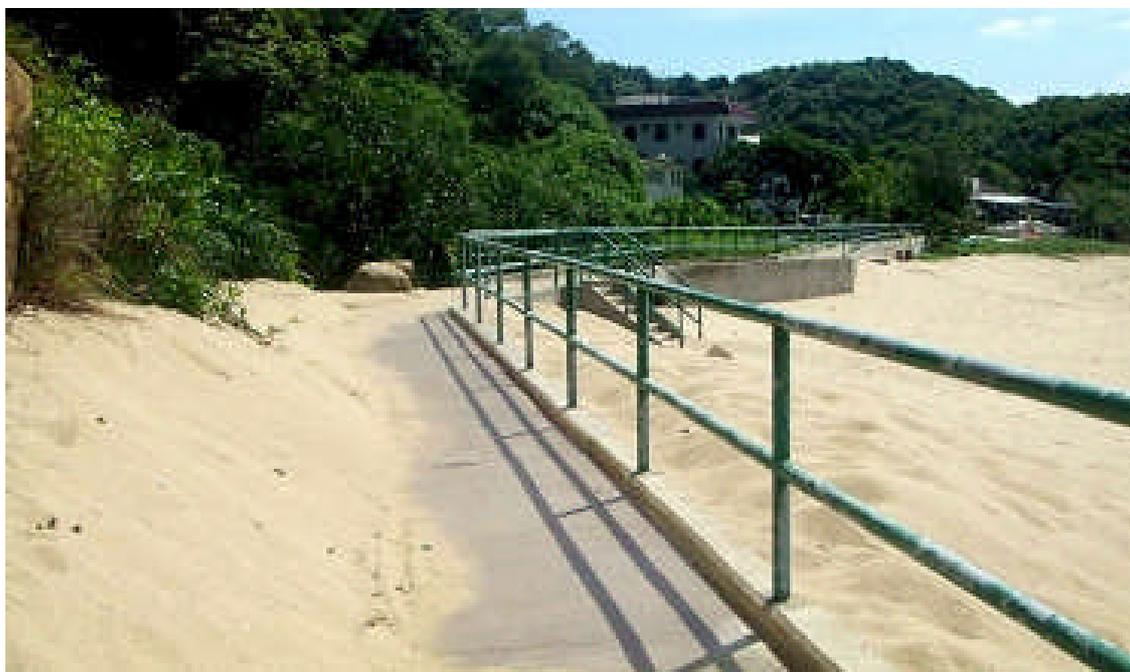
Photograph 9

5.10 The footpath was built for use by pedestrians and emergency vehicles (see para. 5.12(c)). However, during an audit field inspection on 20 June 2006, Audit found that there were thick sand deposits on some parts of the footpath. Such sand deposits covered the drainage channel and significantly narrowed the path width (see Photograph 9).

Footpath partly covered with sand

5.11 The sand deposits were brought to the footpath from the beach by strong wind or sea waves. Because of the re-alignment of the footpath closer to the beach (to avoid damaging the underground electricity cables and watermains — see para. 5.5), sand could easily cover the footpath. **In order that the footpath will be safe and convenient for use by pedestrians and emergency vehicles, Audit considers that the HAD needs to take remedial measures.**

- (a) under the current practice, the HAD will re-examine the justification for a project before giving funding approval for its implementation;
- (b) the HAD has procedures in place to ascertain the presence and alignment of any existing underground utilities in a project site during the planning, design and construction of the project. The HAD will closely monitor projects undertaken by consultants to ensure that the wave impact and underground utilities are taken into account in the designs if the alignment is near beaches or over underground utilities; and
- (c) the Islands District Office will take prompt action to remove the sand from the footpath to ensure public safety.

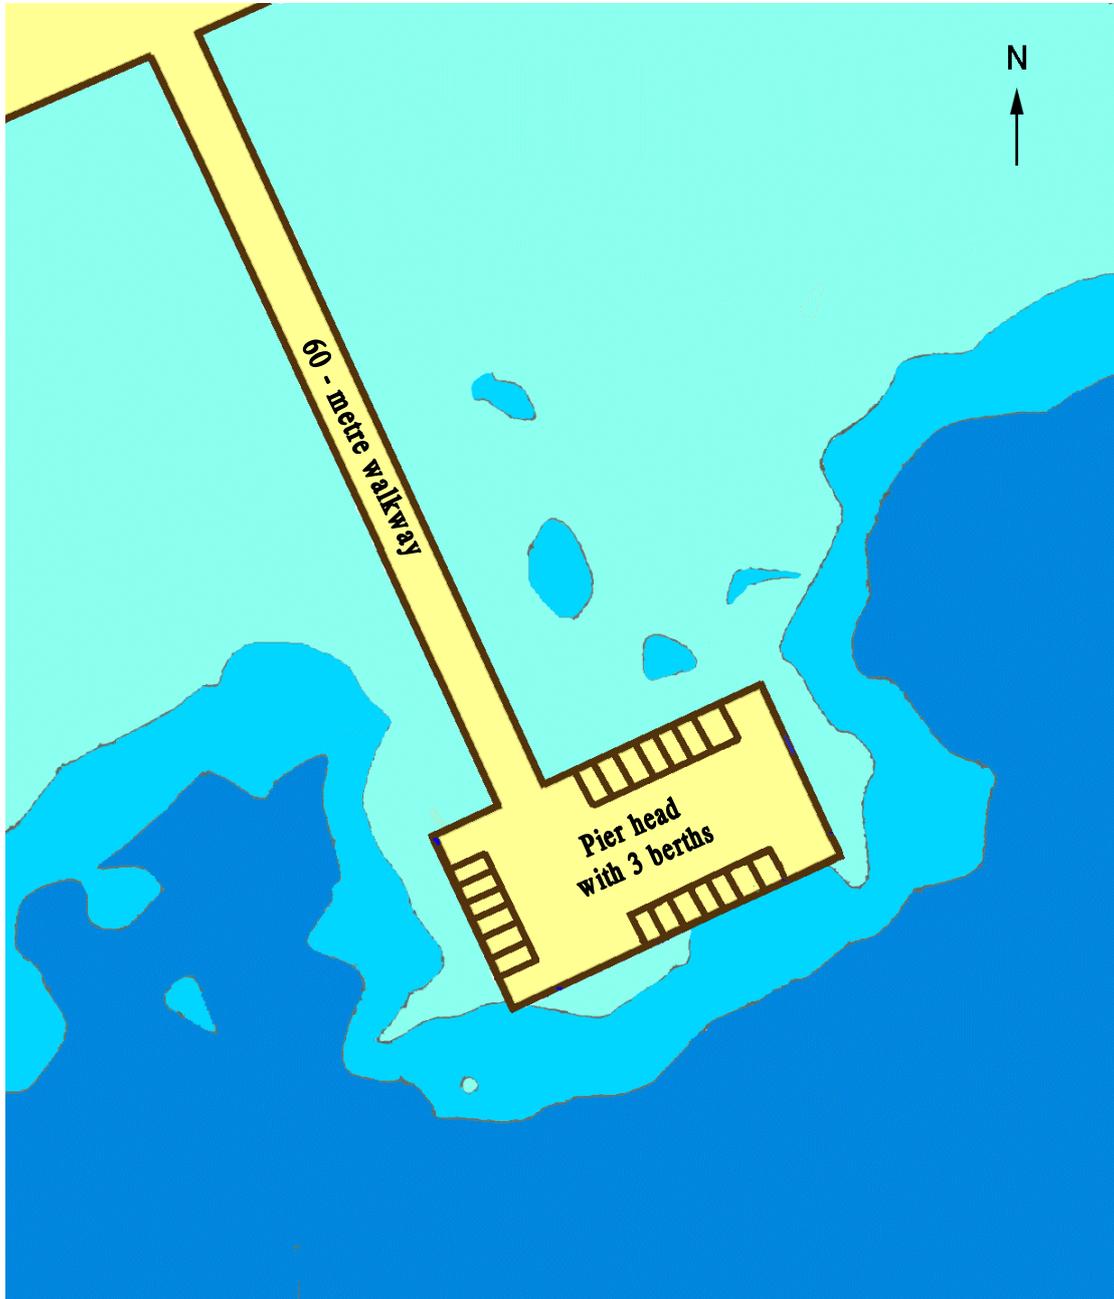
- (a) found that there were signs of siltation at the western side of the pier;
- (b) informed the HAD of the survey results; and
- (c) asked to be informed of any plan or action to be taken.

Sounding survey results around the new pier in Sham Tseng
