**Transport and Housing Bureau
Hong Kong Housing Authority
Housing Department
Buildings Department
Fire Services Department
Water Supplies Department**

**Maintenance and safety-related
improvements of public rental housing flats**

**Audit Commission
Hong Kong
28 October 2016**

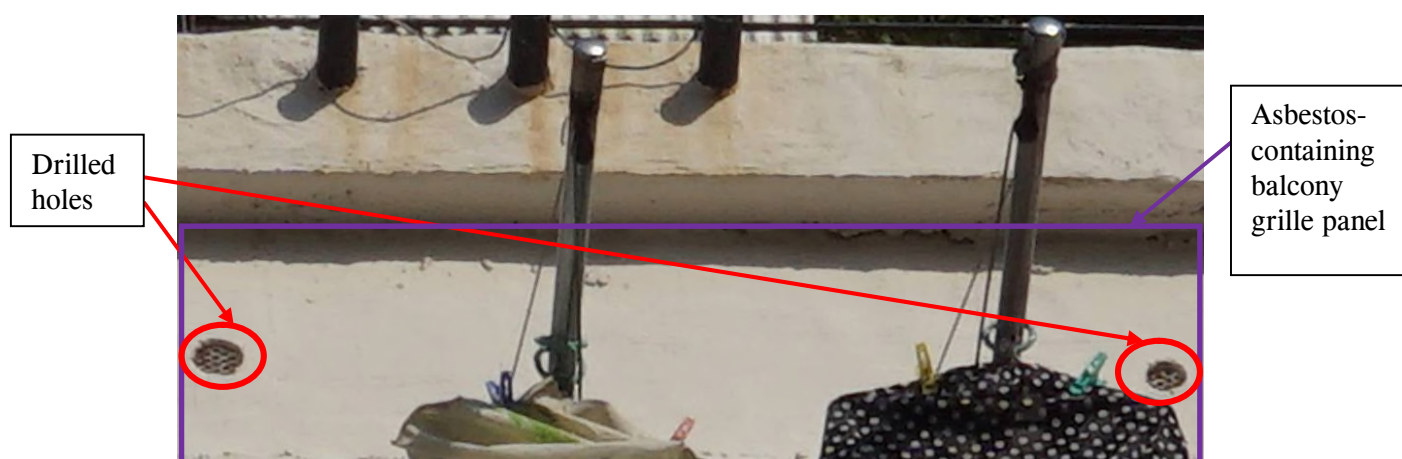
Photograph 4

**Drilled holes on asbestos-containing balcony grille panel
in Hing Wah (II) Estate**

4.14 All these six cases had not been reported by the HD's condition surveys conducted from 2010 to 2015 under the HD's existing assessment criteria (which were based on the length and surface area of the damage) for triggering a close range inspection (see para. 4.9(a)). However, the nature of these damaged parts (e.g. the drilled holes and protruding objects) suggested that there could be damage beneath the surface that warranted more detailed inspections. In Audit's view, the HD needs to review these six cases to see if any necessary follow-up action is required. The HD also needs to consider providing more guidelines on assessing the nature of damage found in condition surveys in light of the six cases.

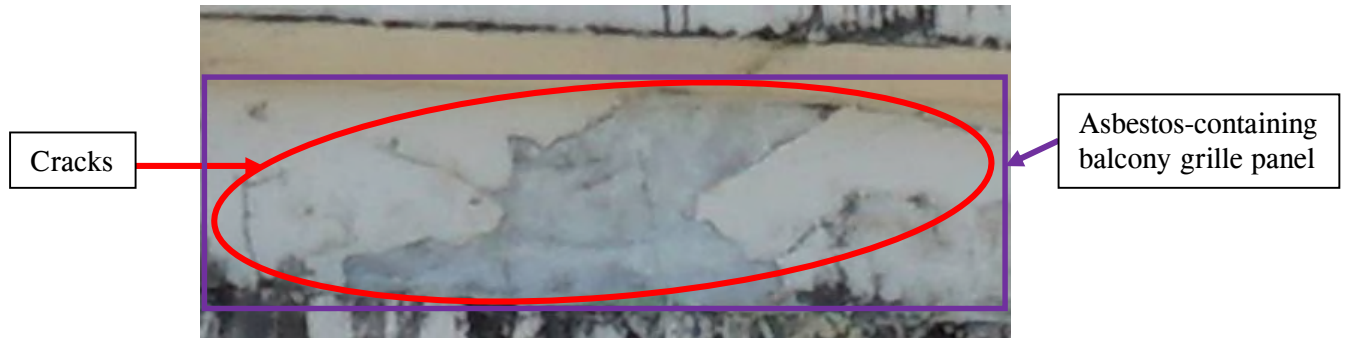
Photograph 5

**Cracks on asbestos-containing balcony grille panel
in Hing Wah (II) Estate**

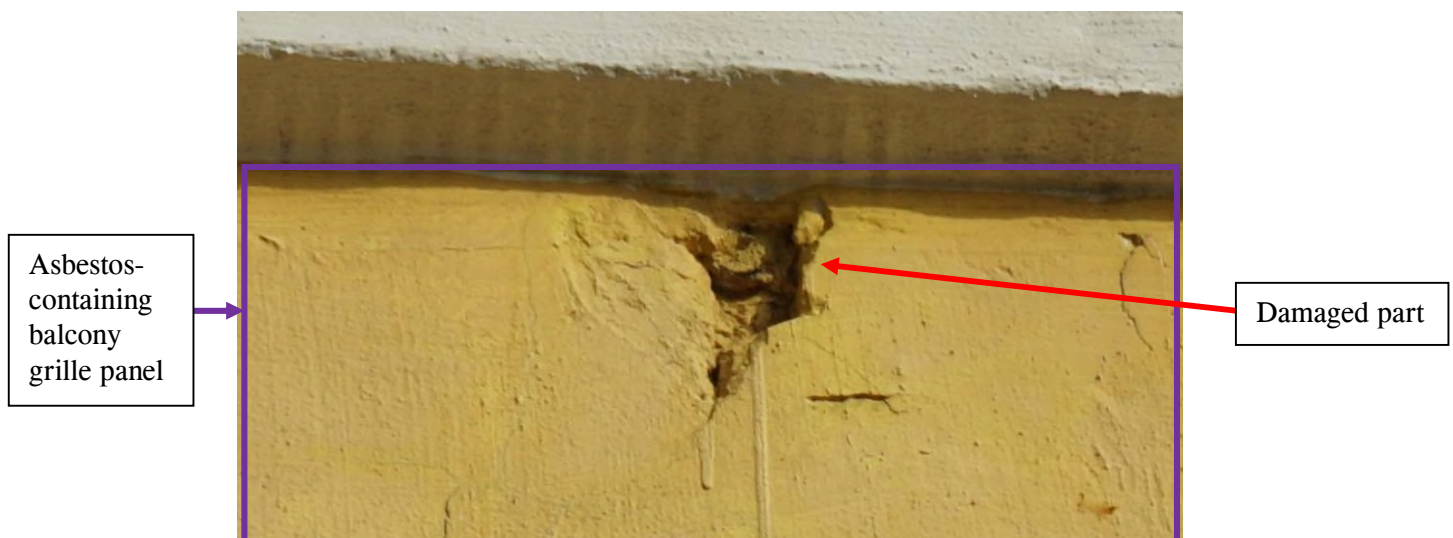
Photograph 6

**Damaged part on asbestos-containing balcony grille panel
in Shek Lei (2) Estate (Interim Housing)**

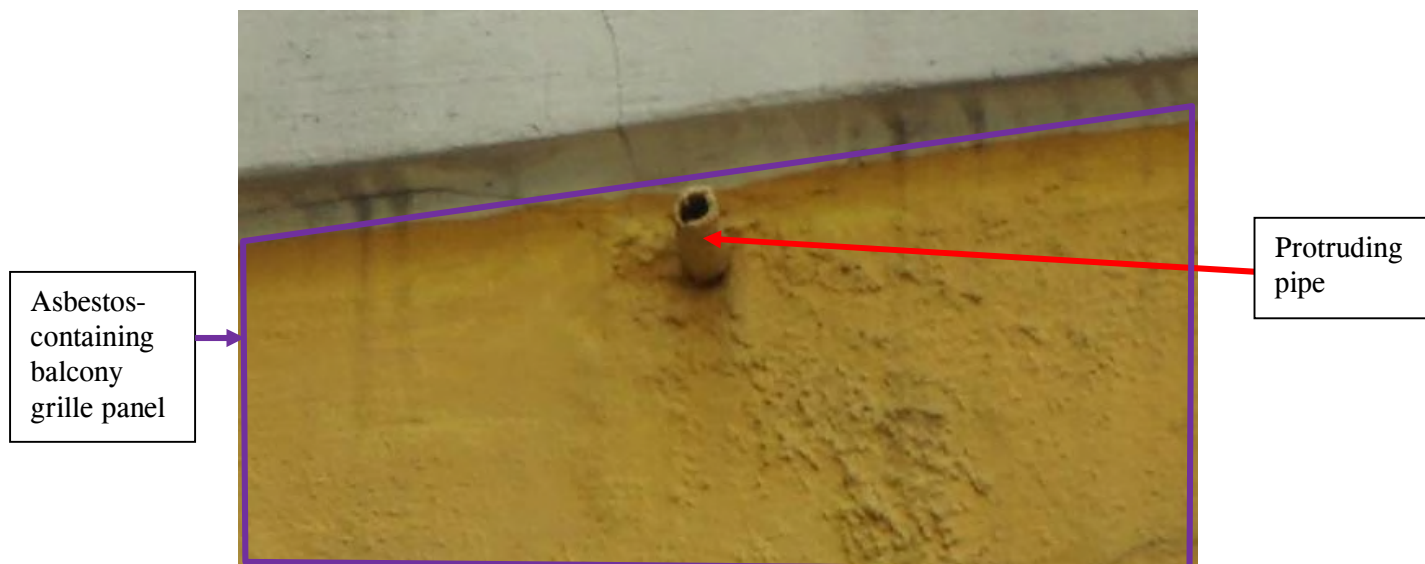
Photograph 7

**Protruding pipe on asbestos-containing balcony grille panel
in Shek Lei (2) Estate (Interim Housing)**

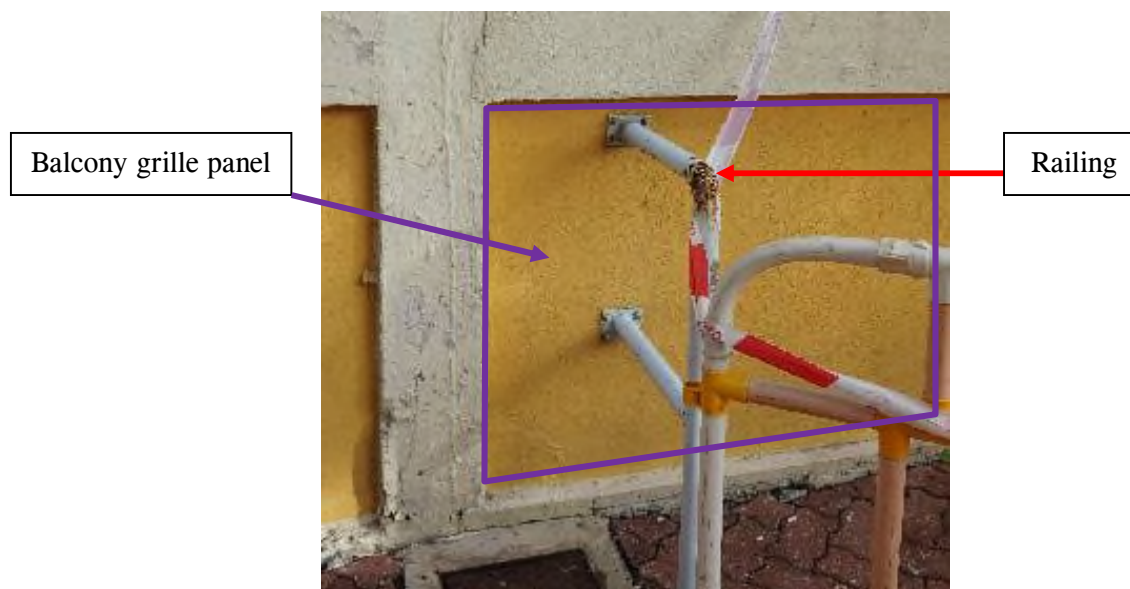
Photograph 8

**Railing installed on the balcony grille panel
of a ground floor flat
in Shek Lei (2) Estate (Interim Housing)**

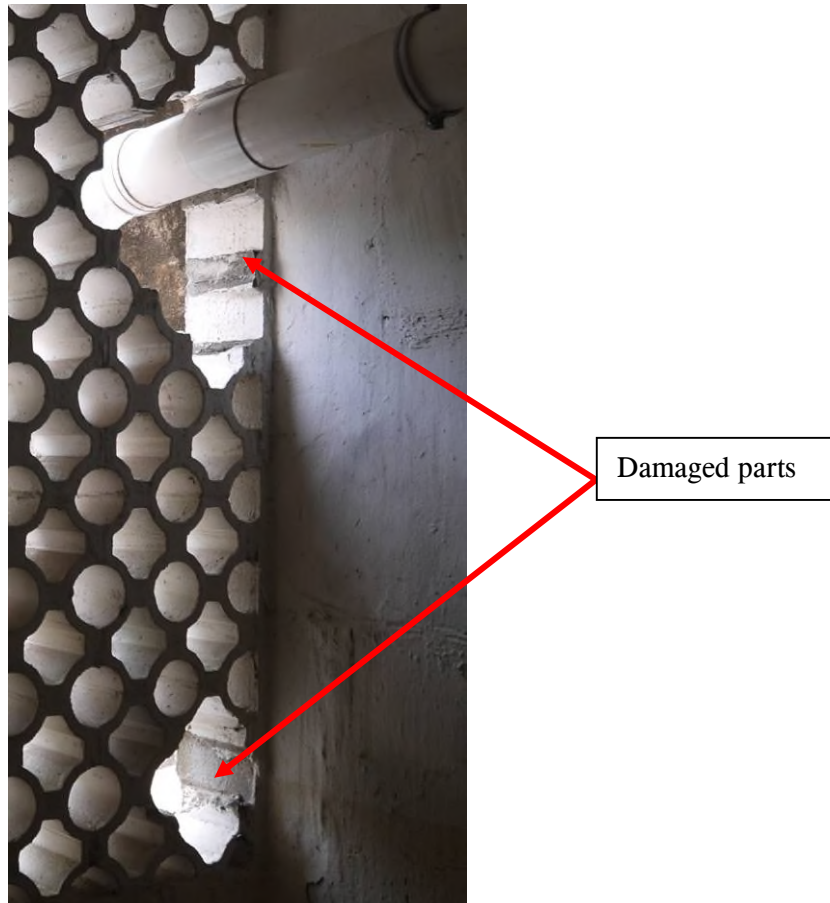
Photograph 9

**Asbestos-containing lobby grille with
damaged parts on the seventh floor of
Fung Hing House, Hing Wah (II) Estate**

4.17 The damaged lobby grilles with un-encapsulated ACMs could increase the risk of tenants' exposure to asbestos. On 25 August 2016, the HD informed Audit that:

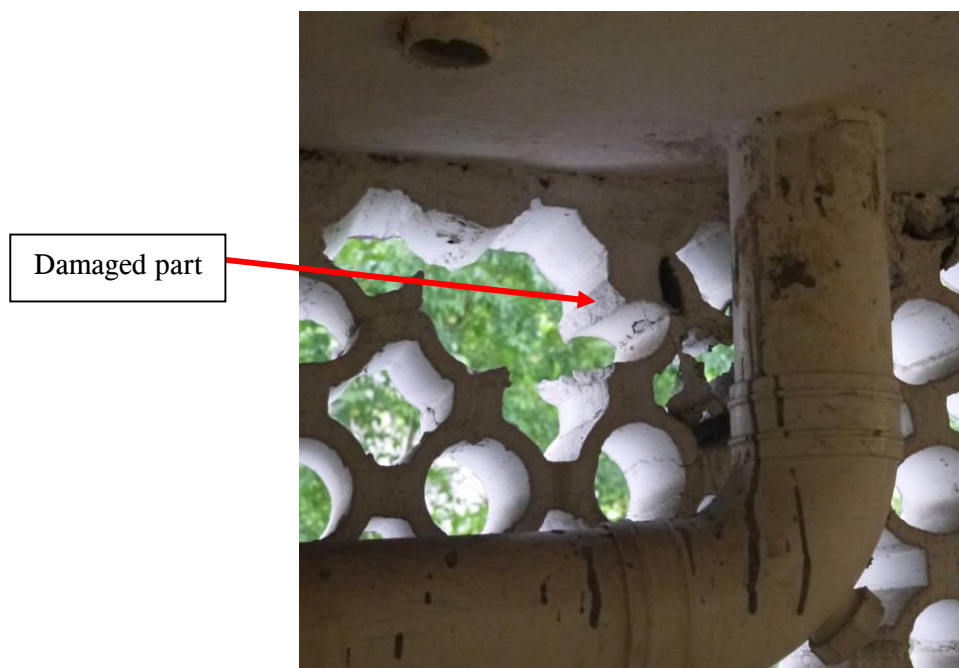
Photograph 10

**Asbestos-containing lobby grille with
a damaged part on the twelfth floor of
Yu Hing House, Hing Wah (II) Estate**

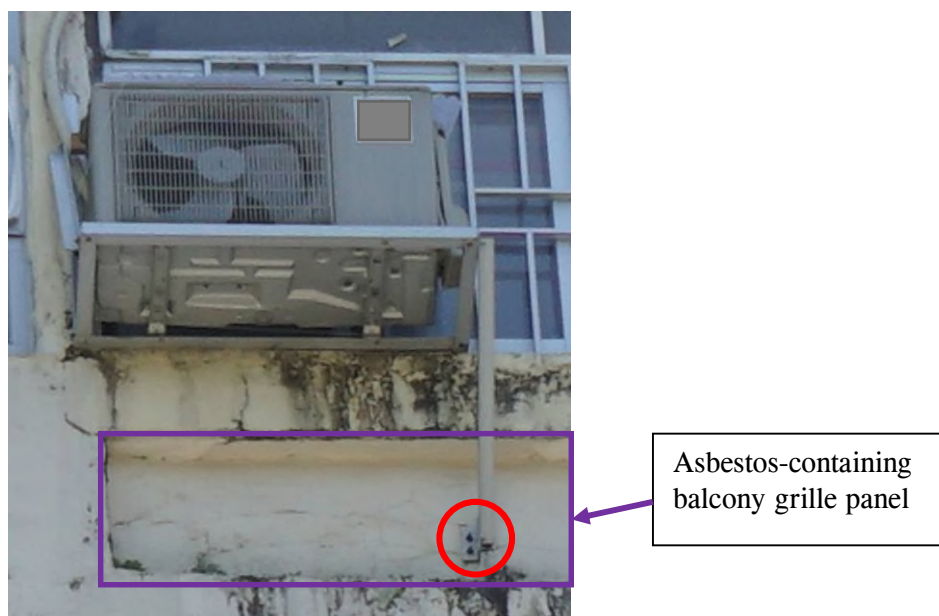
Photograph 13

**Air-conditioner supporting frame mounted
on asbestos-containing balcony grille panel
in Hing Wah (II) Estate**

4.29 ***Need to tighten the control over unauthorised works.*** HD staff had confirmed that all the 17 cases of air-conditioners mounted on the balcony grille panels were unauthorised as they had protrusions exceeding the HD allowed 100 mm from the external walls. There was a risk that the installation of these air-conditioners without the HD's authorisation and hence monitoring could have disturbed the ACMs and exposed the installation workers to asbestos thus released. In Audit's view, the HD needs to tighten the control over unauthorised works undertaken by tenants which could disturb ACMs and expose the tenants and workers to asbestos, and alert them to the risk of ACMs (see para. 4.32).

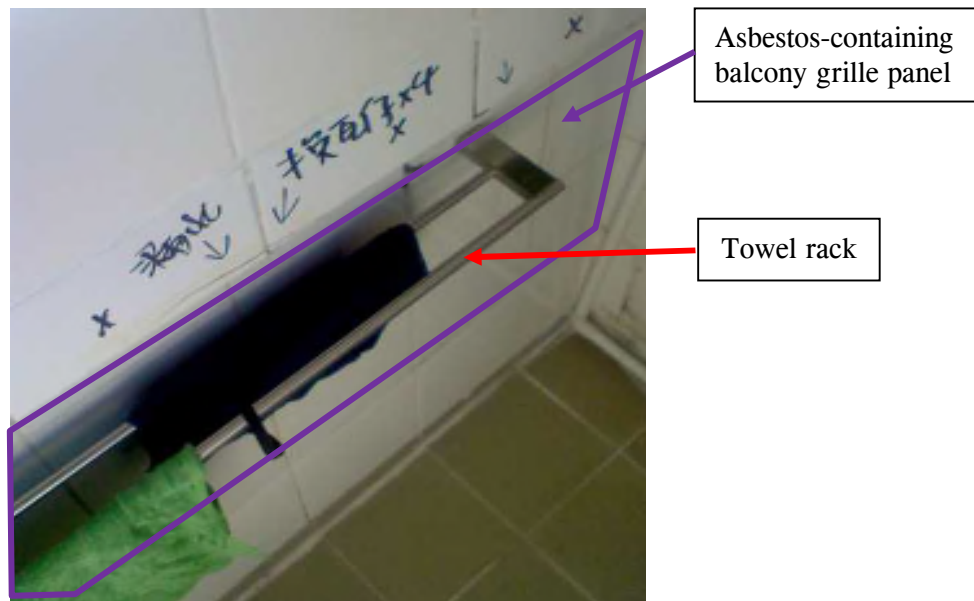
Photograph 14

**Towel rack installed by a tenant on the
encapsulated asbestos-containing balcony
grille panel in Hing Wah (II) Estate**

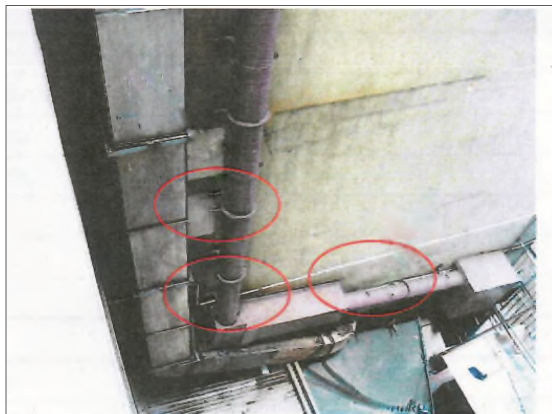
Photograph 15

**Damaged chimney with ACMs
in an estate (2011)**

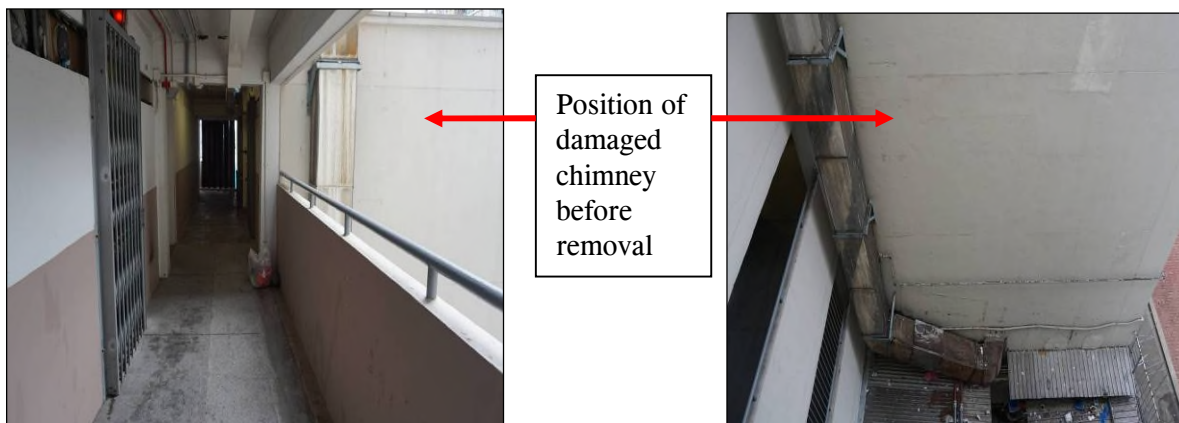
Photograph 16

**Damaged chimney in an estate
near the common corridor of domestic units before removal**

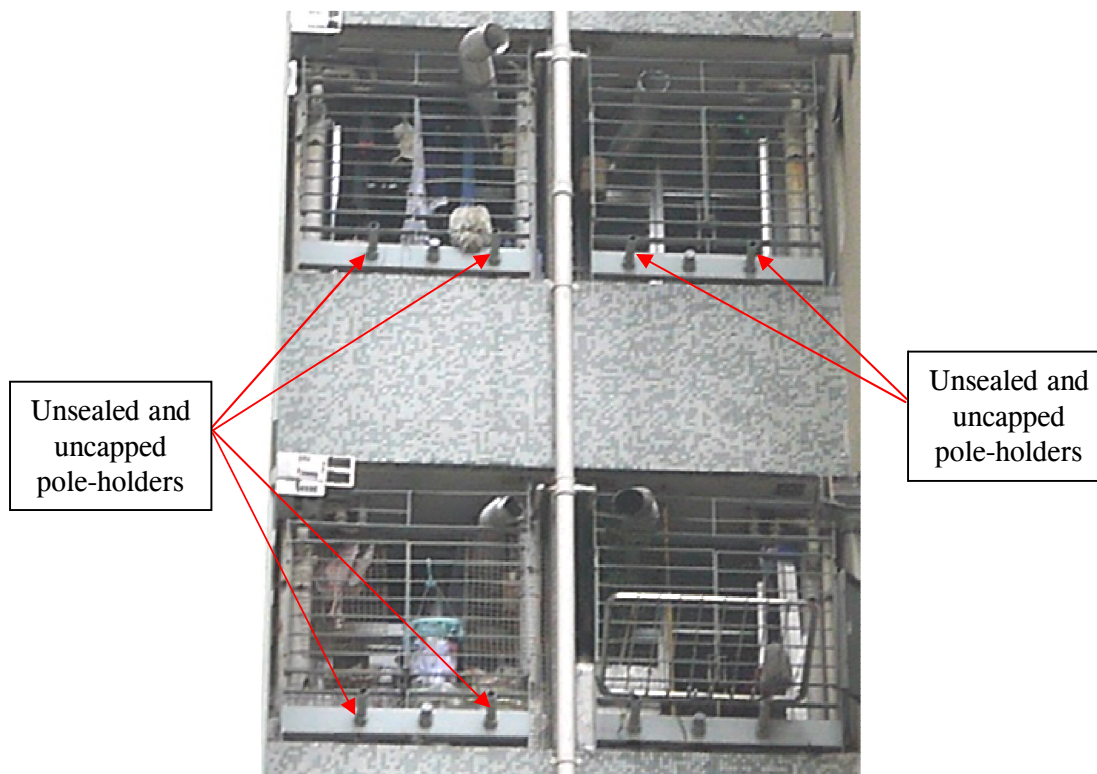
Photograph 17

**Flats with pole-holders partially sealed up
in Shek Yam East Estate**

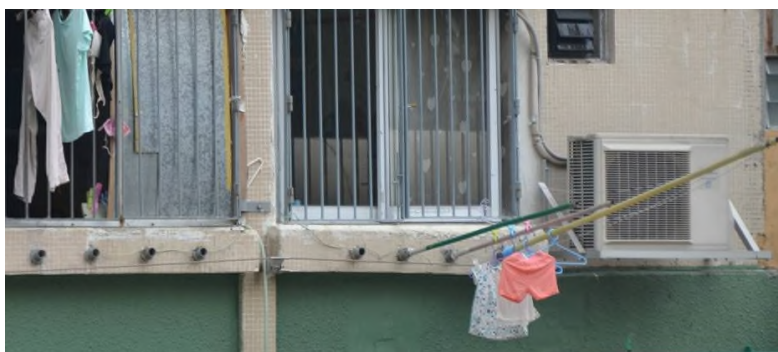
Photograph 18

**Flats with pole-holders not sealed up
in Shek Wai Kok Estate**
