# **Highways Department**

Management of the public lighting system

Audit Commission Hong Kong 27 October 2015 This audit review was carried out under a set of guidelines tabled in the Provisional Legislative Council by the Chairman of the Public Accounts Committee on 11 February 1998. The guidelines were agreed between the Public Accounts Committee and the Director of Audit and accepted by the Government of the Hong Kong Special Administrative Region.

# MANAGEMENT OF THE PUBLIC LIGHTING SYSTEM

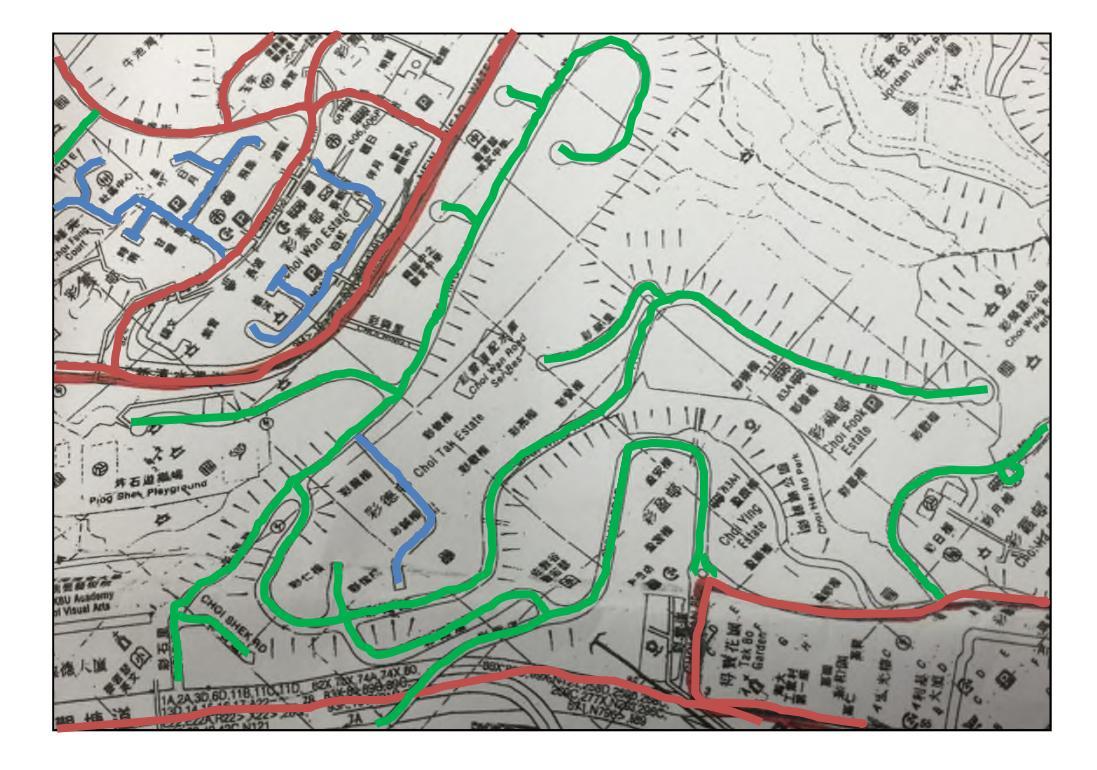
#### Figure 1

2.7 Audit sample checked some lighting points outside the 51 inspection routes and found that they were in fact accessible by vehicles (see Figure 1). According to the HyD, amongst the 52,432 lights not covered by its inspection routes, 38,032 (73%) were village lights or rear-lane and pedestrian-way lights not accessible by vehicles, i.e. the remaining 14,400 (27%) were directly accessible by vehicles. In Audit's view, the HyD needs to set adequate inspection routes to cover all the lighting points within the contract areas as far as possible.

#### HyD's inspection route (extract)

- 2.14 Audit has *recommended* that the Director of Highways should:
  - (a) improve the monitoring of road lighting availability by:
    - (i) setting adequate inspection routes for the night inspections of the MOM contract areas with a view to covering all the lighting points as far as possible;
    - (ii) tightening control over the annual review of inspection routes to ensure that new roads are duly included in the routes; and
    - (iii) enhancing the route selection computer programme to cater for both the randomness of selection and the laid-down requirement for all designated routes to be selected for inspections at least once a month; and
  - (b) review the cost-effectiveness of extending the use of the PLCMS, taking into account factors such as changes in maintenance costs and advancement in technology.

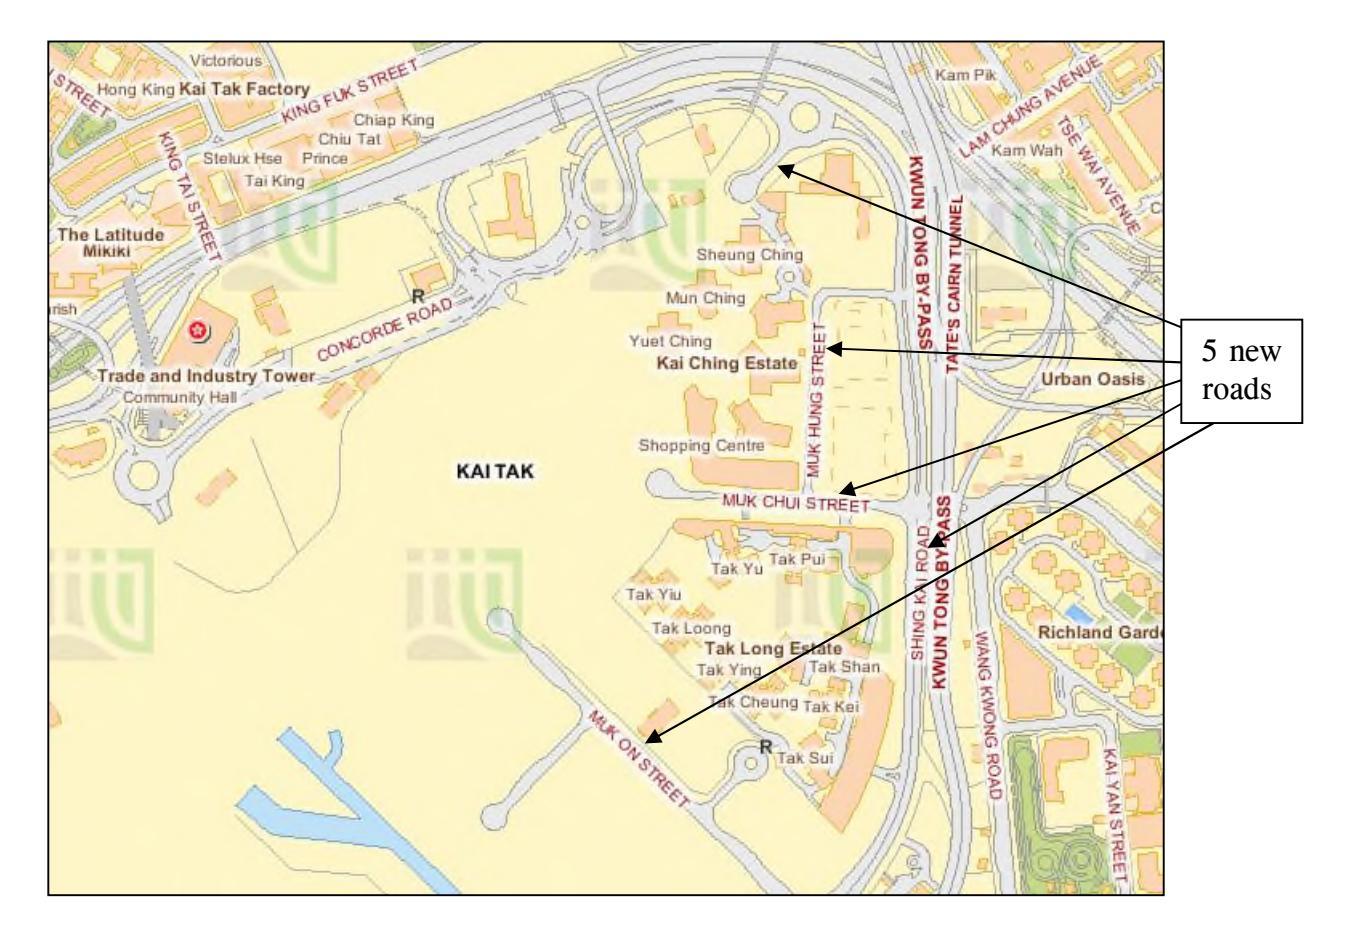
#### Figure 2

2.8 *New roads not included in inspection routes.* According to the HyD's instructions for its staff, an annual review on the inspection routes shall be conducted in the first quarter of a year to cater for any new roads developed (see para. 2.4(a)). However, there was no record to show that such reviews had been conducted in 2014 and 2015. Audit found cases whereby lighting points installed on new roads were not covered in the inspection routes. For example, 241 lighting points installed on five new roads in Kai Tak area from November 2012 to December 2014 were not covered in the HyD's inspection routes (see Figure 2).

#### Lighting points on new roads not covered by HyD's inspection routes

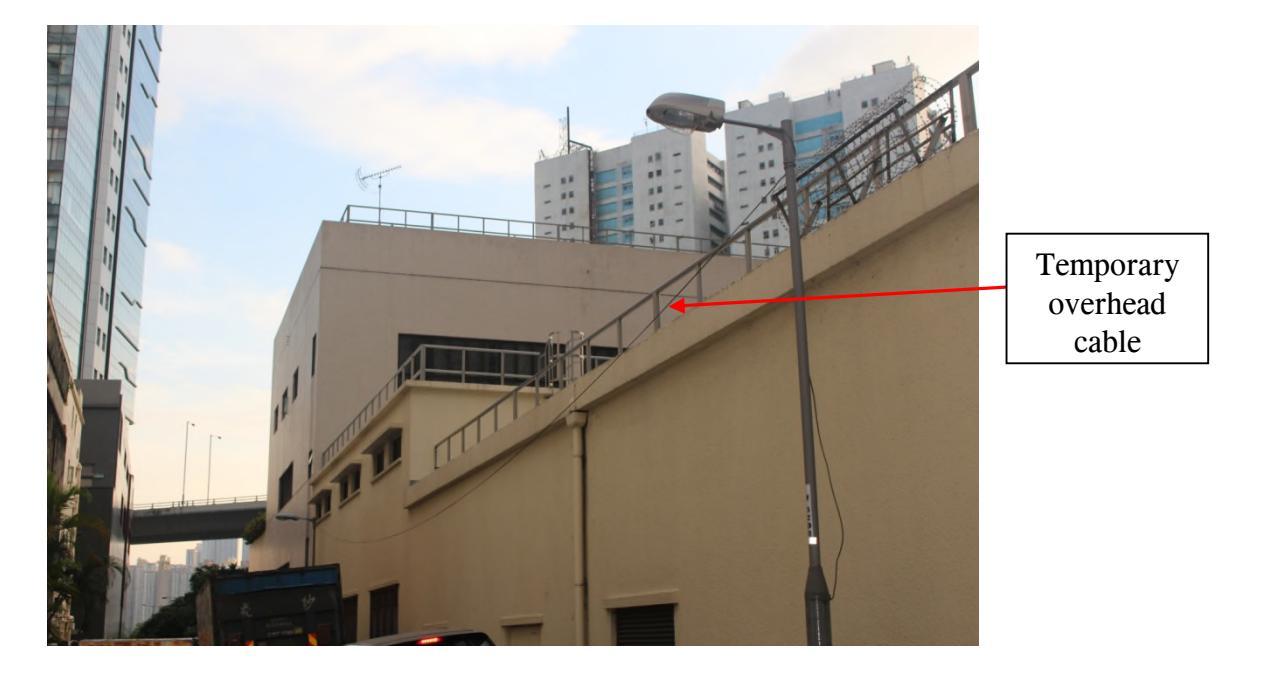
#### Photograph 2

2.35 According to the MOM contracts, when the power supply to a series of lights is faulted and cannot be repaired within a short time, the contractors shall arrange restoration of the lighting service by installing temporary overhead cables. The contractor shall remove all temporary overhead cables as soon as practicable by laying permanent cables.

#### A temporary overhead cable installed before October 2011

Remarks: According to HyD records, the overhead cable was installed before October 2011. The cable connecting two 5-metre lampposts did not comply with the EMSD's Code of Practice requirement on the minimum vertical clearance of 5.2 metres above ground.

- (c) follow up outstanding maintenance works with contractors concerned for completed MOM contracts and where appropriate, seek legal advice on the possible actions to be taken;
- (d) review the service lives of all types of lamps currently in use with a view to determining the most cost-effective replacement cycles and keep proper records of the review results; and
- (e) require contractors concerned to expedite action on completing the outstanding scheduled maintenance works and the replacement of temporary overhead cables by permanent ones.

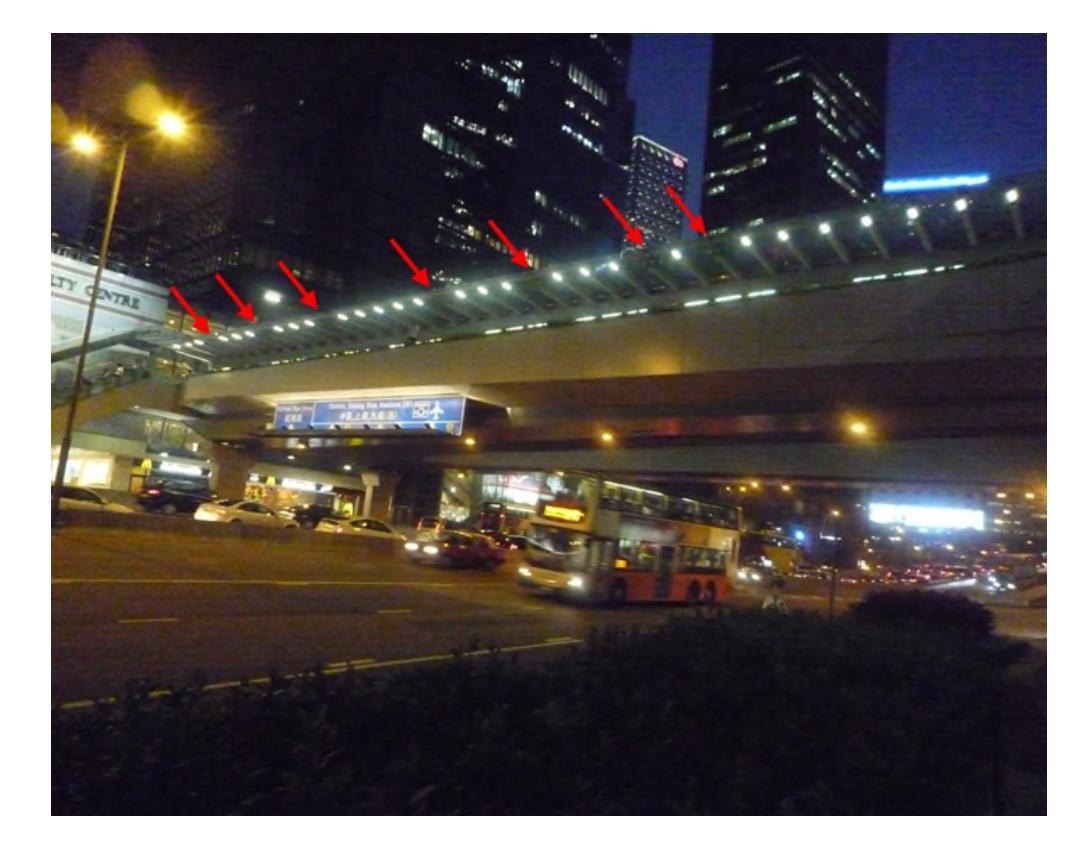
#### Photograph 3

#### A footbridge in Admiralty not covered by regular patrol service

*Legend:* → 7 *unlit lights*

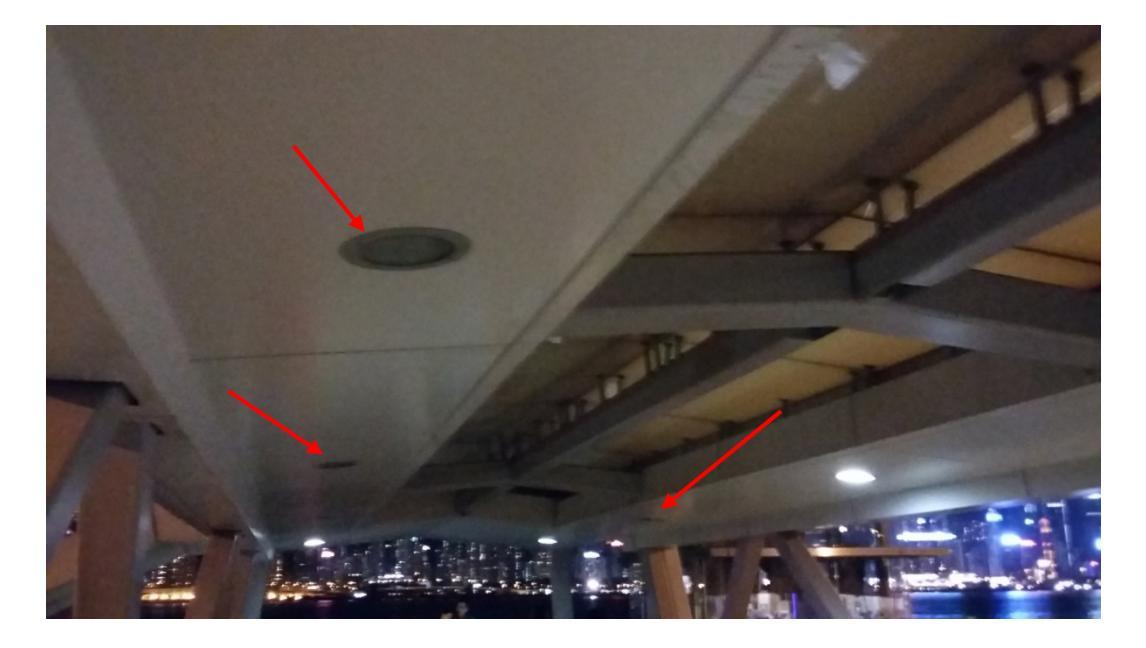
#### Photograph 6

Faulty lights of a footbridge at Salisbury Road not yet rectified since identification in March 2014

Legend:  $\longrightarrow$  3 unlit lights

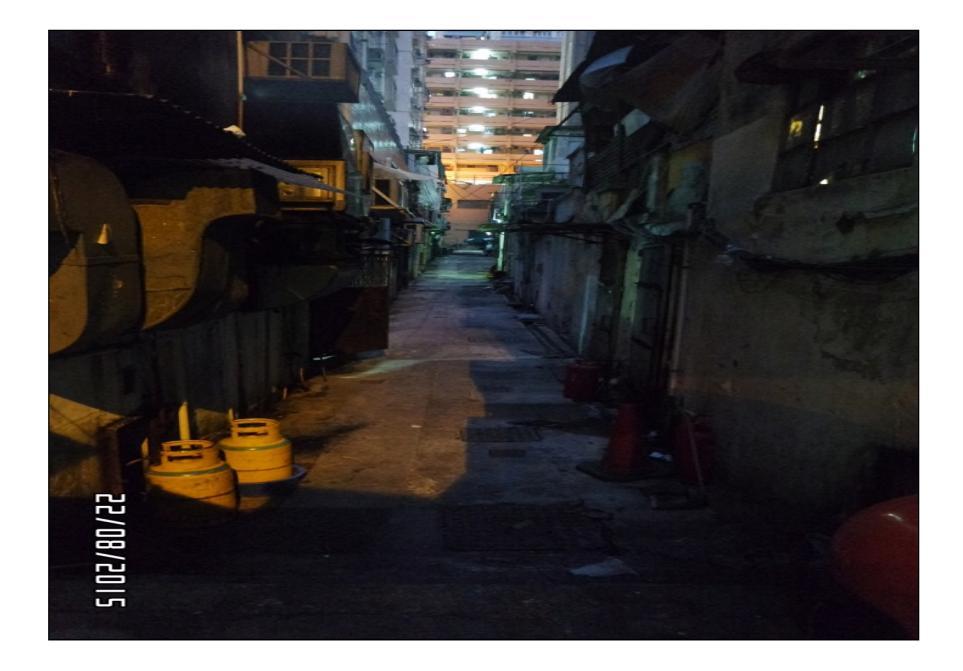
#### Photograph 7

#### Approved lighting installation in a rear lane subsequently found not feasible
