Provision of footbridges and subways

**Audit Commission
Hong Kong
25 October 2007**

PROVISION OF FOOTBRIDGES AND SUBWAYS

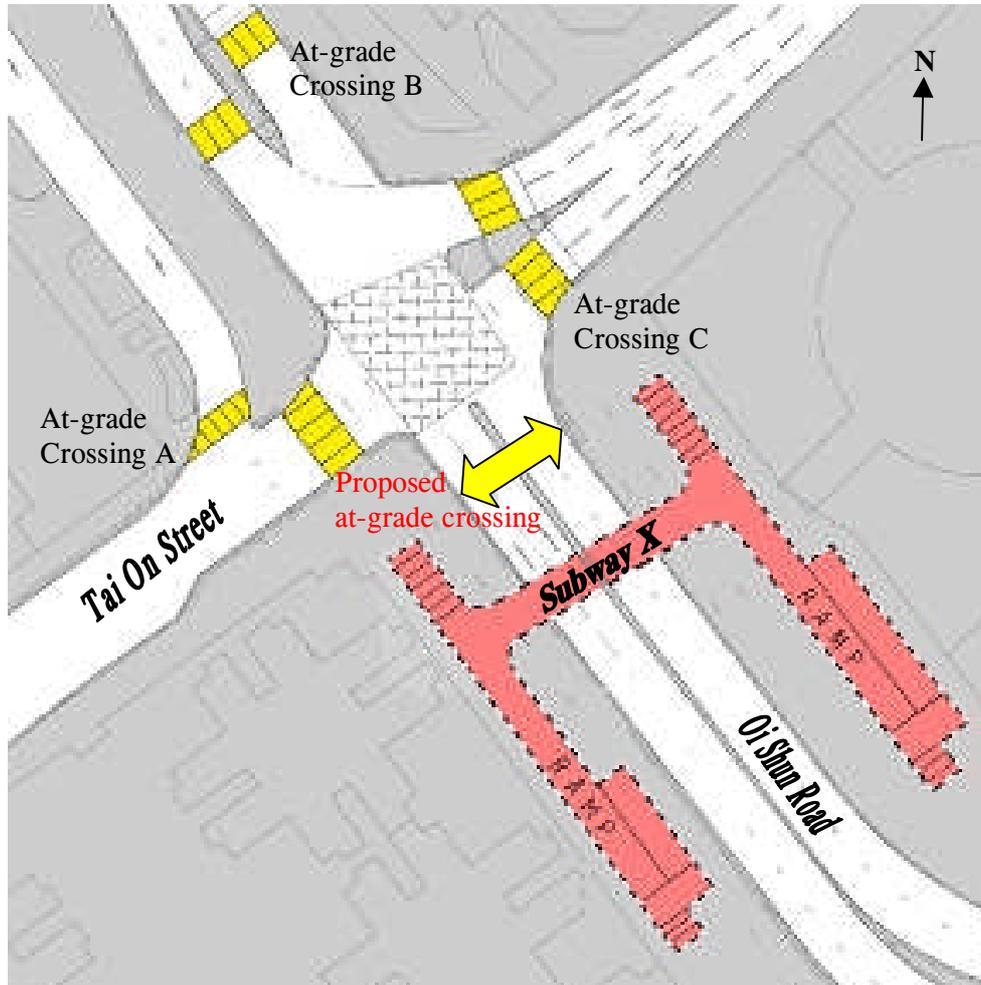
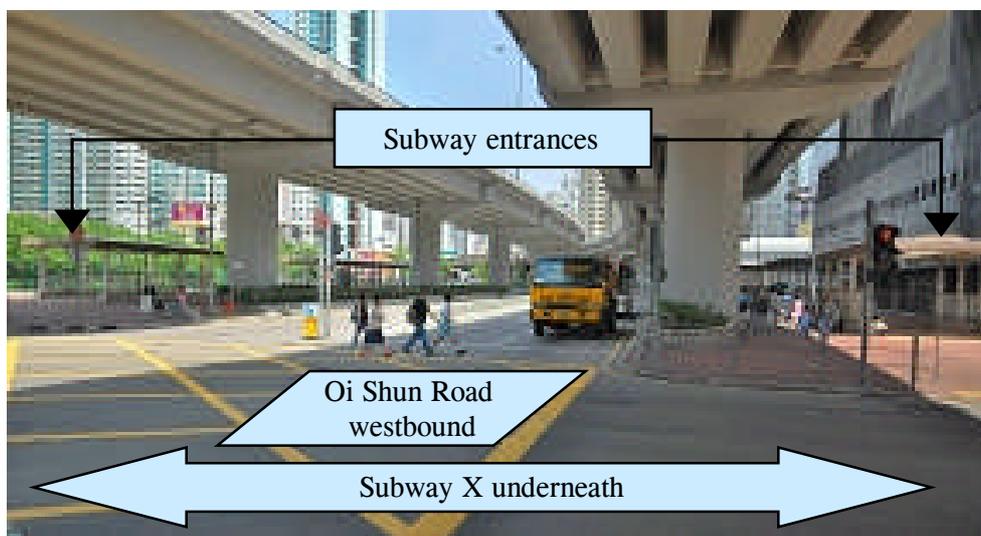
Figure 2
Subway X in Sai Wan Ho

3.3 In December 2003, Subway X was constructed at a cost of \$7.3 million. It is 192 metres long, with a staircase and a ramp at each end. At the junction of Oi Shun Road and Tai On Street, there are also three sets of at-grade signal-controlled pedestrian crossings (Crossings A to C — see Figure 2 and Photograph 1).

Photograph 1
Subway X in Sai Wan Ho

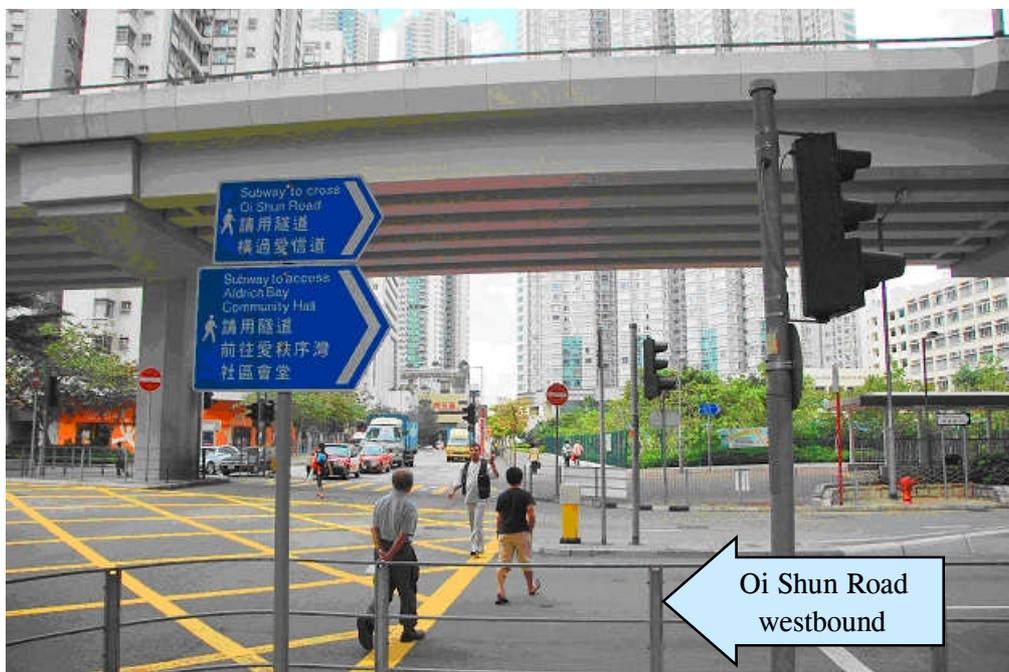
Photograph 2

3.9 In April and July 2007, Audit conducted two field visits to Subway X and the nearby areas. Audit noted that:

Traffic signs guiding pedestrians to use Subway X

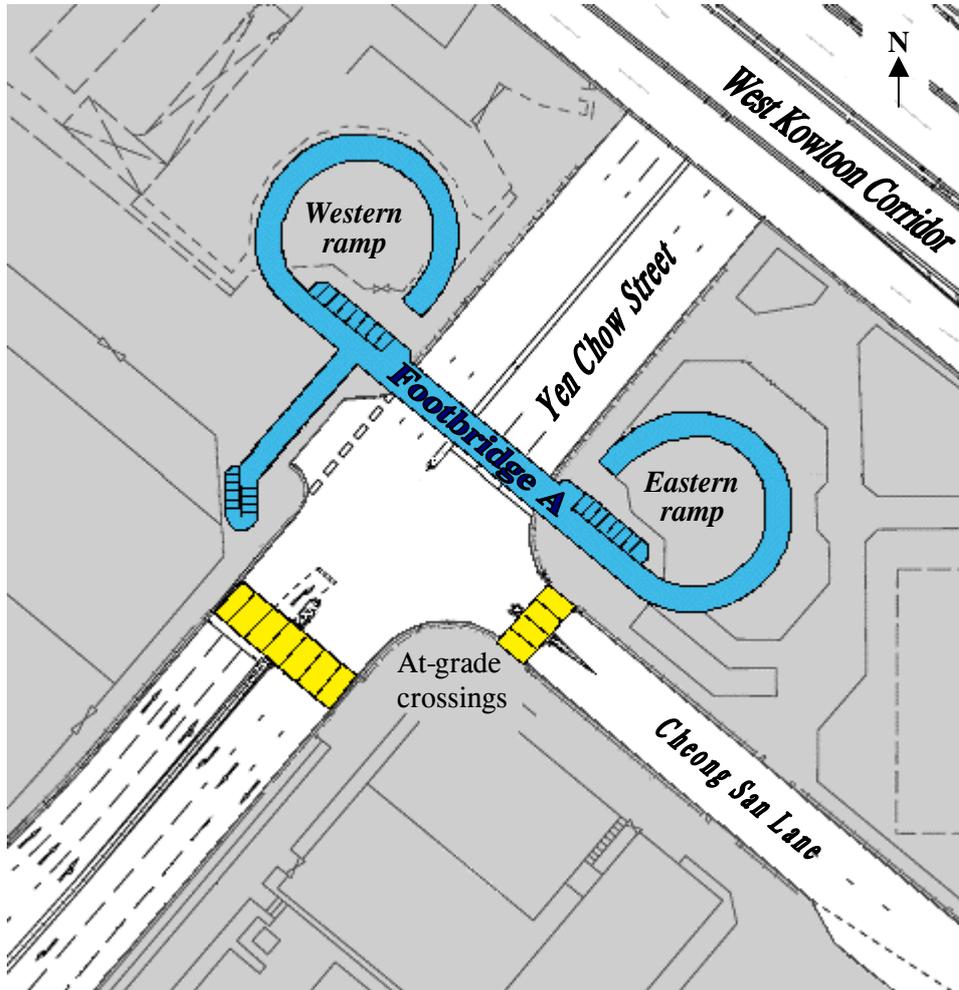
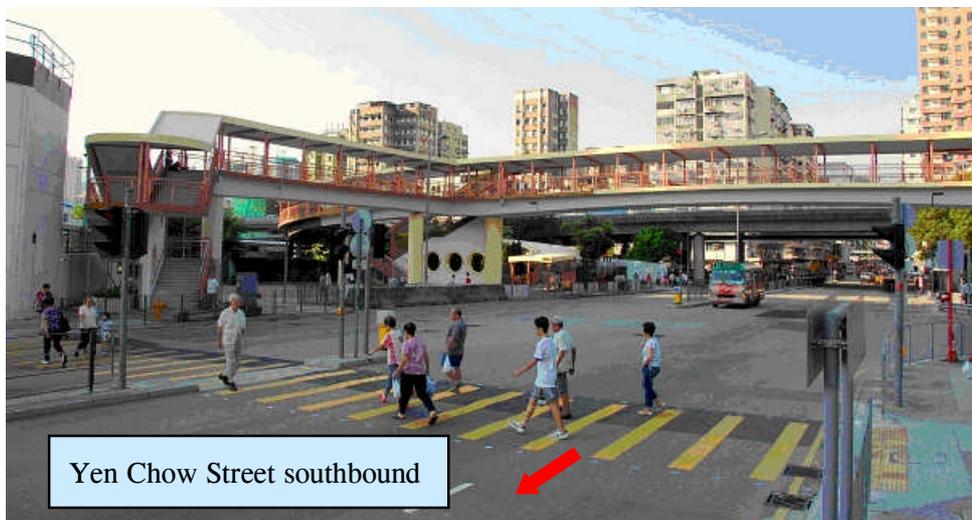
Figure 3
Footbridge A in Sham Shui Po

4.2 In 1990, the HyD constructed Footbridge A under the project “Footbridge across Yen Chow Street near Sham Shui Po Ferry Concourse”. This footbridge is 217 metres long, with a staircase and a circular ramp at each end. It spans across Yen Chow Street near Cheong San Lane. The nearby residential developments include Nam Cheong Estate (completed in 1989) and Fu Cheong Estate (completed in 2001). Close to Footbridge A, there are two sets of at-grade signal-controlled pedestrian crossings for crossing Yen Chow Street and Cheong San Lane respectively (see Figure 3 and Photograph 3).

Photograph 3
Footbridge A in Sham Shui Po

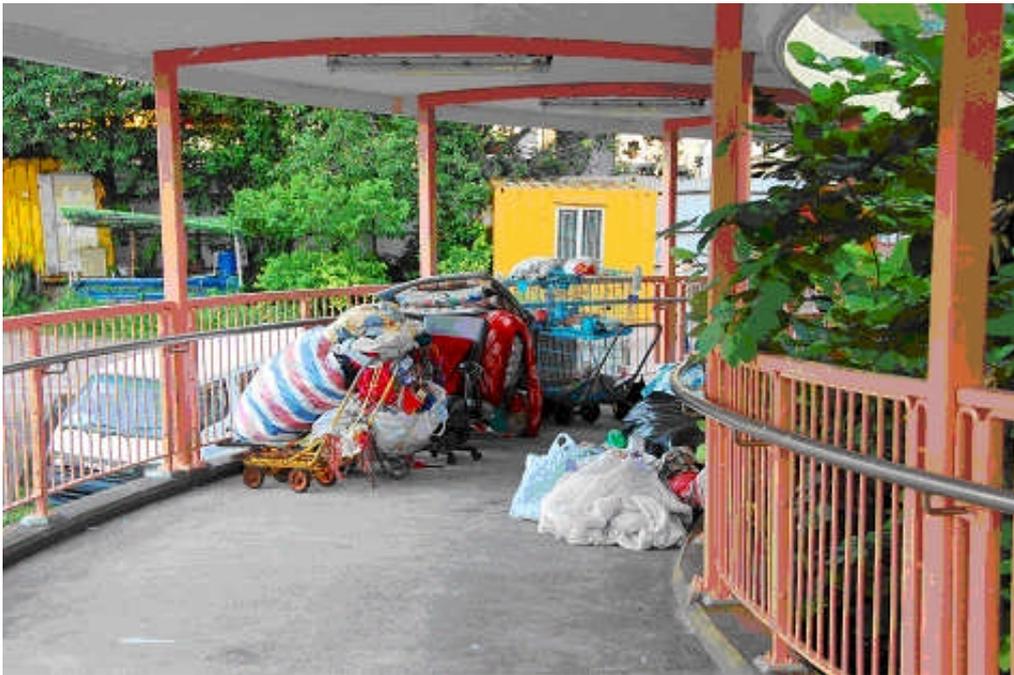
Photograph 4

- 4.7 During the maintenance inspection (see para. 4.6(a)), the HyD also found that:
- (a) Footbridge A's conditions had been deteriorating, with cracks on the paint of the steel and concrete surfaces. There was also corrosion at the steel railings; and
 - (b) it was necessary to carry out major rehabilitation from both the maintenance and aesthetics points of view.

Trolleys and debris at western ramp of Footbridge A

4.19 **Audit has recommended that the Commissioner for Transport and the Director of Highways should formulate a strategy for the future maintenance of the five footbridges mentioned in this PART, taking into account expected utilisation, pedestrian needs, the street-sleeper problem and the cost of maintenance (see para. 4.18).**

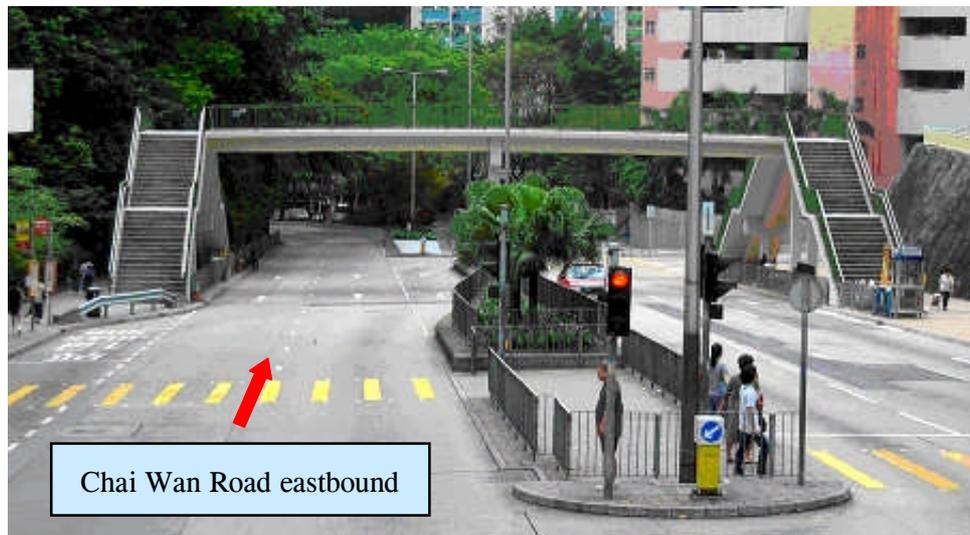
Photograph 5
Footbridge B in Chai Wan

| Footbridge | Location | Year of construction | Year of installation of nearby at-grade crossing |
|---|---|---|--|
| B | Across Chai Wan Road near Wan Tsui Road in Chai Wan (see Figure 4 and Photograph 5) | 1971 | 1982 |

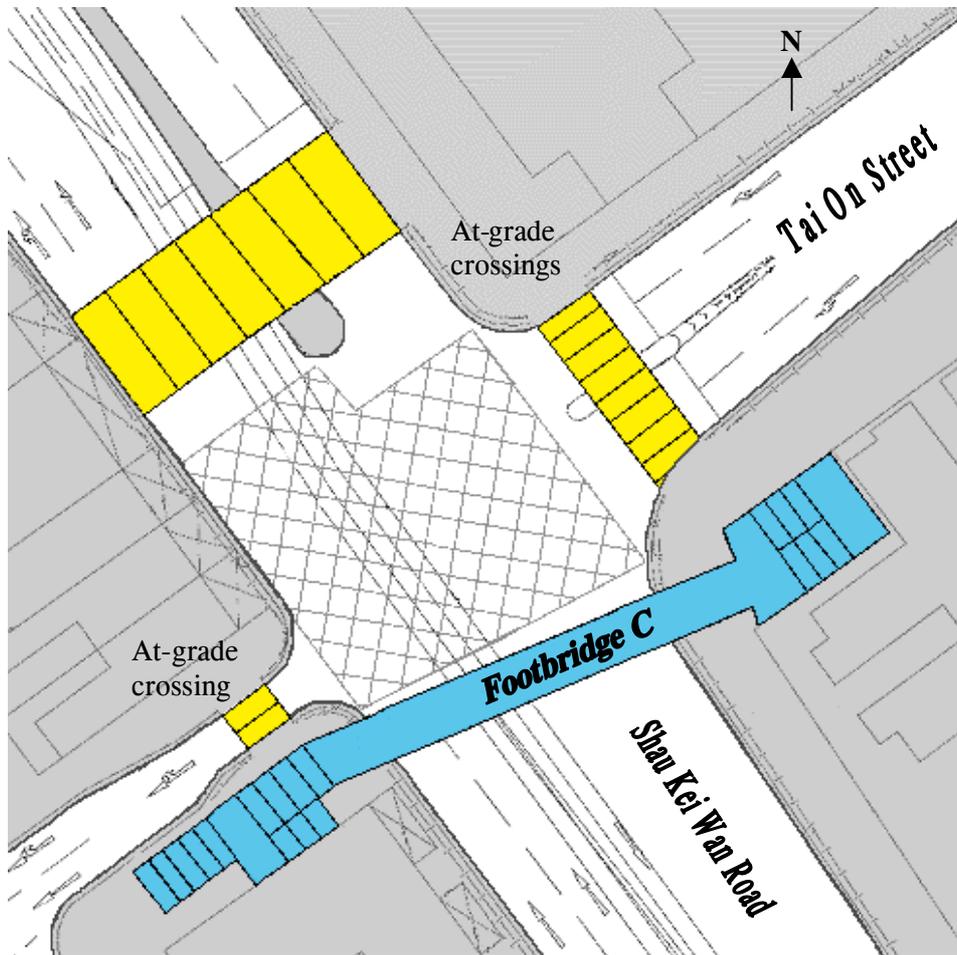
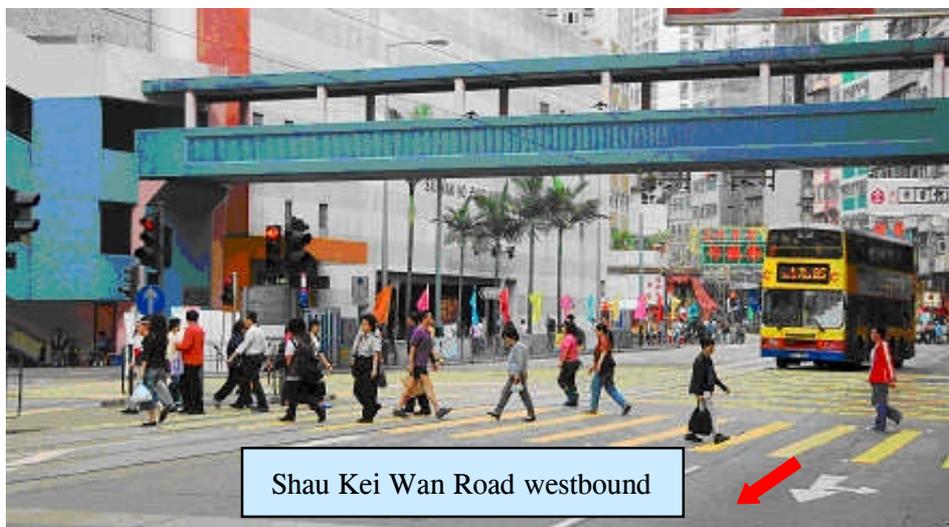
Figure 5
Footbridge C in Sai Wan Ho

Photograph 6
Footbridge C in Sai Wan Ho

- (b) in May 1992, the Eastern DO of the HAD informed the HyD that:
 - (i) many pedestrians were unwilling to use Footbridge C to cross Shau Kei Wan Road. The main reason was that pedestrians, especially the elderly, found the footbridge very high to walk up. Many pedestrians jaywalked to cross the road and risked the danger involved. This gave rise to a road safety problem; and
 - (ii) if escalators were installed, pedestrians would be very willing to use Footbridge C.

Owing to insufficient space, escalators were not installed for Footbridge C. In September 2007, the HAD informed Audit that, apart from site constraint, it was not cost effective to carry out substantial improvement works to Footbridge C due to its age and deteriorated conditions; and

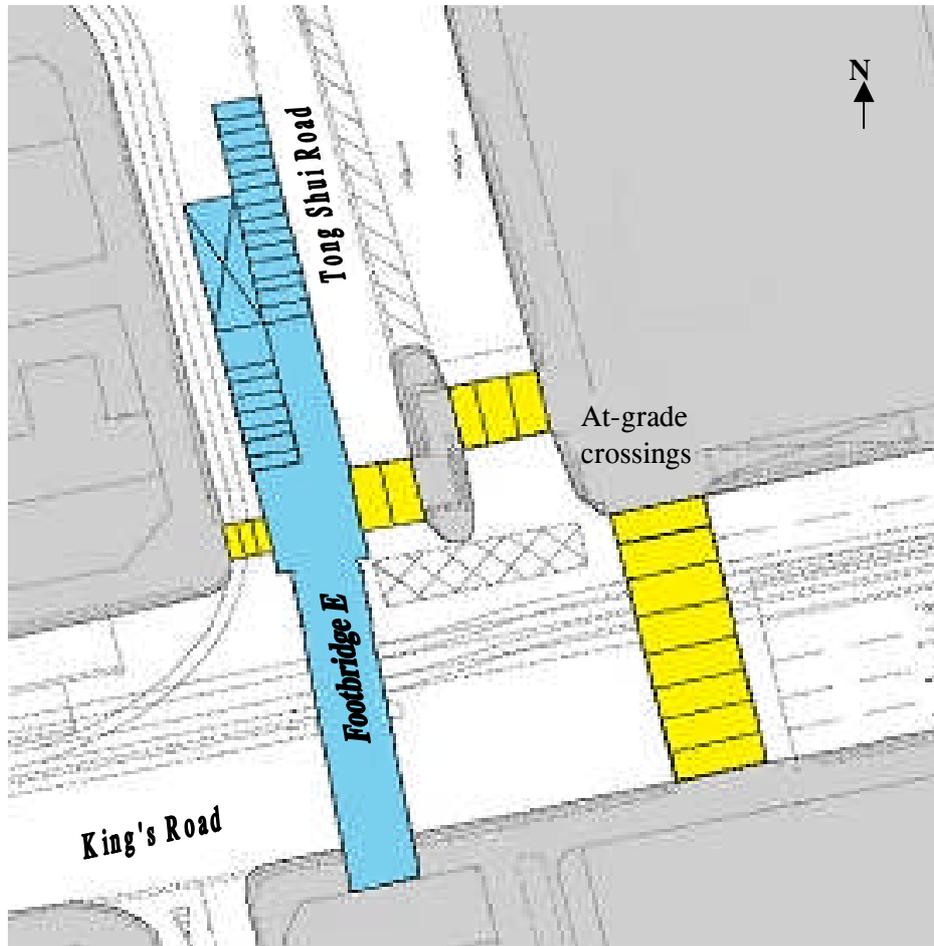
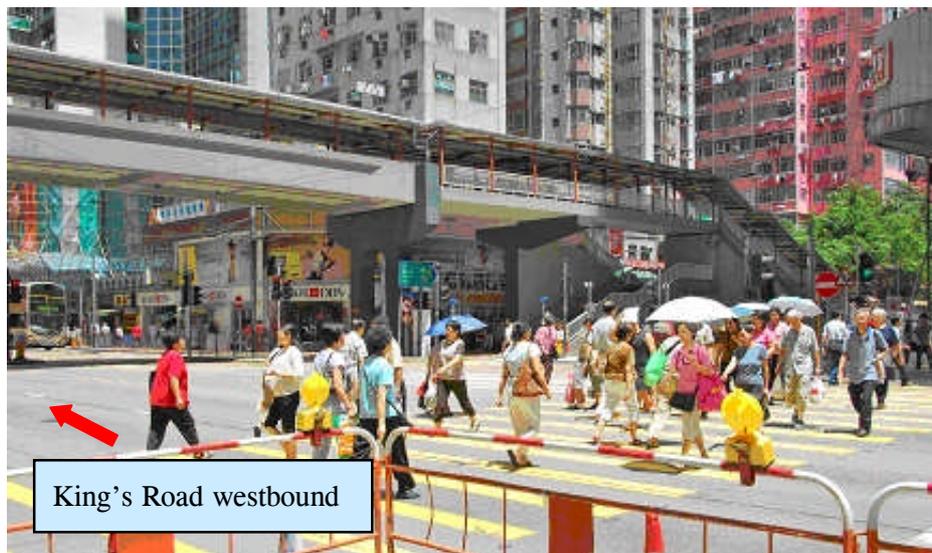
Figure 7
Footbridge E in North Point

Photograph 8
Footbridge E in North Point

4.17 For Footbridge E, Audit noted that, from 2002 to 2006, there were 24 traffic accidents involving pedestrians at the location. **With a view to enhancing pedestrian safety, there is a need for the TD to take measures to encourage more pedestrians to use Footbridge E.**

4.18 The four footbridges were built 22 to 36 years ago. They require substantial recurrent operation and maintenance costs. For example, in 2002, the HyD spent \$1.4 million on major rehabilitation of Footbridge E to deal with the water leakage and

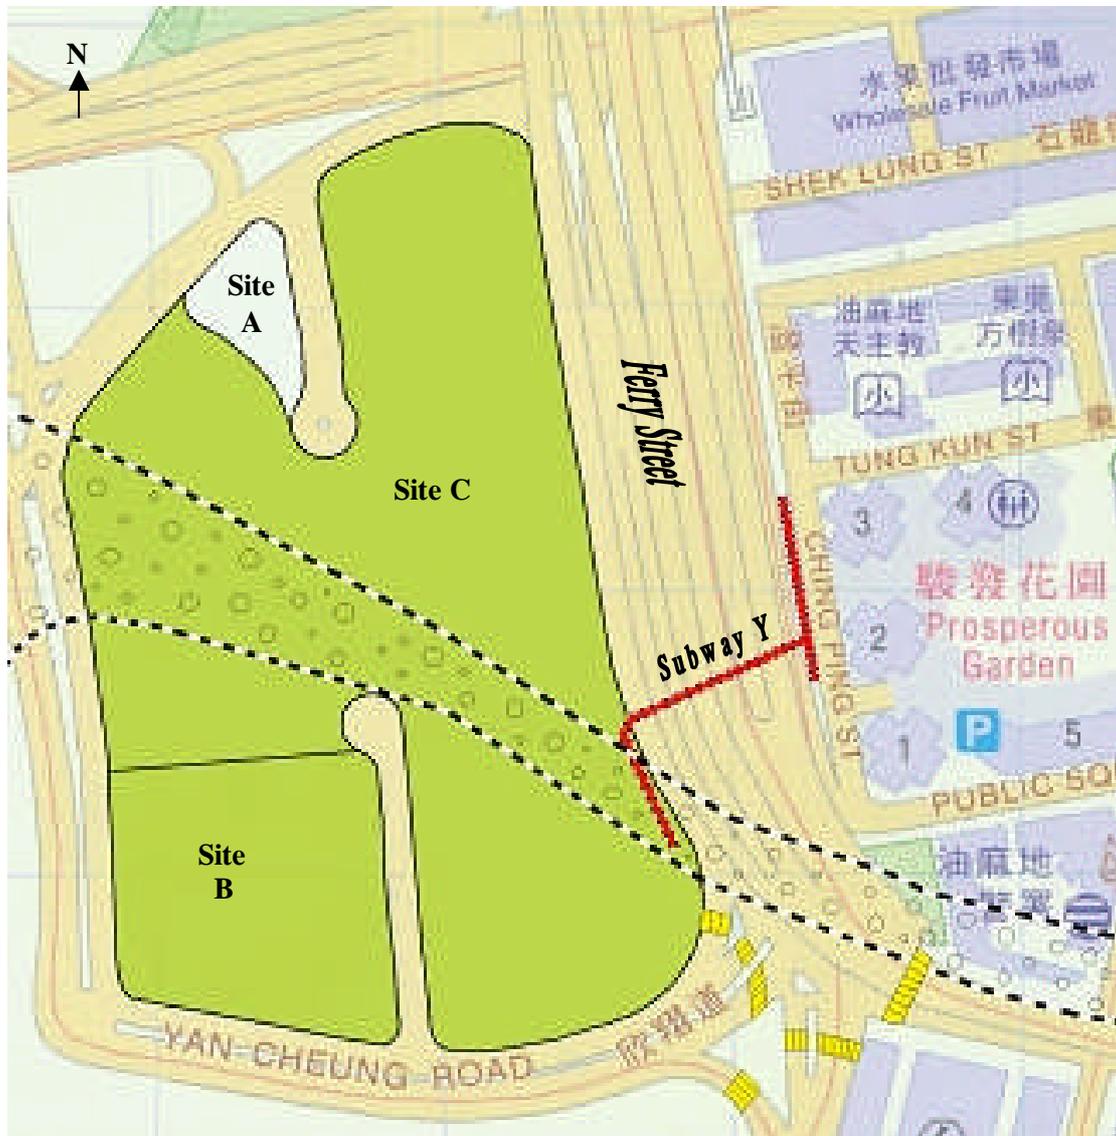
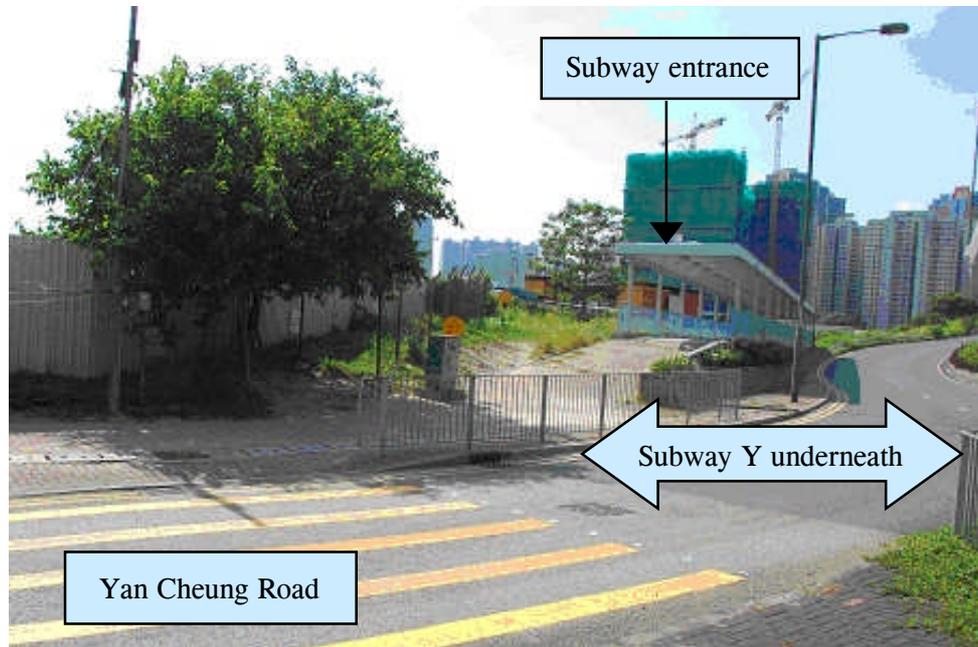
Figure 8
Subway Y in Yau Ma Tei

5.2 In January 1997, the HyD completed constructing Subway Y at a cost of \$6.8 million as part of the project “West Kowloon Corridor — Yau Ma Tei Section, Phase II and associated footbridge and subway systems”. The subway is 96 metres long. It spans across Ferry Street, connecting Ching Ping Street (near Prosperous Garden) to sites in a reclamation area pending development (see Figure 8 and Photograph 9).

Subway Y in Yau Ma Tei

5.3 In June 2000, the HyD noted during an inspection that many street sleepers had occupied Subway Y, polluting the walls and causing blockage of the subway drains. In August 2000, the HyD requested the Yau Tsim Mong DO to take appropriate action. The DO carried out operations jointly with the Food and Environmental Hygiene Department, the Social Welfare Department, the Lands Department and the Hong Kong Police Force. Despite several operations, the problem persisted. Gambling and drug abuse activities were noted inside this subway, giving rise to public complaints. The departments conducted joint operations on a weekly basis. In June 2001, the Yau Tsim Mong DO wrote to the government departments concerned:

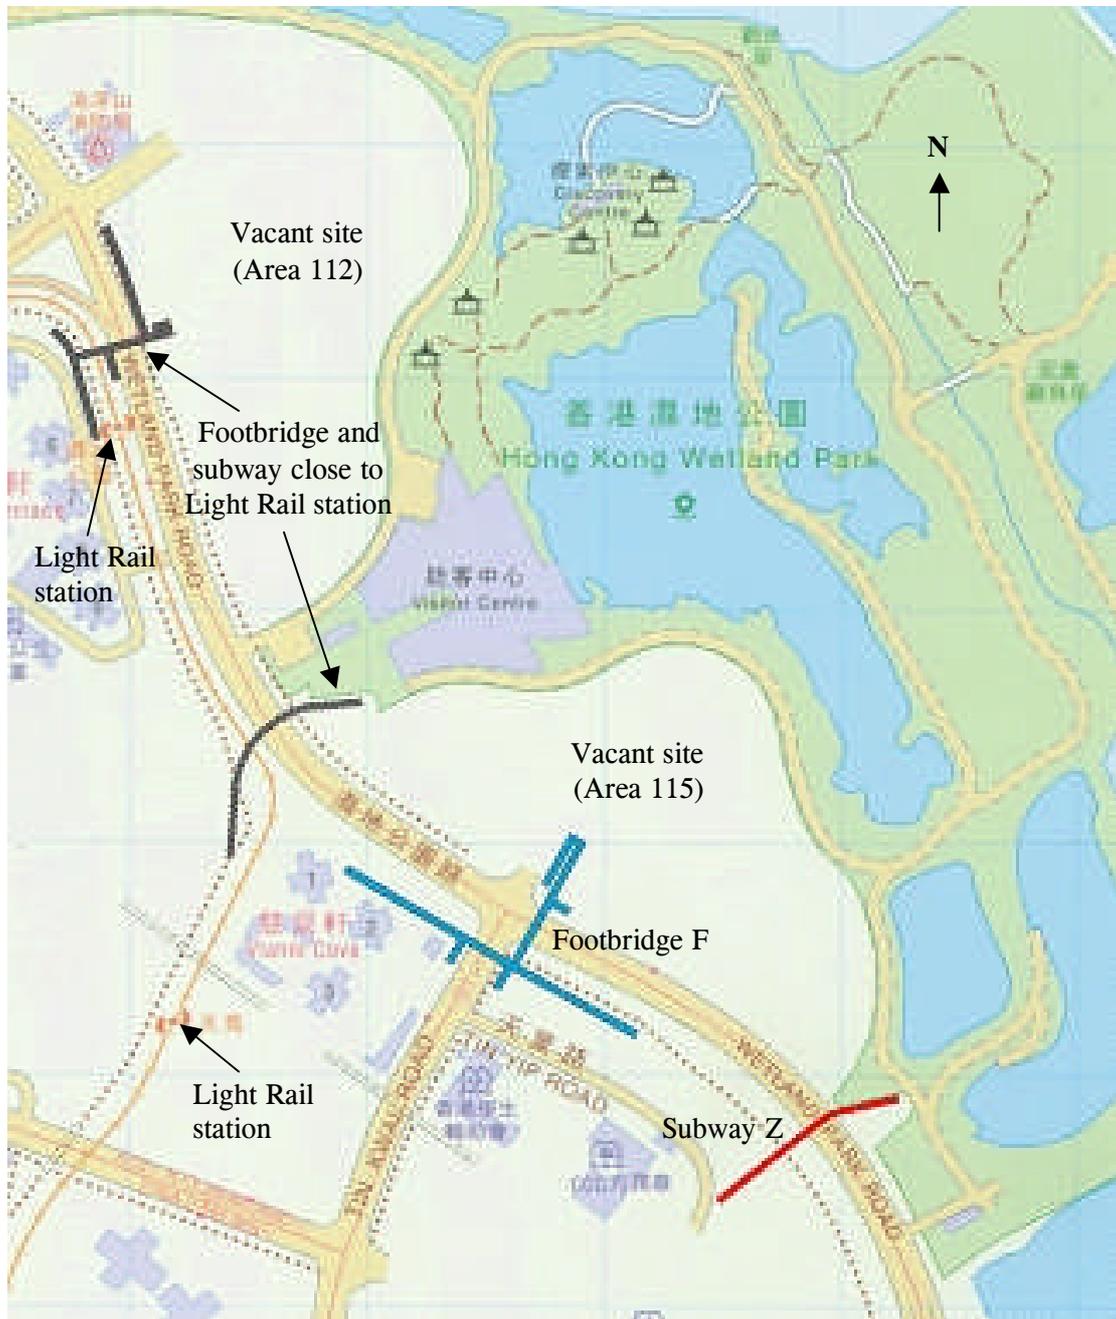
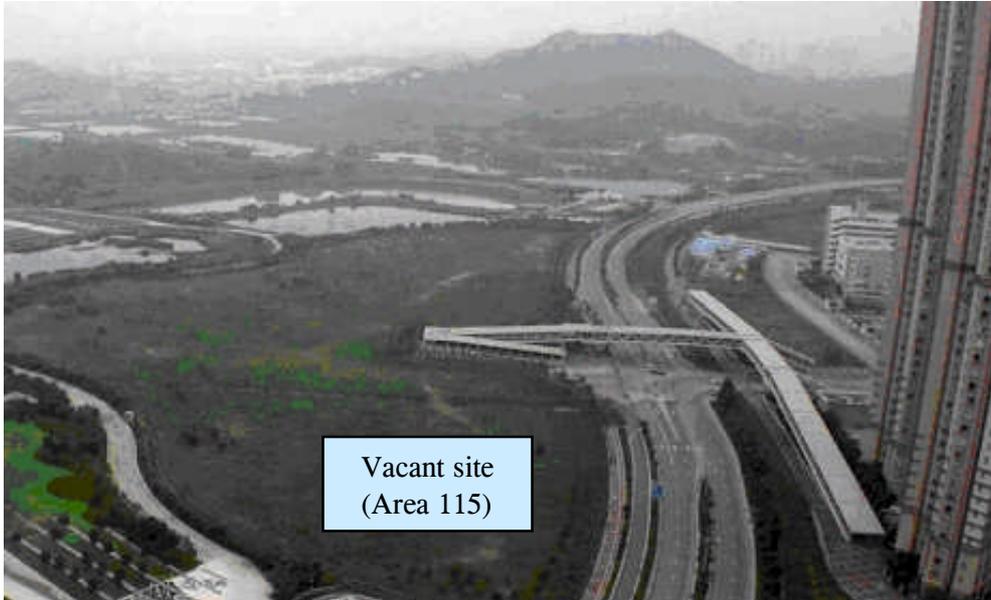
Figure 9
Footbridge F and Subway Z in Tin Shui Wai

5.15 Along Wetland Park Road in Tin Shui Wai, there are two footbridges and two subways. There are a footbridge and a subway located in the northern section of Wetland Park Road. Another footbridge (Footbridge F) and another subway (Subway Z) are located in the southern section of the road near Tin Yip Road. The construction of Footbridge F and Subway Z was completed in May 2004 by the CEDD at the costs of \$39.5 million and \$10.3 million respectively, as part of the transport infrastructure provided under the project “Tin Shui Wai further development — road junction improvement, site formation and main engineering infrastructure”. Footbridge F is 470 metres long, and Subway Z is 194 metres long. Footbridge F connects to a vacant site (Area 115), and Subway Z connects to the southern edge of the site and a work area of the Hong Kong Wetland Park (HKWP — see Figure 9 and Photograph 10).

Footbridge F in Tin Shui Wai

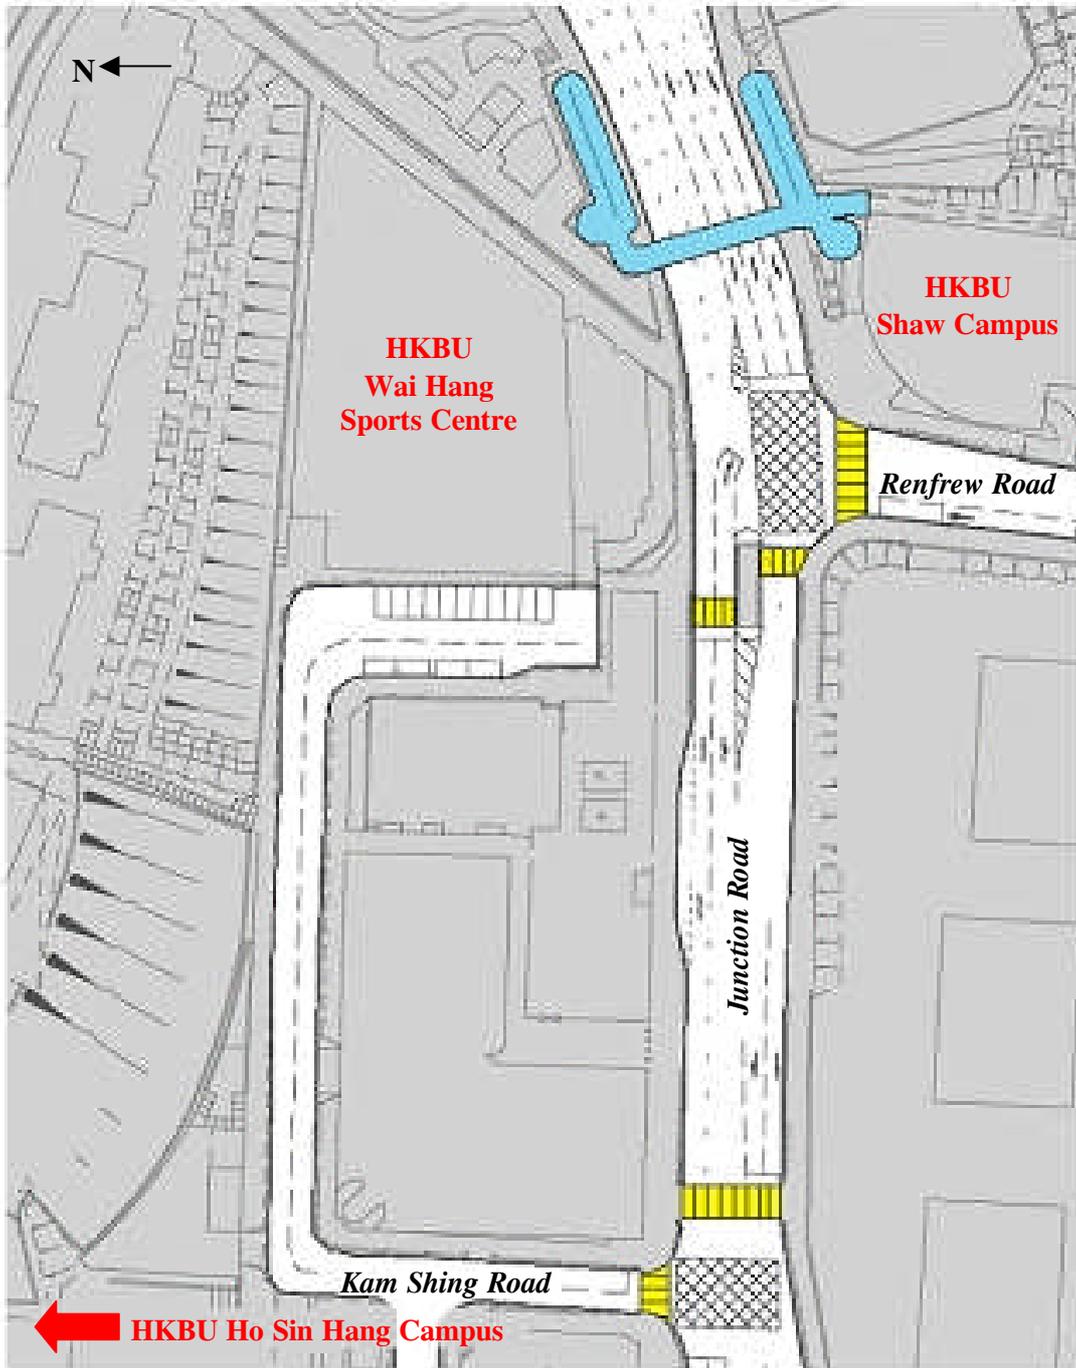
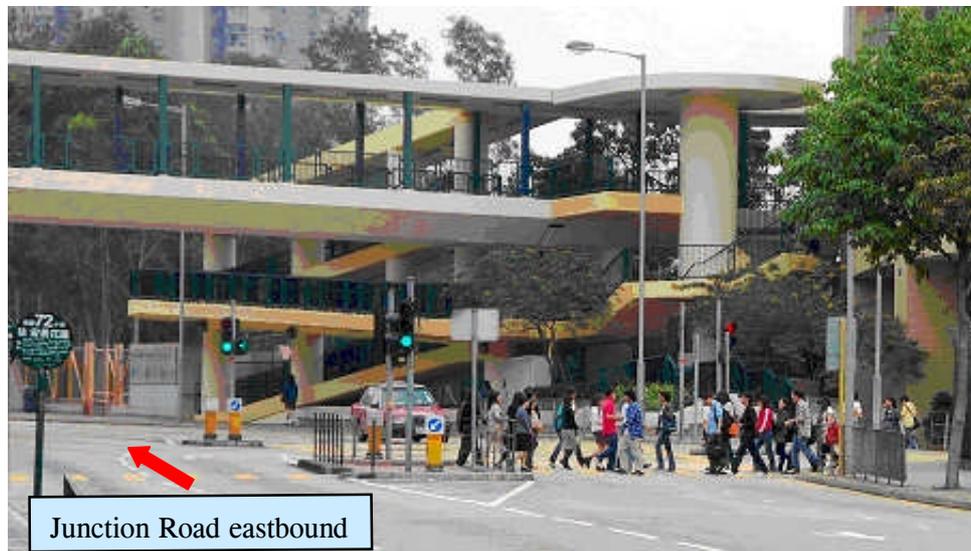
Figure 10
Footbridge G in Kowloon Tong

Before constructing Footbridge G, there were two sets of at-grade signal-controlled pedestrian crossings at the junction of Renfrew Road and Junction Road. In October 1998, Footbridge G was completed at a cost of \$17.7 million, with a staircase and a ramp at both ends. The two at-grade pedestrian crossings at the road junction were retained (see Figure 10 and Photograph 11).

Footbridge G in Kowloon Tong

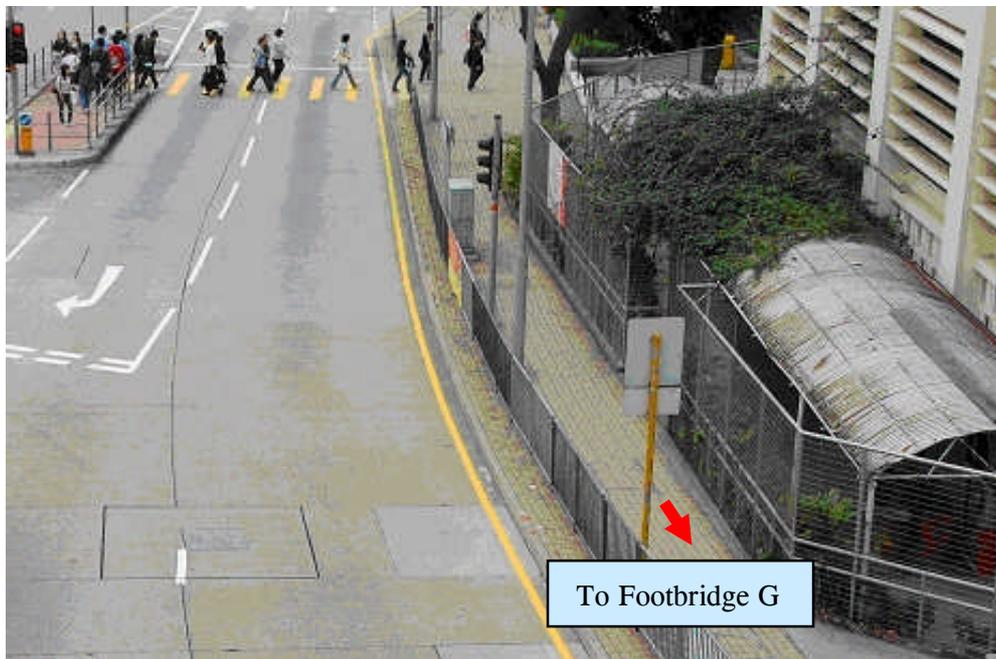
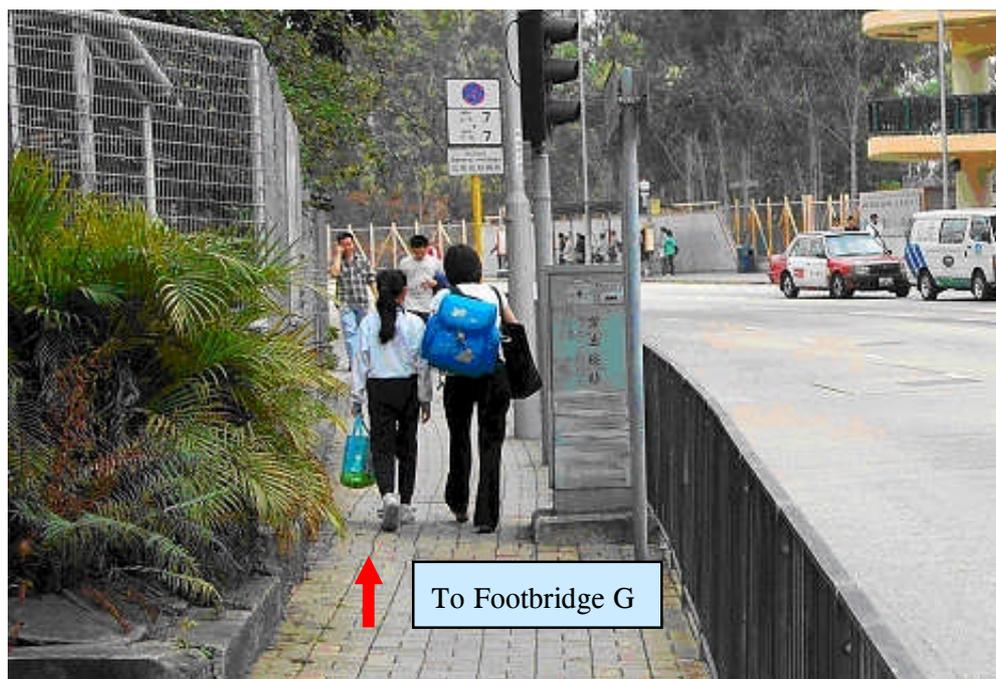
Photograph 12

6.12 Audit noted that a section of the walkway alongside Junction Road leading to Footbridge G was very narrow. The walkway section was about 30-metre long but was only about 1.1 to 1.9 metres wide. There was a section in the middle of it where a signal controller box further narrowed the walkway (see Photographs 12 and 13).

Narrow walkway leading to Footbridge G

The narrow section of the walkway

6.13 In August 2007, in response to Audit enquiry, the TD said that the width of the walkway was acceptable for the present pedestrian flow, and that the condition of the walkway could be further improved by relocating the signal controller box. **Audit considers that this narrow walkway limits the pedestrian flow capacity and may deter pedestrians from using Footbridge G. There is a need to consider widening this walkway section.**

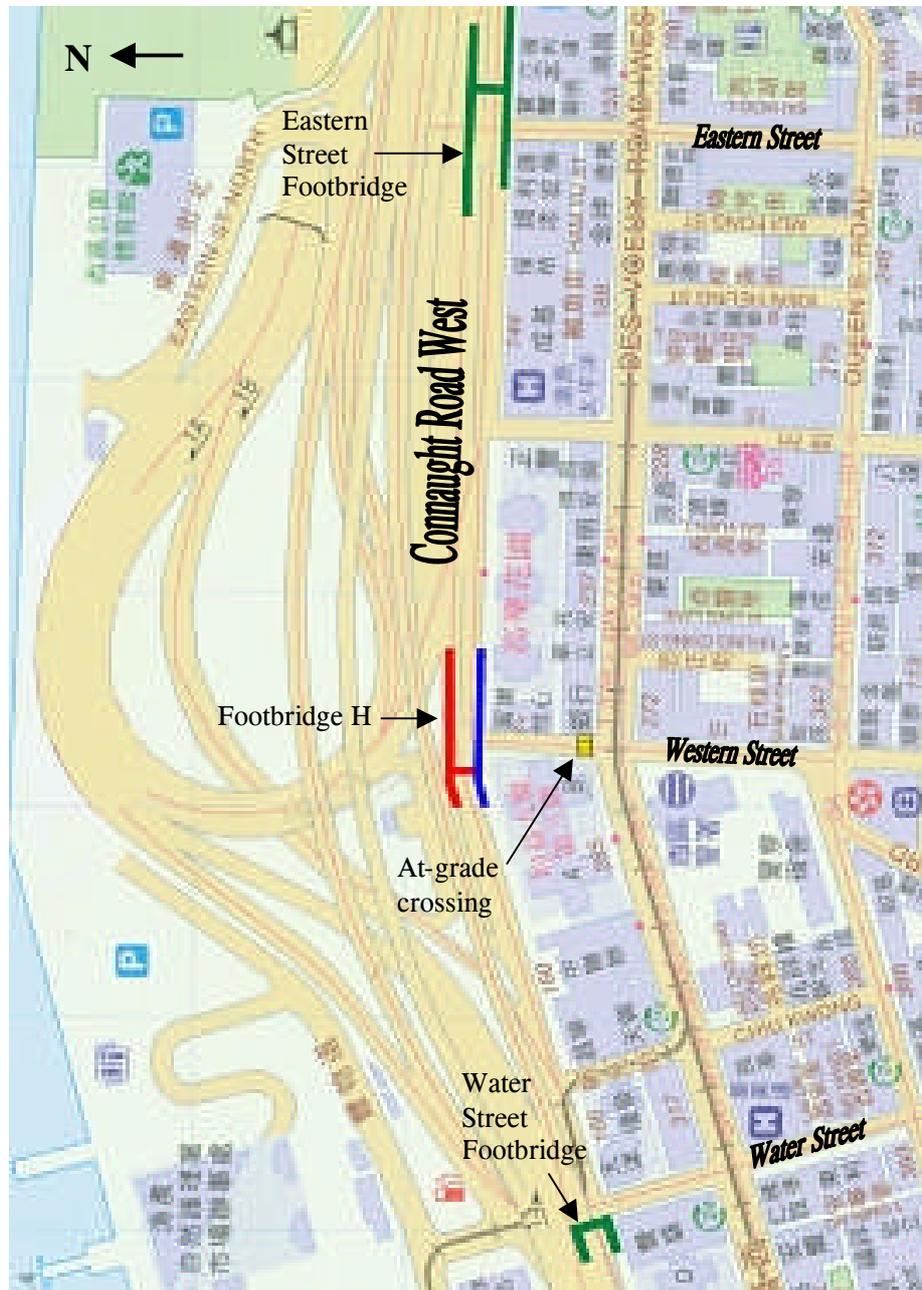
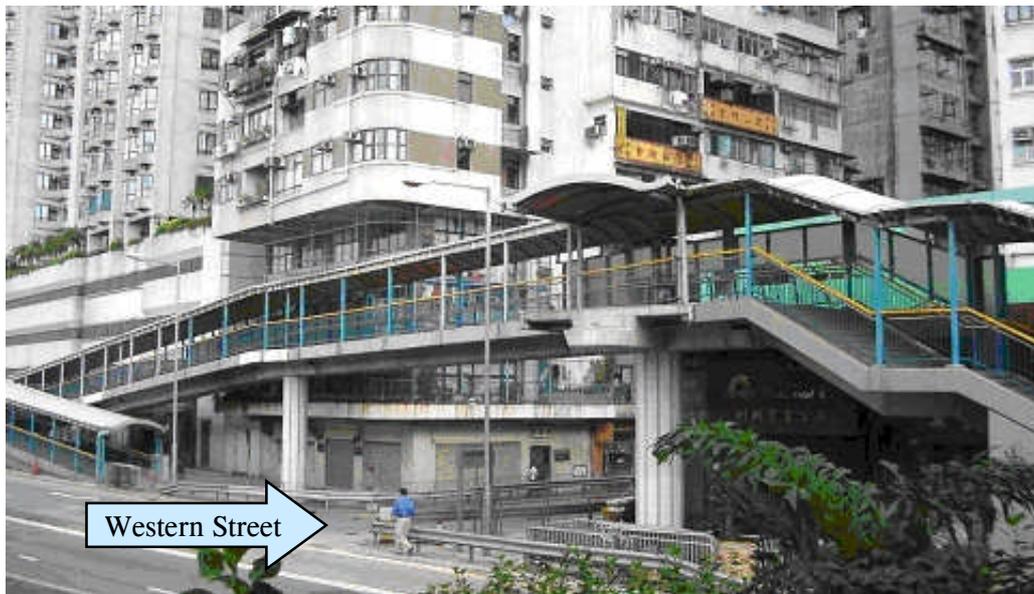
Figure 11
Footbridge H in Sai Ying Pun

7.3 In the late 1980s, the Government decided to construct the Western Harbour Crossing, with the Hong Kong side entrance located in Sai Ying Pun. In mid-1993, after a consultancy study, the Government decided to demolish the Eastern Street Footbridge, the Water Street Footbridge and the northern portion of Footbridge H to make way for constructing the Western Harbour Crossing interchange (see Figure 11).

- Legend:
- Remaining portion of Footbridge H
 - Demolished portion of Footbridge H
 - Demolished footbridge
 - An at-grade signal-controlled pedestrian crossing near Footbridge H

Footbridge H in Sai Ying Pun

- (a) conduct a review of the costs and benefits of retaining Footbridge H, taking into account:**
 - (i) the pedestrian flow;**
 - (ii) the recurrent costs of operation and maintenance;**
 - (iii) the obstruction caused to the view of nearby buildings; and**
 - (iv) the cost of demolishing the footbridge (see paras. 7.8 and 7.9); and**
