CHAPTER 3

Construction of pedestrian crossing facilities

**Audit Commission
Hong Kong
29 March 2010**

CONSTRUCTION OF PEDESTRIAN CROSSING FACILITIES

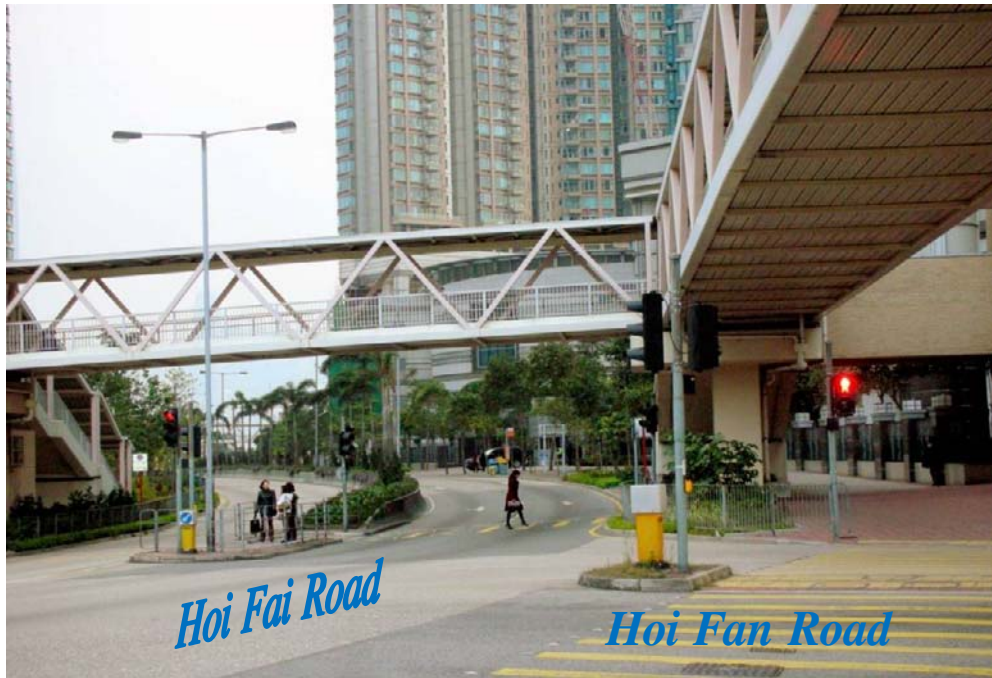
Photograph 1

Footbridge at the junction of Hoi Fan Road and Hoi Fai Road in Tai Kok Tsui

2.12 The presence of nearby at-grade crossings is the major reason affecting the utilisation of footbridges and subways. Audit noted that there was an at-grade crossing (Note 4) in the vicinity of each of the 7 footbridges and 2 subways identified by Audit (see para. 2.11) as having low utilisation. Most pedestrians crossed the road by using the at-grade crossings. Photographs 1 to 4 show four such footbridges (see Items 1 to 4 in Appendix A).

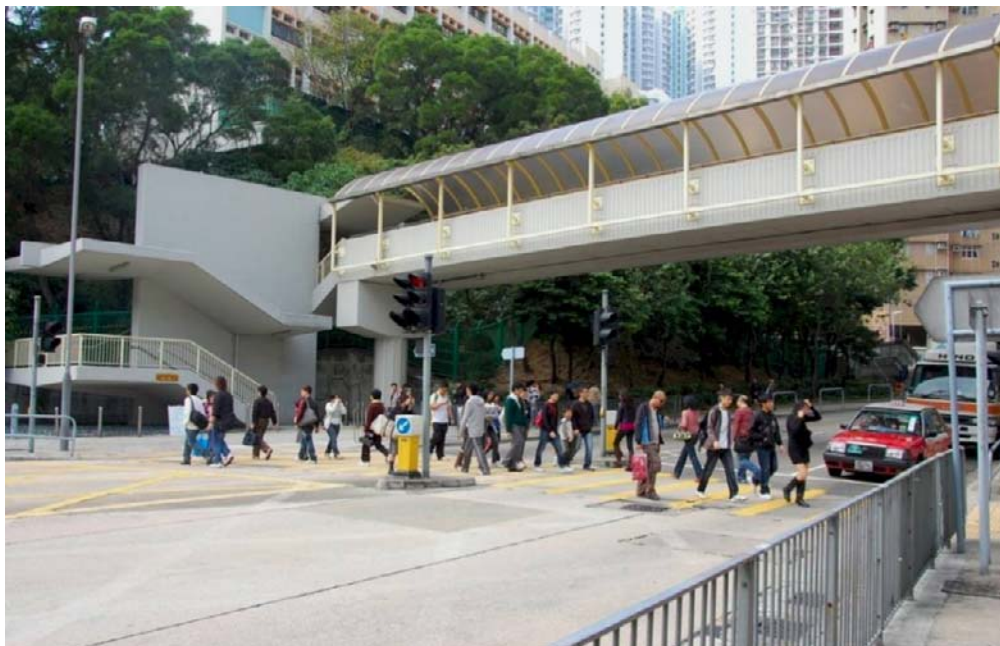
Photograph 2

Footbridge across Tai Wo Hau Road near Hing Fong Road in Kwai Chung

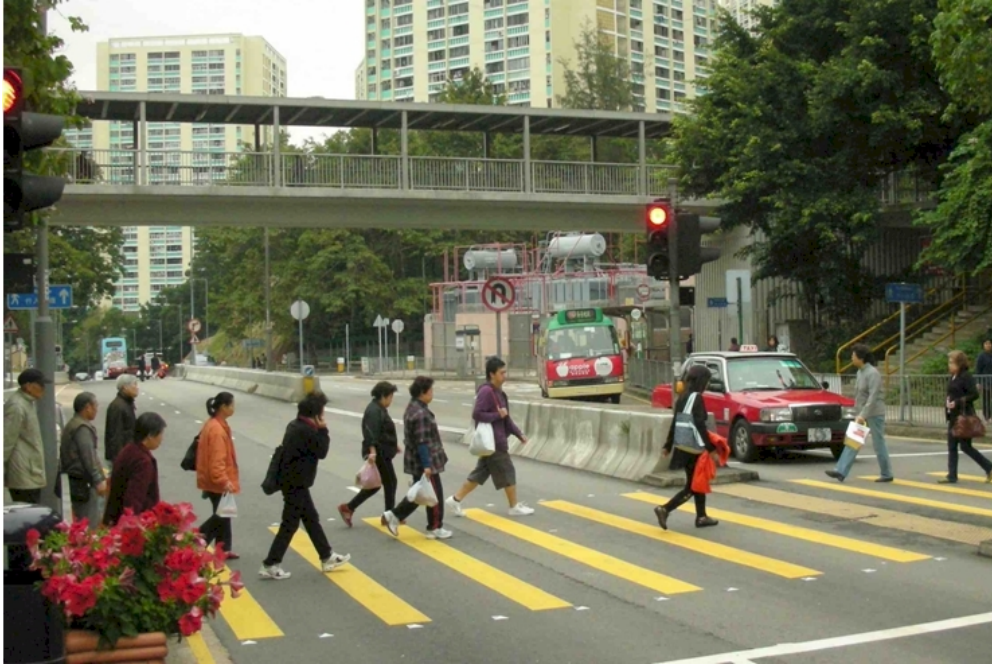
Photograph 3

Footbridge across Chung Mei Road near Sheung Ko Tan Street in Tsing Yi

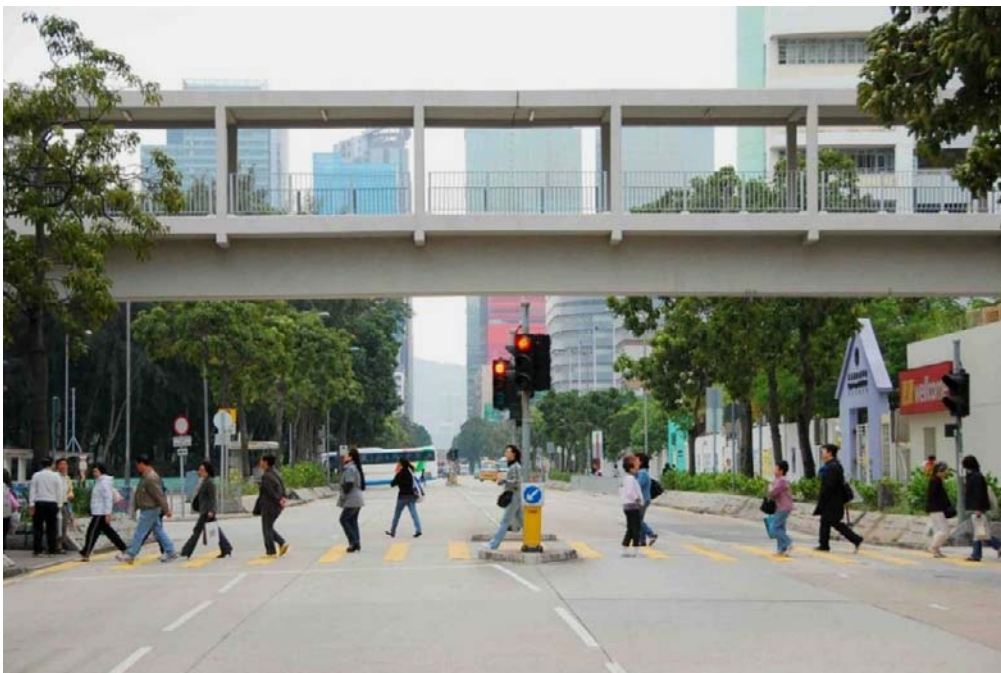
Photograph 4

Footbridge across Wang Chiu Road near Kai Yip Estate in Kowloon Bay

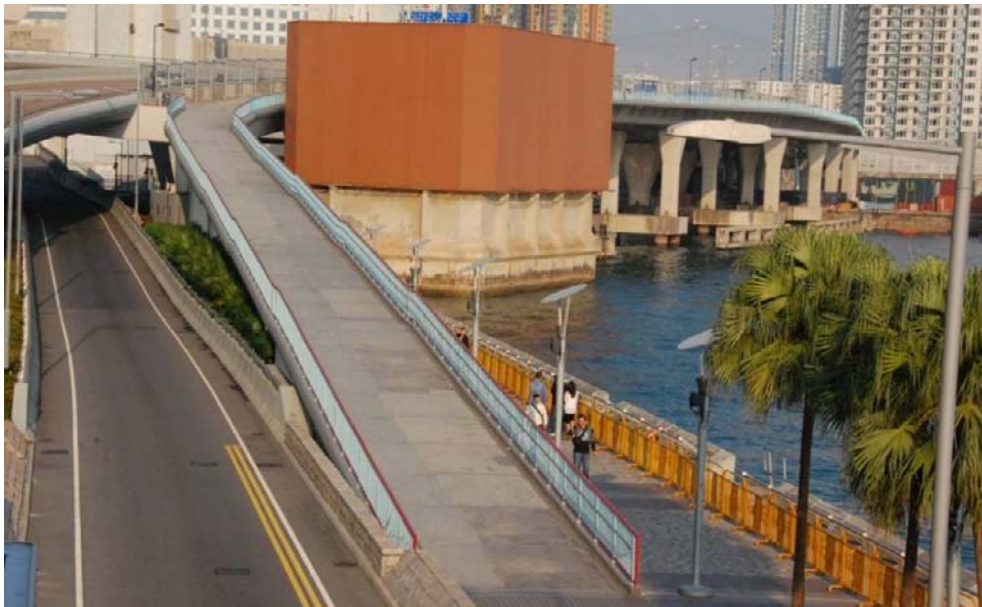
Photograph 5

Footbridge J

3.3 Footbridge J is a 600-metre long elevated pedestrian walkway with supporting columns — with some planted on the seabed. The footbridge, with ramps at both ends and a staircase at the Hung Hom side, does not have a cover.

3.13 In October and December 2009, Audit conducted site visits to Footbridge J and the nearby areas. Audit found that:

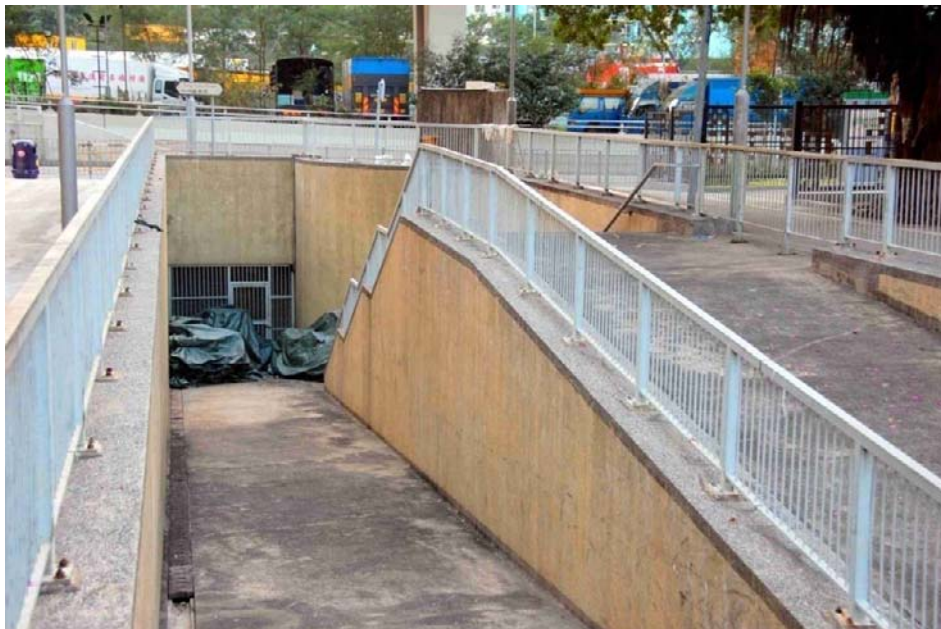
Photograph 6

Subway W — the northern end near Kiu Kiang Street

4.3 Subway W was completed in 1988 at a cost of \$1.96 million as part of an HyD major roadworks project for constructing West Kowloon Corridor Stage III, Cheung Sha Wan Section. In the paper submitted in July 1984 to the PWSC seeking funding for this project, it was stated that a subway would be built under the project. However, the justifications for and the estimated cost of the subway were not provided.

4.15 The HyD found that the flooding was caused by the disconnection of electricity supply to the automatic water pumping system inside Subway W for draining rainwater. It also found that the pumping system was damaged due to flooding. In August 2000, the HyD re-applied for an electricity account and re-connected electricity supply to the pumping system. Remedial works for repairing the control system and replacing the pump, at a cost of \$70,000, were completed in April 2001.

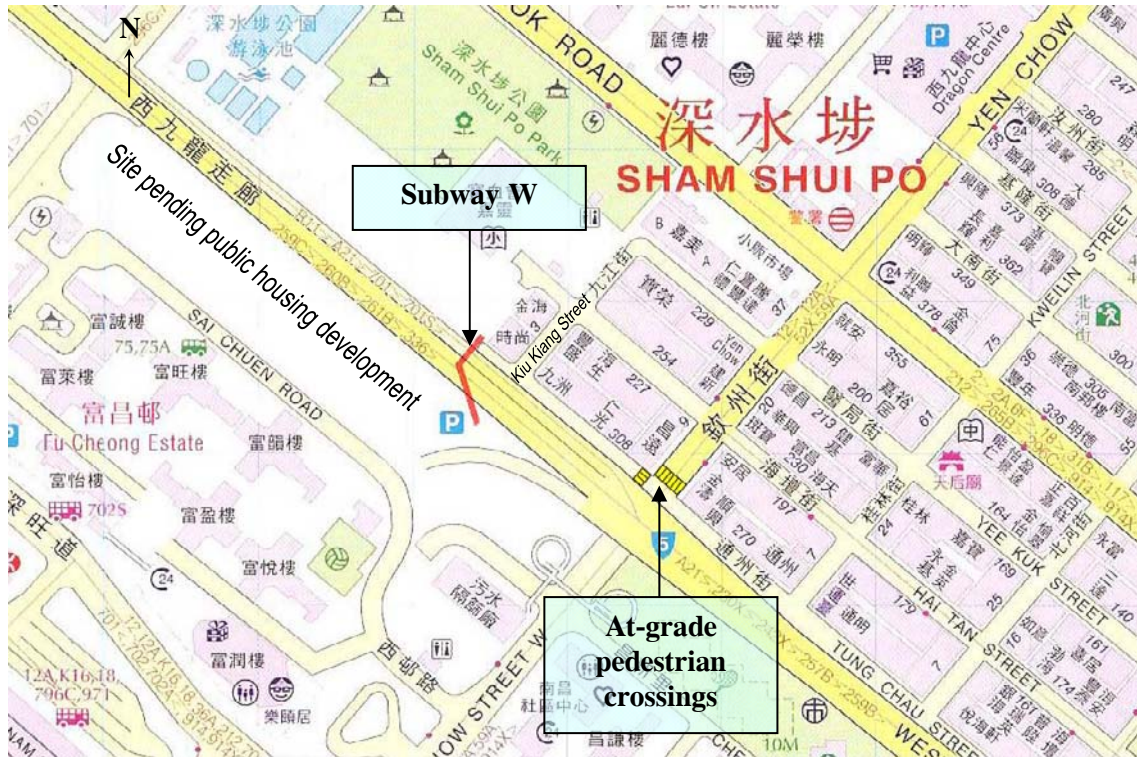
Figure 4
Location of Subway W

4.2 In Sham Shui Po, underneath the West Kowloon Corridor, there is a subway (Subway W — see Photograph 6) across Tung Chau Street near Kiu Kiang Street. It is closed with locked gates at both ends of the subway barrel. The subway is about 150 metres long and occupies an area of about 590 square metres. With a staircase and a ramp at each end, Subway W connects Kiu Kiang Street to an undeveloped site pending public housing development. Part of the site is let under a short term tenancy for use as a temporary carpark. Figure 4 shows Subway W's location.

- (a) the expected utilisation of the subway would not be high as residents mainly used the two at-grade signal-controlled crossings nearby (see Figure 4 in para. 4.2);
- (b) if the subway was open, it would be prone to illegal occupation by street sleepers; and
- (c) it had no plan to open Subway W for public use.

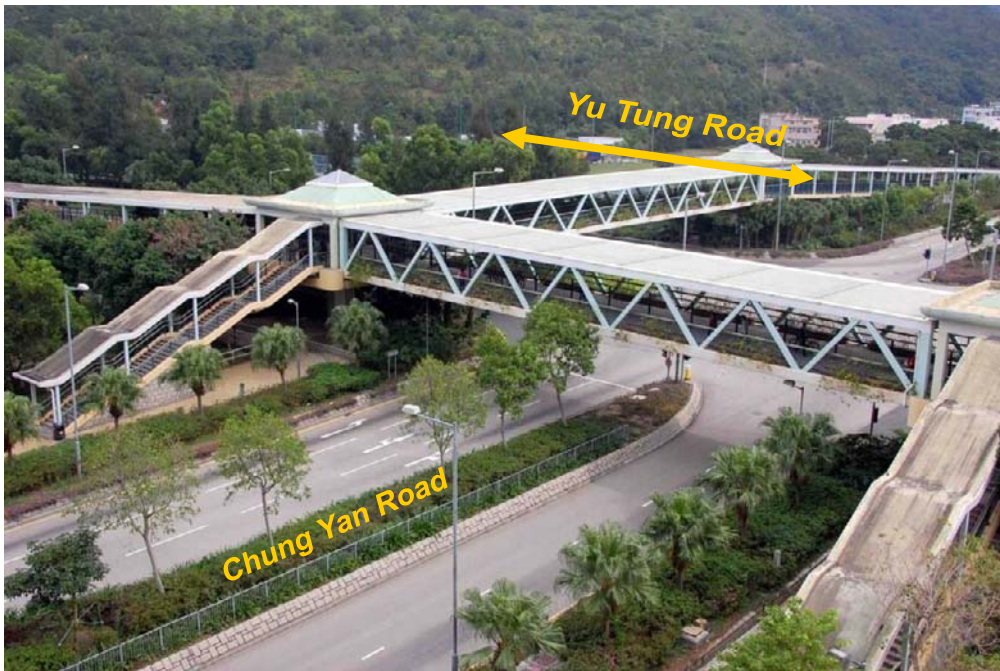
Photograph 7

Footbridge K in Tung Chung West

5.5 Surveys conducted by the TD in October 2009 found that the utilisation of Footbridges K and L was not low as they provided the only pedestrian links at the locations. During the peak hour in the morning, 1,254 pedestrians/cyclists used Footbridge K (7:30 a.m. to 8:30 a.m.) and 379 pedestrians/cyclists used Footbridge L (8:00 a.m. to 9:00 a.m.).

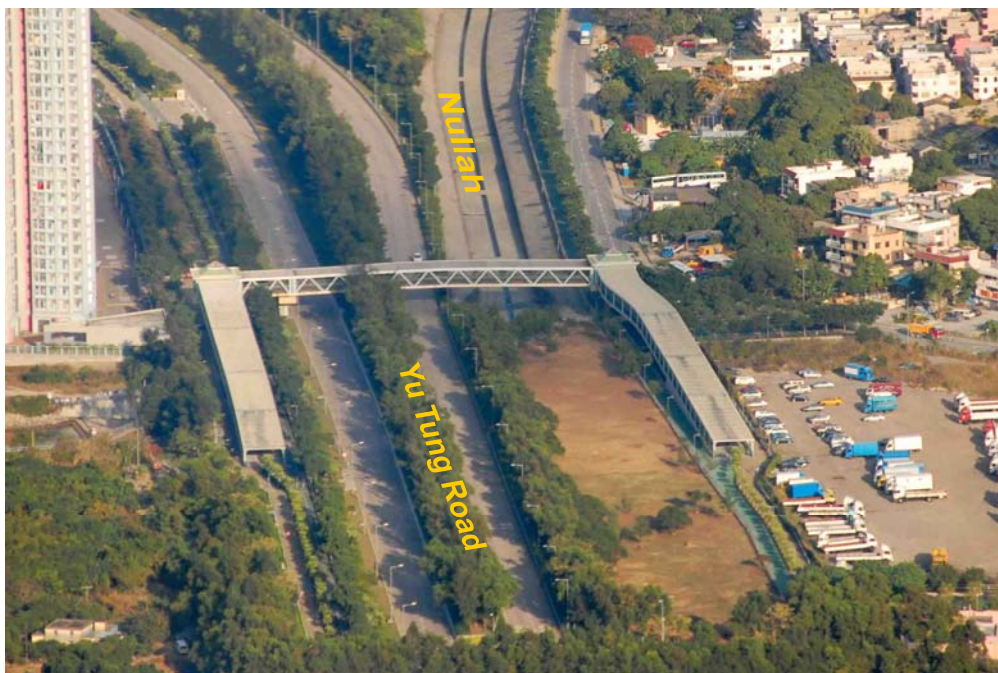
Photograph 8

Footbridge L in Tung Chung West

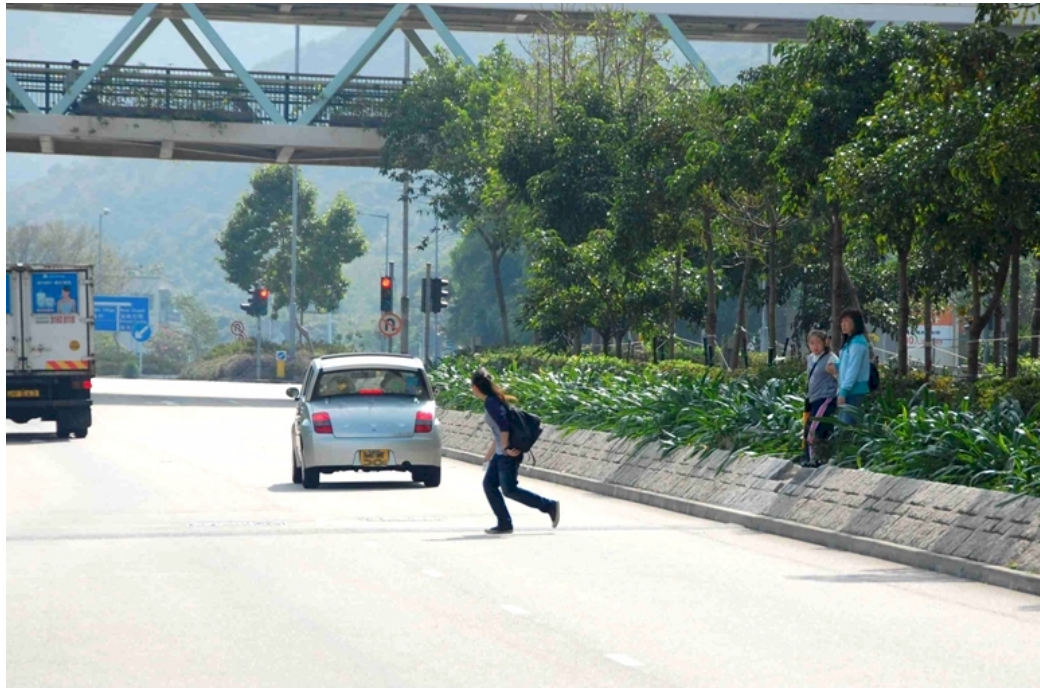
Photograph 9

Jaywalkers crossing Chung Yan Road near Footbridge K

5.29 **Audit has recommended** that the **Commissioner for Transport** should, in consultation with the **Director of Highways**, continue to monitor the problem of jaywalking near Footbridge K at Chung Yan Road after the completion of the at-grade crossing (see para. 5.27).

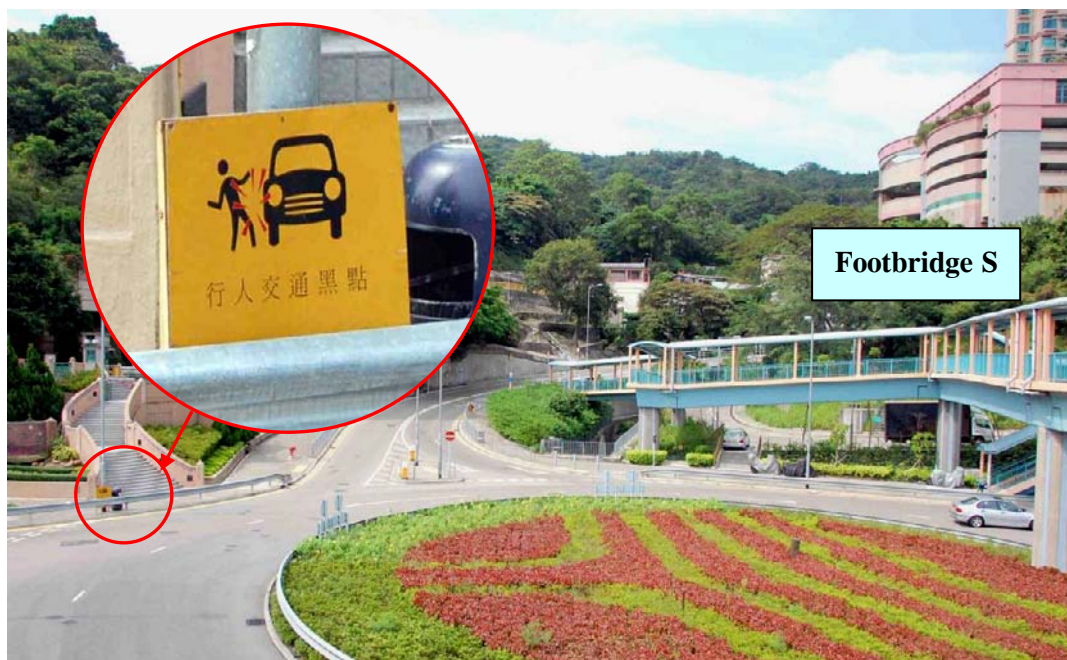
Photograph 10

6.19 The TD's survey found that, of the 568 pedestrians crossing the road at the 11 footbridge locations during peak hours, 196 (35%) crossed the road by jaywalking. At Footbridges S, U and V, the numbers of jaywalkers exceeded the numbers of footbridge users. Audit also noted that close to Footbridge S (near Sham Tseng Public Pier), a warning sign was posted (see Photograph 10).

A warning sign posted at the roundabout near Footbridge S

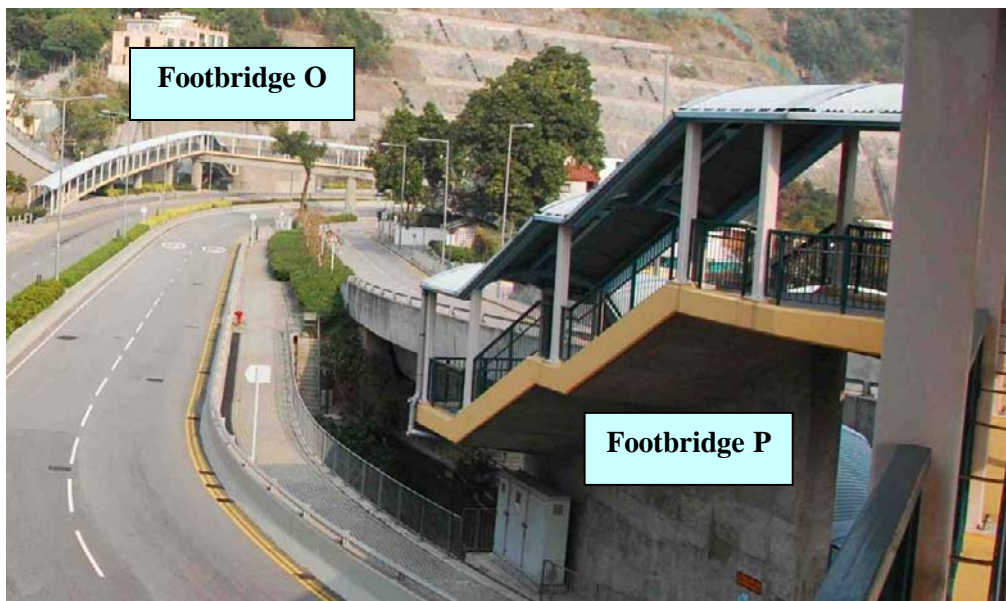
Photograph 11

Footbridges O and P in Ting Kau

6.33 In October 2009, Audit conducted a site visit to the locations of Footbridges O and P. Audit noted that Footbridge P connected a nearby carpark to the western access of Ting Kau Village. Moreover, there was also a footpath along a flyover linking the carpark to the western access of Ting Kau Village, serving as an alternative pedestrian path in addition to Footbridge P.

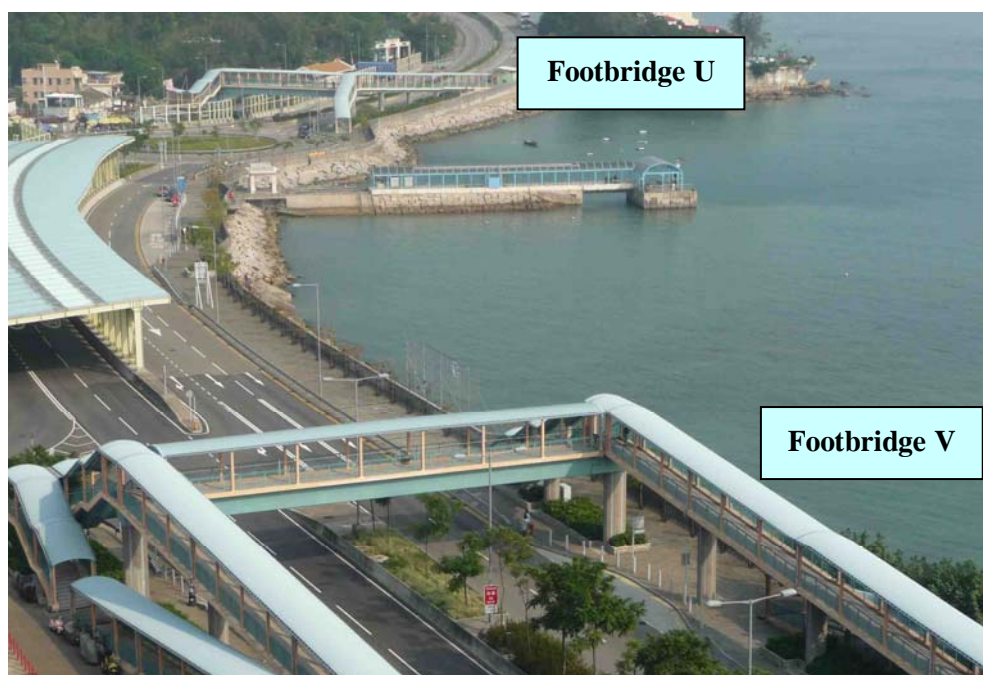
Photograph 12

Footbridges U and V in Tsing Lung Tau

6.37 In October 2009, Audit conducted a site visit to the locations of Footbridges U and V. Audit observed that the traffic and pedestrian flows were not high. The TD's survey found that the peak-hour vehicular flows at the locations were only 17% of the design flow capacity and the peak-hour pedestrian flows were around 70 pedestrians per hour (see Table 2 in para. 6.12). Audit also found that there was a road junction near Footbridge V allowing vehicles right-turning from the westbound lane. The right-turning vehicles were not controlled by traffic light signals and the vehicles would cut across two traffic lanes of the opposite direction. In Audit's view, the provision of an at-grade crossing at the location of Footbridge V might be an alternative option as it would allow pedestrians to cross the road at grade and the light signal can also control the right-turning vehicles to enhance road safety. Moreover, because of a break in the central divider at the road junction near Footbridge V, the location was prone to jaywalking. According to results of the TD's survey, there were more jaywalkers than footbridge users at the locations of Footbridges U and V (see Table 3 in para. 6.18).
