**Lands Department
Rating and Valuation Department
Civil Engineering and Development Department**

**Management of squatter and
licensed structures**

**Audit Commission
Hong Kong
3 April 2017**

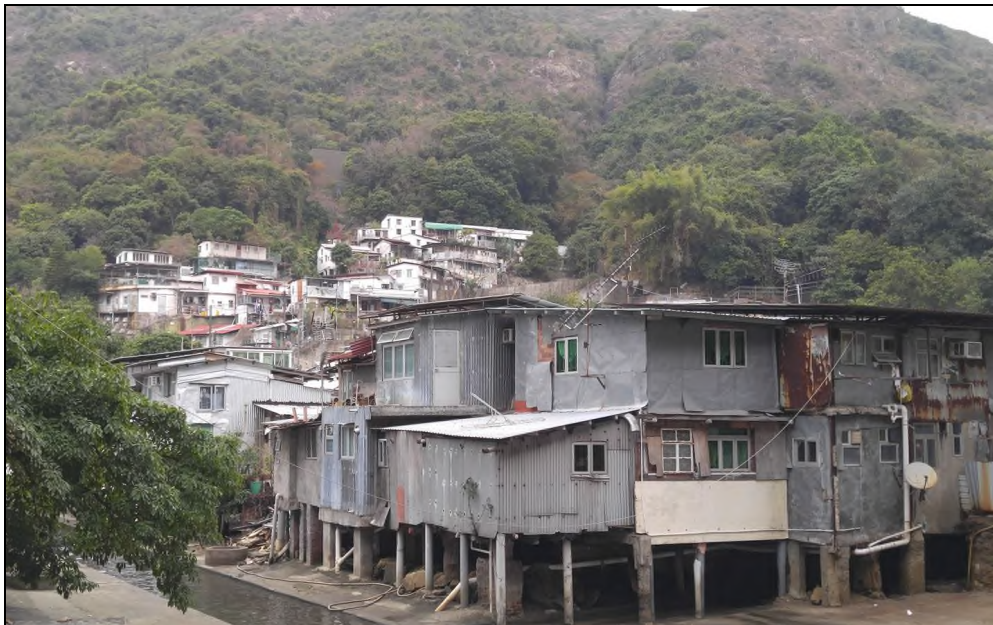
Photograph 1

**Squatter structures in Sham Tseng
(February 2017)**

1.2 From mid-1940s to late 1970s, due to the influx of Mainland immigrants and the rising birth rate, housing supply was unable to cope with the surge in demand. As a result, thousands of people erected squatter structures (see Photograph 1) on undeveloped and unleased government land or private agricultural land.

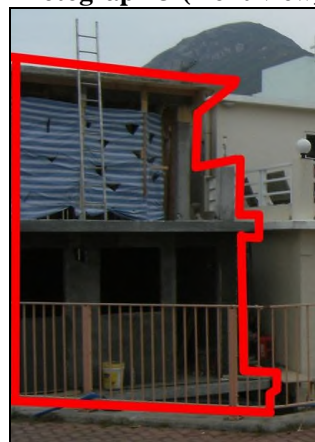
SS Structure A (December 2014)

1. During the preliminary audit planning work in December 2014, Audit's site visit to Village A noted that construction works at a squatter structure (SS Structure A — see Photographs 2 and 3) were in progress. SS Structure A was located adjacent to a promenade.

3. In January 2017, upon Audit's referral, the SCO/HK&LYM found that, according to the 1982 Survey Records, SS Structure A consisted of two squatter survey numbers (SS Structures A1 and A2). Hence, SS Structure A should originally be two structures instead of one. The SC staff also conducted a site inspection and carried out an on-site measurement of SS Structure A. The on-site measurement revealed that there had been extensions and heightening of SS Structure A as compared with the aggregate dimensions of SS Structures A1 and A2 as indicated in the 1982 Survey Records. Details of the 1982 Survey Records and the Lands D's inspection results in January 2017 are as follows:

4. According to Lands D records, SS Structure A was located on government land and in the urban area. According to the SC Policy, rebuilding of SS Structure A, which is located in the urban area, is not allowed (see para. 2.3(e)). However, the photographs taken during Audit's site visit in December 2014 showed that construction works were in progress at SS Structure A. Audit noted that the Lands D had not maintained records on the number of SC patrols covering SS Structure A in recent years. Audit considers it unsatisfactory that:

5. According to the Lands D, if rebuilding of SS structures without government approval is found, the squatter survey numbers of these structures will be cancelled instantly and enforcement actions will be taken. Audit considers that the Lands D needs to:

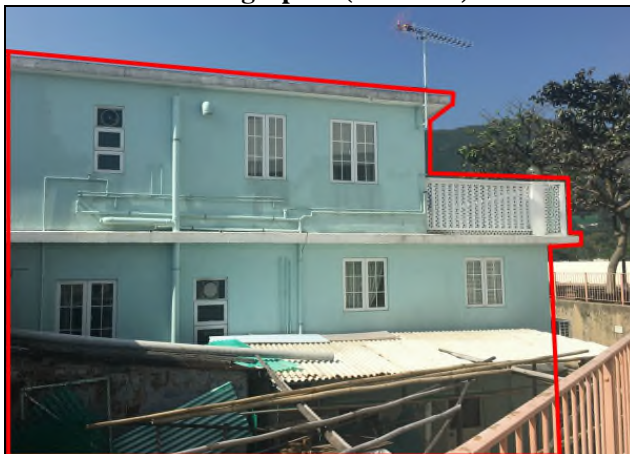
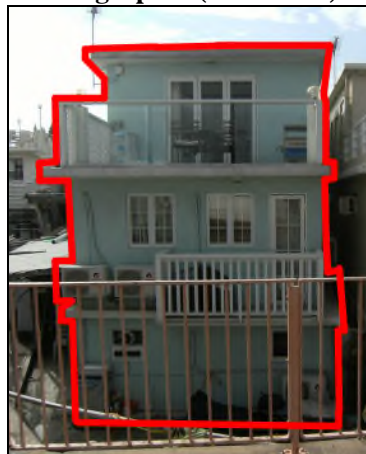
SS Structure A (December 2016)

2. In December 2016, Audit conducted another site visit to SS Structure A and noted that the construction works had been completed (see Photographs 4 and 5).

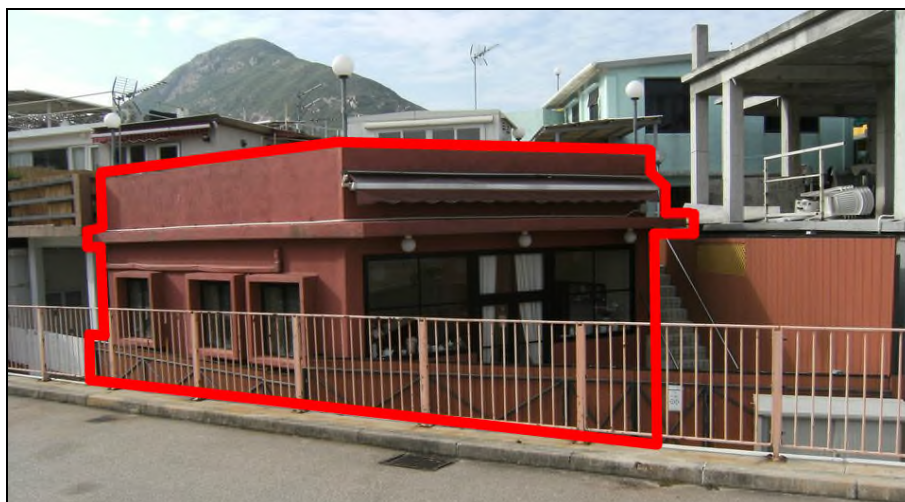
Photograph 6

SS Structure B (December 2016)

2. In January 2017, upon Audit's referral, the SCO/HK&LYM found that, according to the 1982 Survey Records, SS Structure B consisted of two squatter survey numbers (SS Structures B1 and B2). Hence, SS Structure B should originally be two structures instead of one. The SC staff also conducted a site inspection and carried out an on-site measurement of SS Structure B. The inspection results revealed that the dimensions, use and building materials of the structure did not conform with those of SS Structures B1 and B2 in the 1982 Survey Records. Details are as follows:

3. According to the SC Policy, the dimensions, building materials and use of SS structures cannot be changed as compared with those in the 1982 Survey Records without government approval (see para. 2.3(c)). According to Lands D records, SS Structure B was located on government land and in the urban area. Audit noted that the Lands D had not maintained records on the number of SC patrols covering SS Structure B in recent years. Audit considers it unsatisfactory that:

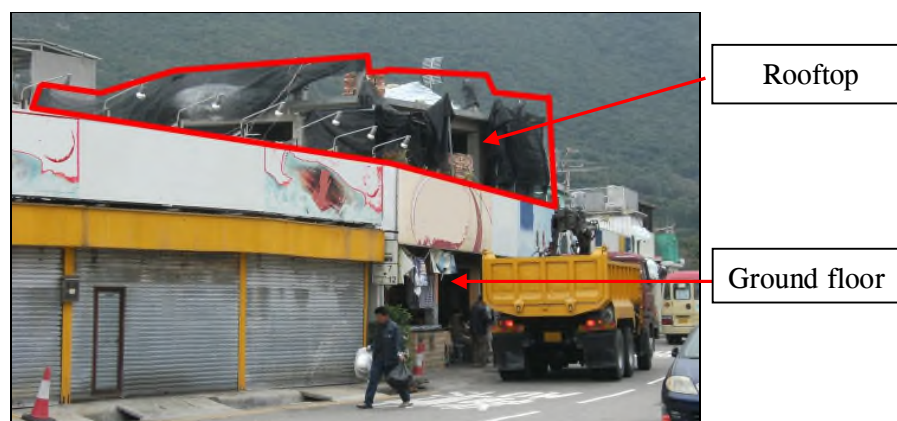
Photograph 7

1. During the preliminary audit planning work in December 2014, Audit's site visit to Village A noted a squatter structure (SS Structure C — see Photograph 7). SS Structure C was adjacent to a main road and opposite to a bus terminal.

SS Structure C (December 2014)

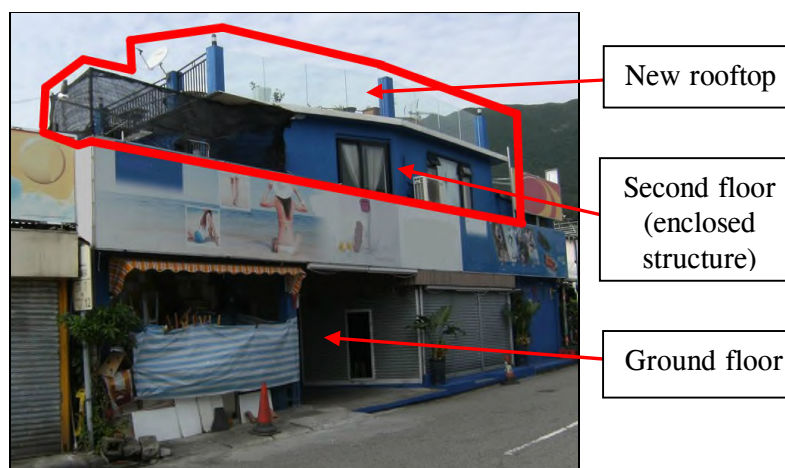
Photograph 8

7. In December 2016, Audit conducted another site visit to SS Structure C, and noted that the enclosed concrete structure located on the second floor had not yet been removed (see Photograph 8).

**SS Structure C
(December 2016)**

10. According to Lands D records, SS Structure C was located on government land and in the urban area. Audit noted that the Lands D had not maintained records on the number of SC patrols covering SS Structure C in recent years. Audit considers it unsatisfactory that:

8. In January 2017, the SCO/HK&LYM issued a warning letter to the occupant requesting him to rectify the irregularities of SS Structure C by February 2017.

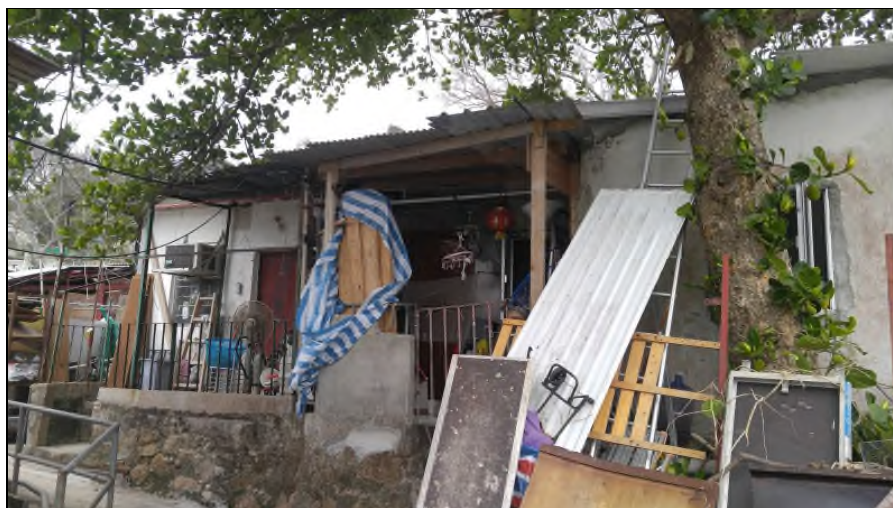
Photograph 9

3. Audit's site visit in February 2017 noted that there were signs of re-occupation of SS Structure D (see Photograph 9).

SS Structure D (February 2017)

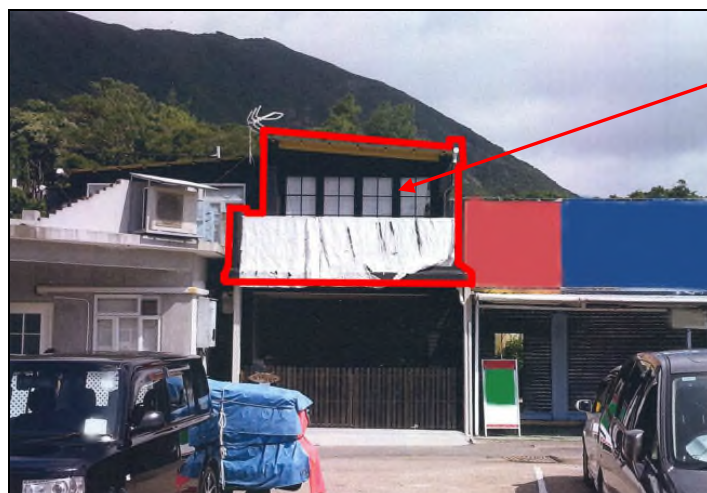
Photograph 10

SS Structure E (July 2016)

Unauthorised
structure

7. Audit noted that SS Structure E was situated at a prominent location (near a public carpark and a store) in Village A. According to Lands D records, SS Structure E was located on government land and in the urban area. Audit noted that the Lands D had not maintained records on the number of SC patrols covering SS Structure E in recent years. Audit considers it unsatisfactory that:

- (a) the repeated control actions taken in 2013 and 2014 had failed to deter the recurrence of the unauthorised works and extension of SS Structure E; and
- (b) irregularities detected in July 2016 had not been rectified up to February 2017.

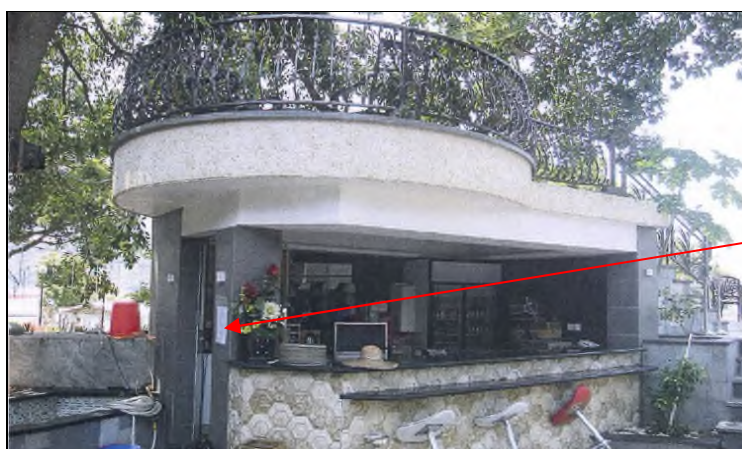
Photograph 11

**SS Structure G (a structure located on an upper level of a restaurant)
(August 2016)**

Lands D
demolition
notice

2. Audit's site visit in February 2017 found that the two restaurants operating at SS Structures H and I were open for business. (Audit could not get access to the upper level of the restaurant relating to SS Structure G.)

5. According to Lands D records, SS Structures G, H and I were located on government land and in the urban area. Audit noted that the Lands D had not maintained records on the number of SC patrols covering SS Structures G, H and I in recent years. Audit considers it unsatisfactory that, during the routine patrols, the SC staff were unable to detect the unauthorised rebuilding of SS Structures G, H and I, as well as the irregularities of the other 48 SS structures located along the seafront in Kowloon. Moreover, the demolition notices issued by the Lands D in August/September 2016 had not been complied with up to January 2017. In Audit's view, the Lands D needs to expedite:

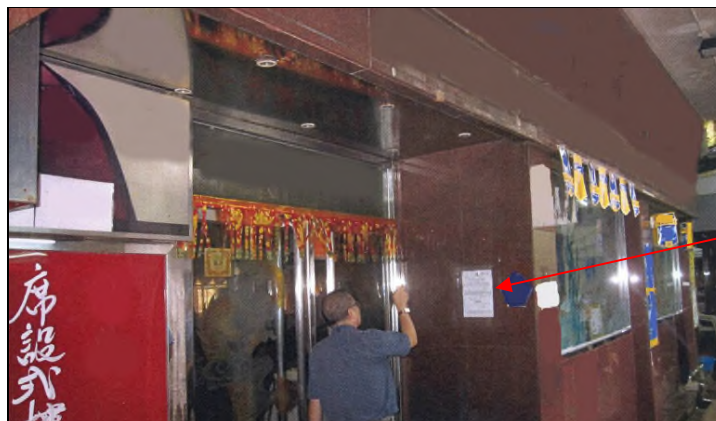
Photograph 12

**SS Structure H (operating as a restaurant)
(September 2016)**

Lands D
demolition
notice

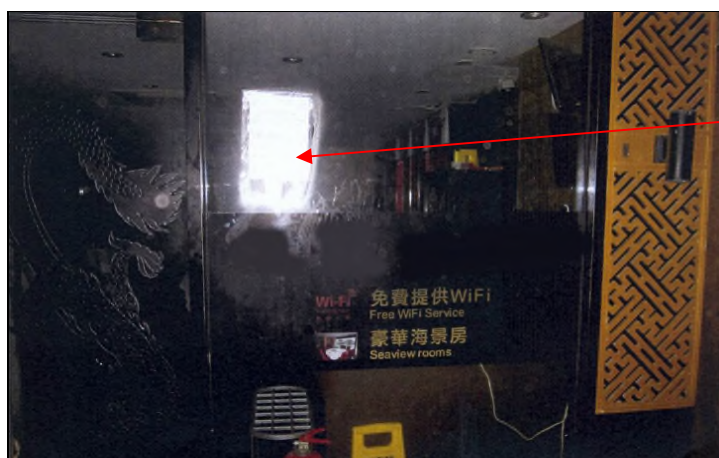
Photograph 13

**SS Structure I (operating as a restaurant)
(September 2016)**

Lands D
demolition
notice

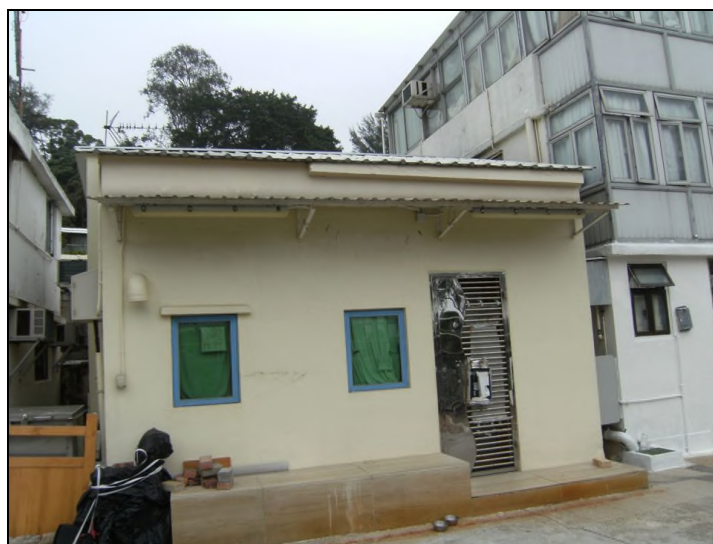
Photograph 15

2. In November 2011, upon enquiry by the DLO/Islands, the Immigration Department confirmed that Licensee B had passed away in September 2000. According to the Lands D's instructions, a GLL may be cancelled upon the death of a licensee is made known to the Lands D unless a licensee's immediate family member has applied and being approved to become a new licensee. However, Audit could not find records showing an approved transfer of GLL B to another person. In January 2017, Audit's site visit noted that there were signs of occupation of Licensed Structure B (see Photograph 15).

Licensed Structure B (January 2017)

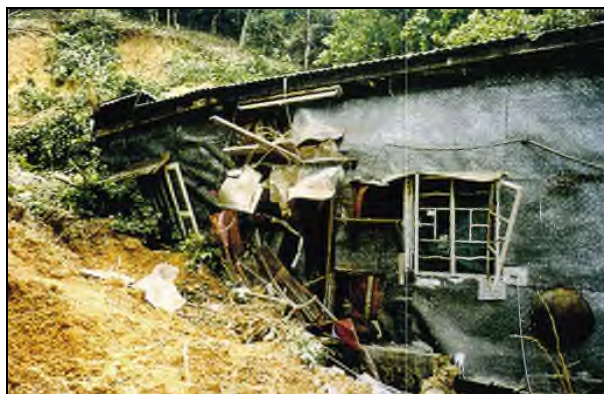
Photograph 16

**A landslide destroying a squatter structure at Kau Wa Keng, Lai Chi Kok
(4 June 1997)**
