Home Affairs Department

**Implementation of minor works projects
by the Home Affairs Department**

**Audit Commission
Hong Kong
23 October 2006**

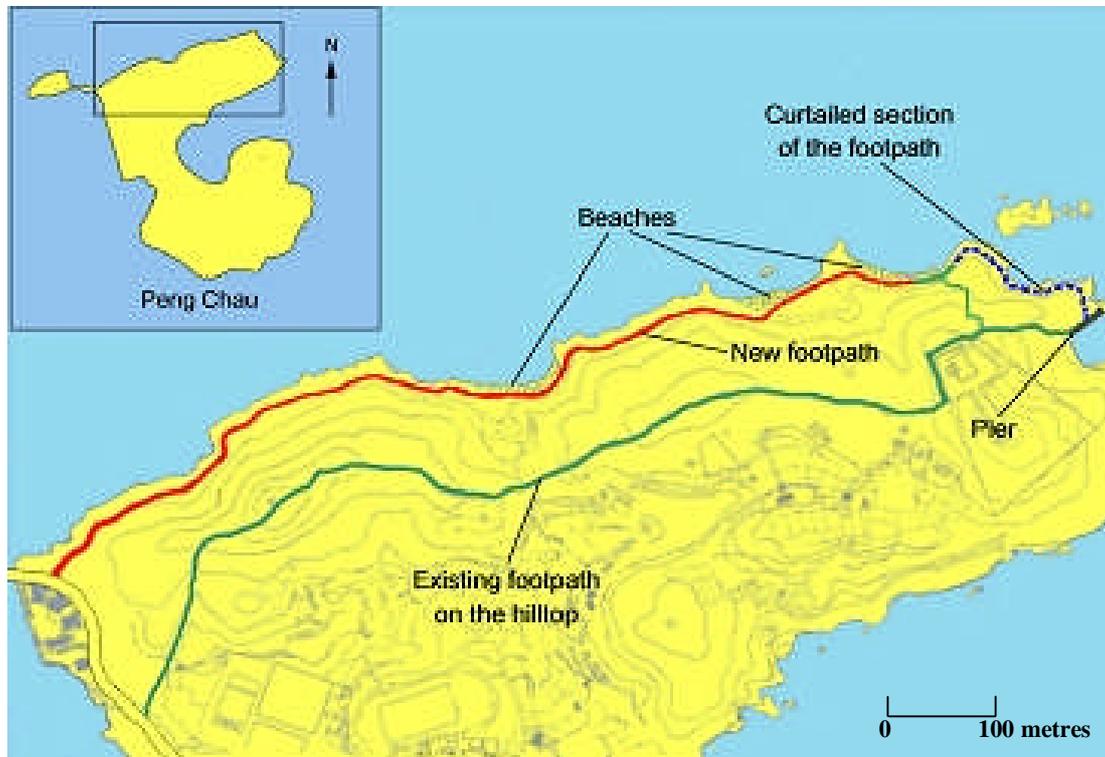
Figure 1
Footpath project on Peng Chau

2.4 In June 1999, the HAD awarded a contract to a contractor (Contractor A) for the works of seven projects, including this footpath (see Figure 1). The contract price of the footpath was \$4.3 million. The works for the footpath commenced in June 1999 and was targeted for completion in June 2000.

- 2.6 In October 1999, the HAD conducted a site inspection with Consultant A and found that Contractor A:
- (a) had not followed the contract design in excavation works;
 - (b) had constructed 600 metres of footpath, with 50% of the alignment deviating from the contract design; and

2.17 Audit noted that, in February and March 2001, a green group (Green Group A) raised a complaint over the justifications for constructing the new footpath as there was a hilltop path running parallel to the new one (see Figure 1 in para. 2.4). In reply, the HAD said that:

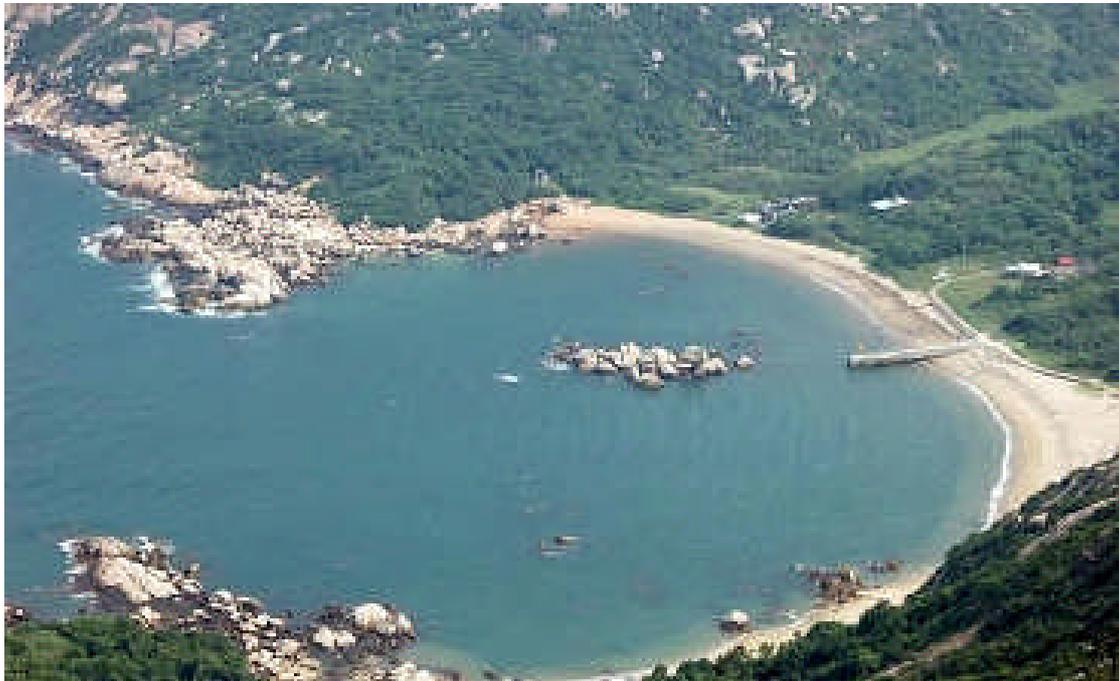
Photograph 4

4.2 Shek Pai Wan is a bay with a sandy beach located on the south-eastern part of Lamma Island (see Photograph 4). It is connected by a trail to Sok Kwu Wan and by a footpath to Mo Tat Wan. There are two licensed ferry services at Sok Kwu Wan, namely between Sok Kwu Wan and the Central District, and between Sok Kwu Wan and Aberdeen via Mo Tat Wan. There are two villages at Shek Pai Wan, namely Tung O and Yung Shue Ha.

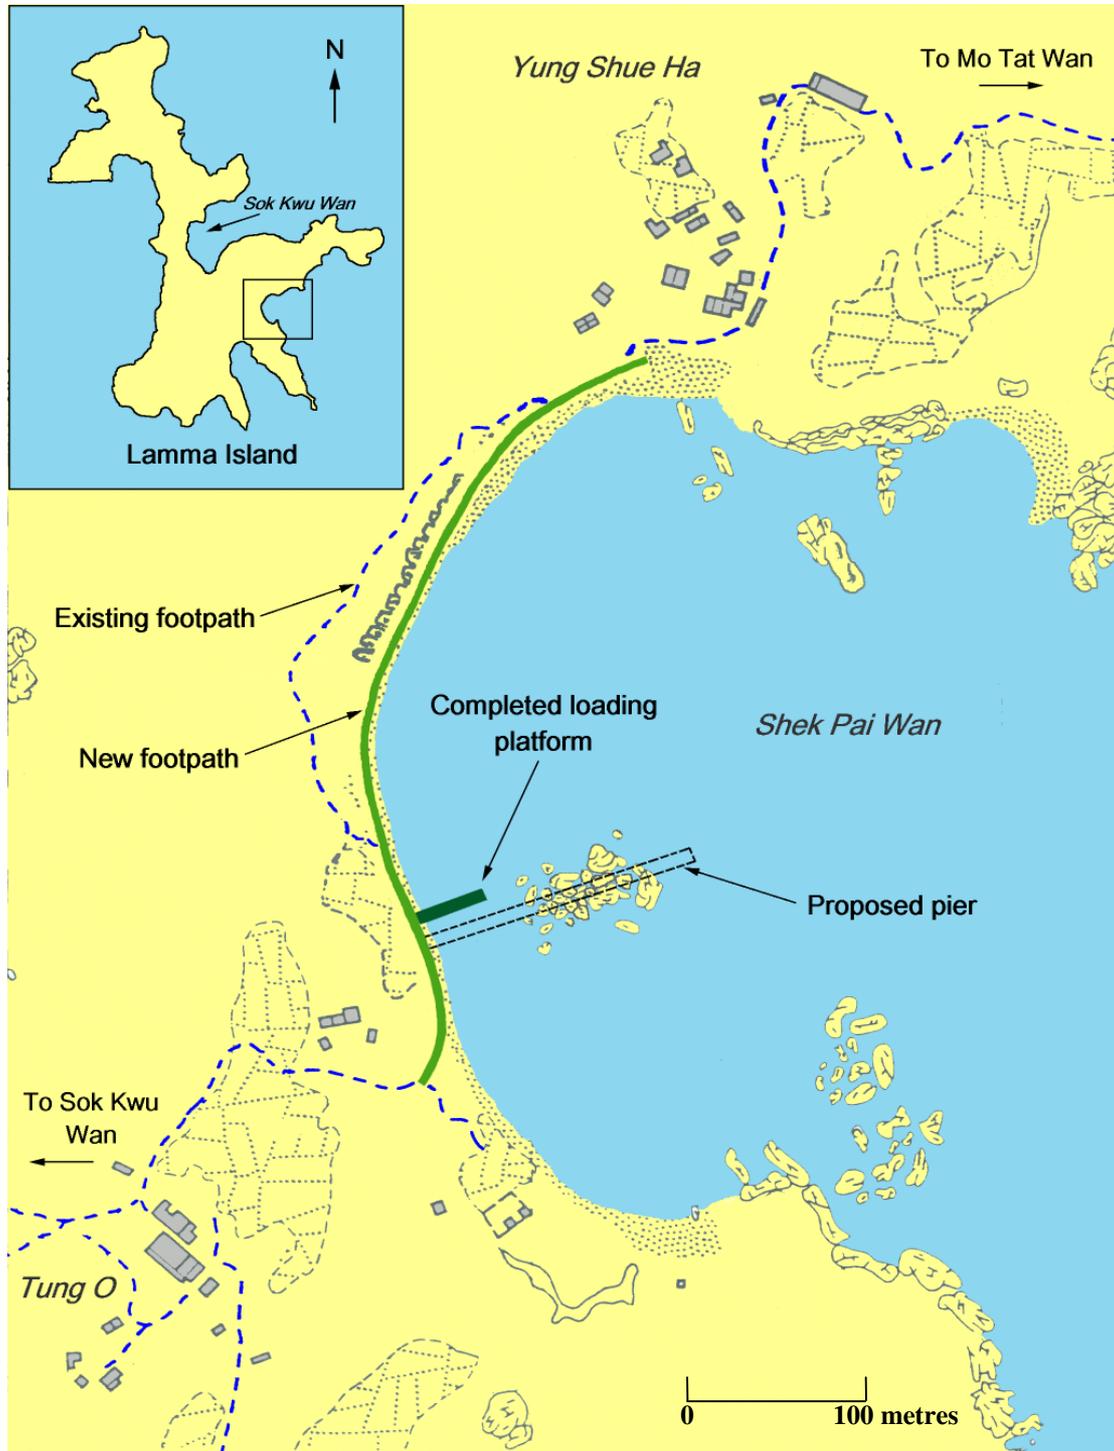
- (a) Shek Pai Wan had a sandy seabed with large boulders near the location of the proposed pier;
- (b) there were extensive submerged rock strata in the area. Water was shallow for a large part of the seabed around the proposed pier; and
- (c) the proposal was to build a 150-metre pier across the large boulders at the centre of the bay to facilitate marine access (see Figure 2).

5.7 As shown in Figure 2 in paragraph 4.5, there is an existing footpath on the hillside providing access between the two villages. Audit considers that this was important and relevant information, which should have been disclosed in the project proposal for the consideration of the District Working Group and the Steering Committee. **Audit considers that improvement in this area can be made by implementing the audit recommendation in paragraph 2.24(d)(ii).**
