# **Highways Department**

Management of the public lighting system

Audit Commission Hong Kong 27 October 2015 This audit review was carried out under a set of guidelines tabled in the Provisional Legislative Council by the Chairman of the Public Accounts Committee on 11 February 1998. The guidelines were agreed between the Public Accounts Committee and the Director of Audit and accepted by the Government of the Hong Kong Special Administrative Region.

# MANAGEMENT OF THE PUBLIC LIGHTING SYSTEM

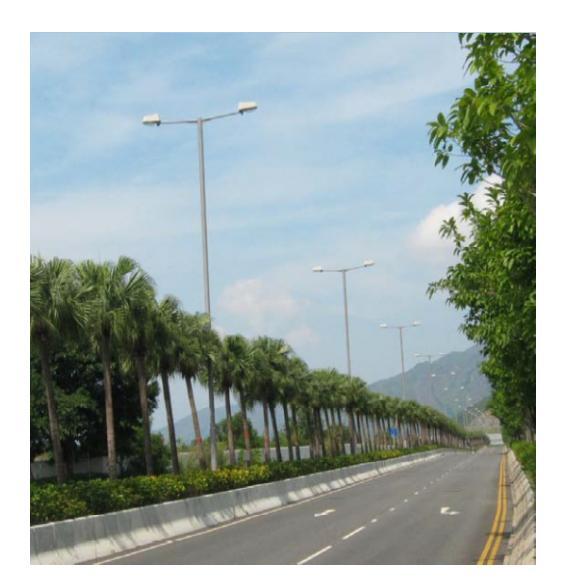
(a) Road lights along a carriageway

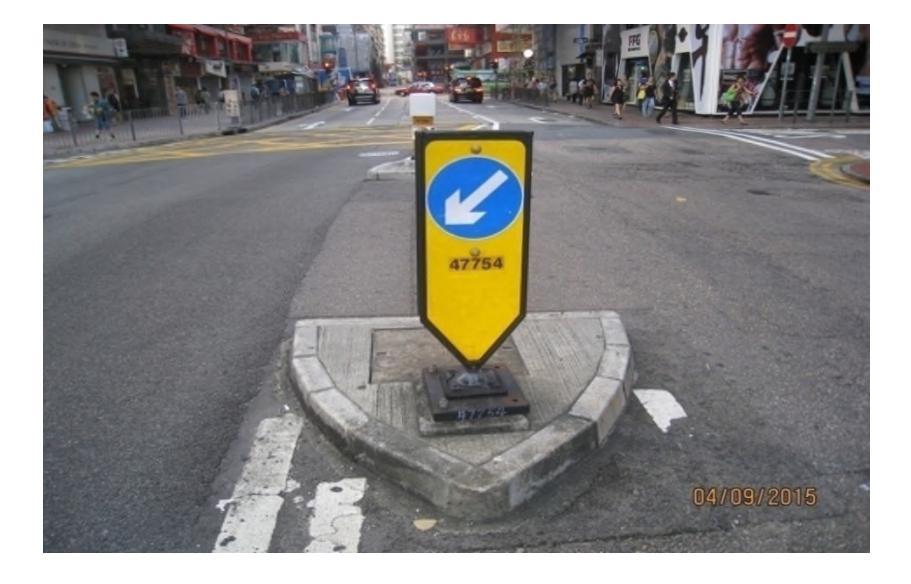
#### Photograph 8

- (a) Use of non-illuminated retro-reflective traffic bollards (NRTBs) to replace ITBs. Since 2006, the HyD had put on trial use of NRTBs (see Photograph 8) to replace ITBs (see Photograph 1(c) in para. 1.2). An evaluation in January 2015 confirmed that replacing ITBs by NRTBs could achieve energy and cost savings (Note 39). According to the HyD, to avoid unnecessary disposal of existing ITBs, NRTBs would be used for new installations and replacing damaged ITBs at suitable locations (Note 40). As at April 2015, of the 10,820 traffic bollards installed, 9,900 (91%) were ITBs and 920 (9%) were NRTBs;

#### A non-illuminated retro-reflective traffic bollard
