**Transport and Housing Bureau
Hong Kong Housing Authority
Housing Department
Buildings Department
Fire Services Department
Water Supplies Department**

**Maintenance and safety-related
improvements of public rental housing flats**

**Audit Commission
Hong Kong
28 October 2016**

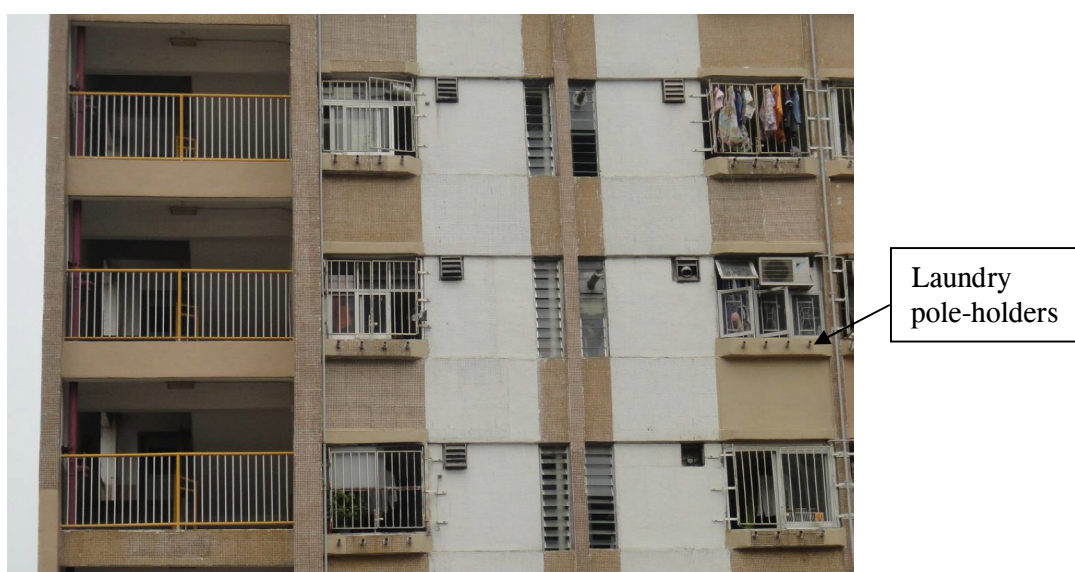
Photograph 1

1.11 Some 550,000 PRH flats in estates completed before 2005 were installed with laundry pole-holders for drying laundry (see Photograph 1). Laundry pole-holder design had been replaced by laundry racks for PRH estates completed between 2005 and 2010 and by parallel type laundry rods for PRH estates completed from 2011 onwards. In the past years, there were safety concerns over the use of laundry pole-holders by tenants. To encourage the change of laundry pole-holders to laundry racks, the HA in 2004-05 launched a one-off subsidy scheme under which each household was only required to pay \$200 (about half the cost) for

Laundry pole-holders

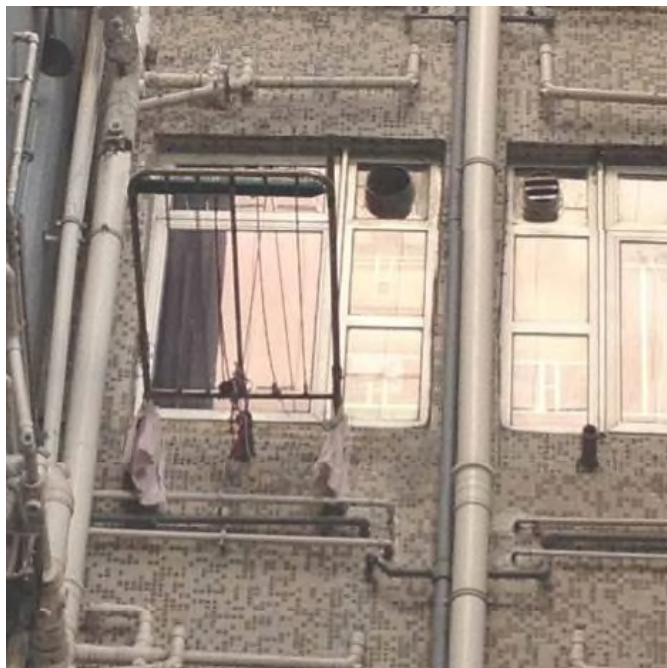
Photograph 2

Perpendicular-type laundry rack

replacing the pole-holders with laundry racks (see Photographs 2 and 3 for examples). Tenants might also install the HD's approved types of laundry racks at their own costs. According to the HD, up to February 2014 about 55,000 PRH flats had carried out the replacement works. To enhance the quality and safety of PRH flats, the HA in February 2014 approved the replacement of laundry pole-holders with laundry racks at a total estimated cost of \$520 million.

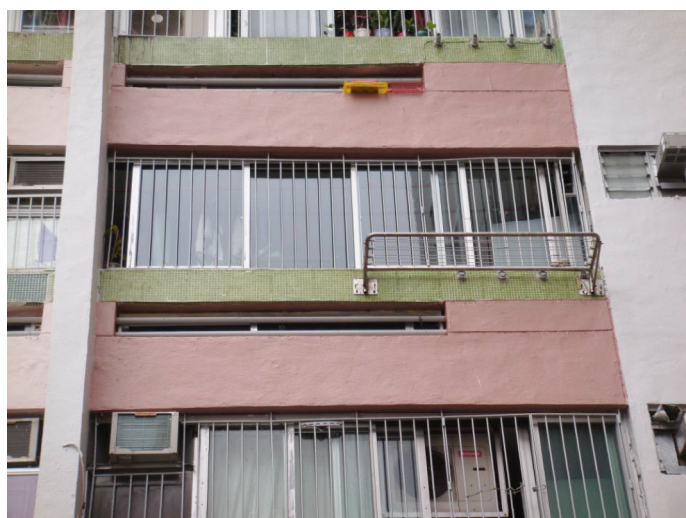
Photograph 3

Parallel-type laundry rack

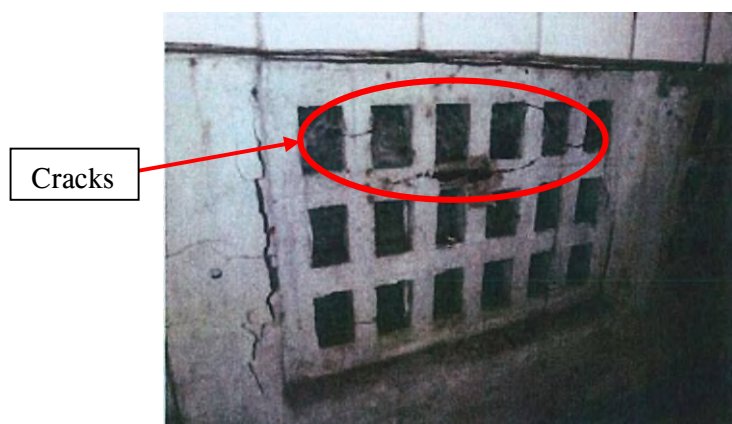
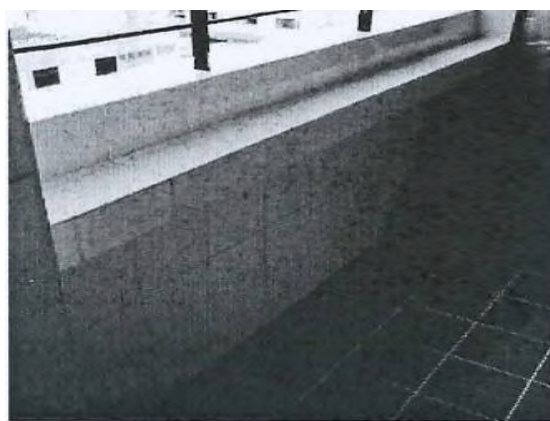
Before works

After works

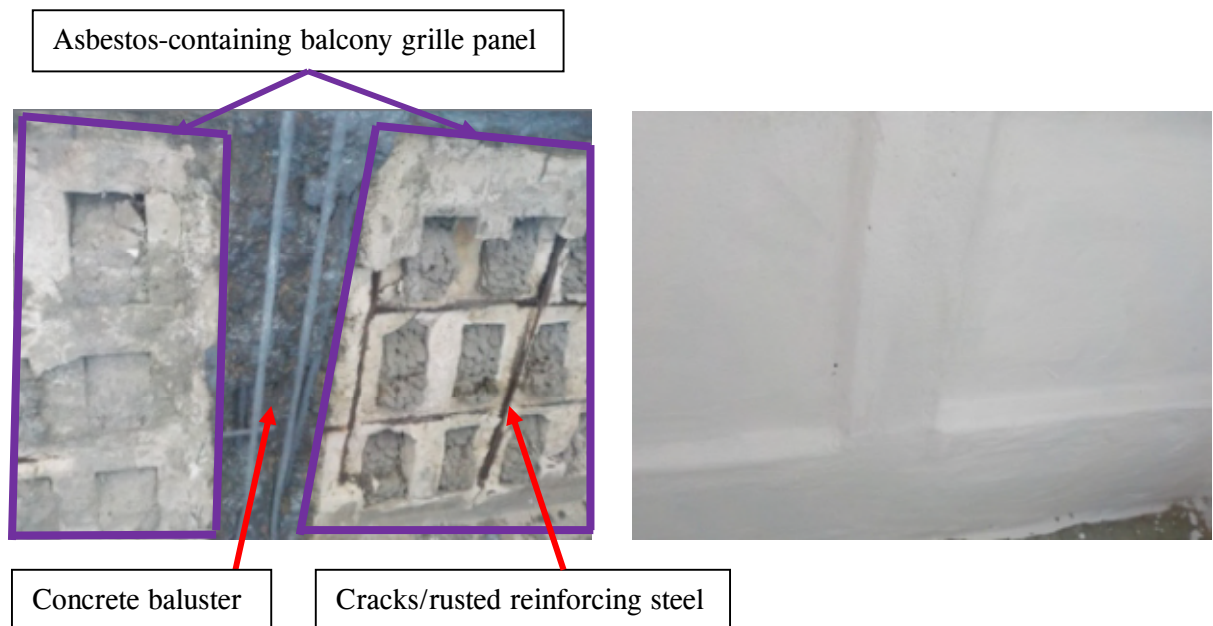
Before encapsulation

After encapsulation

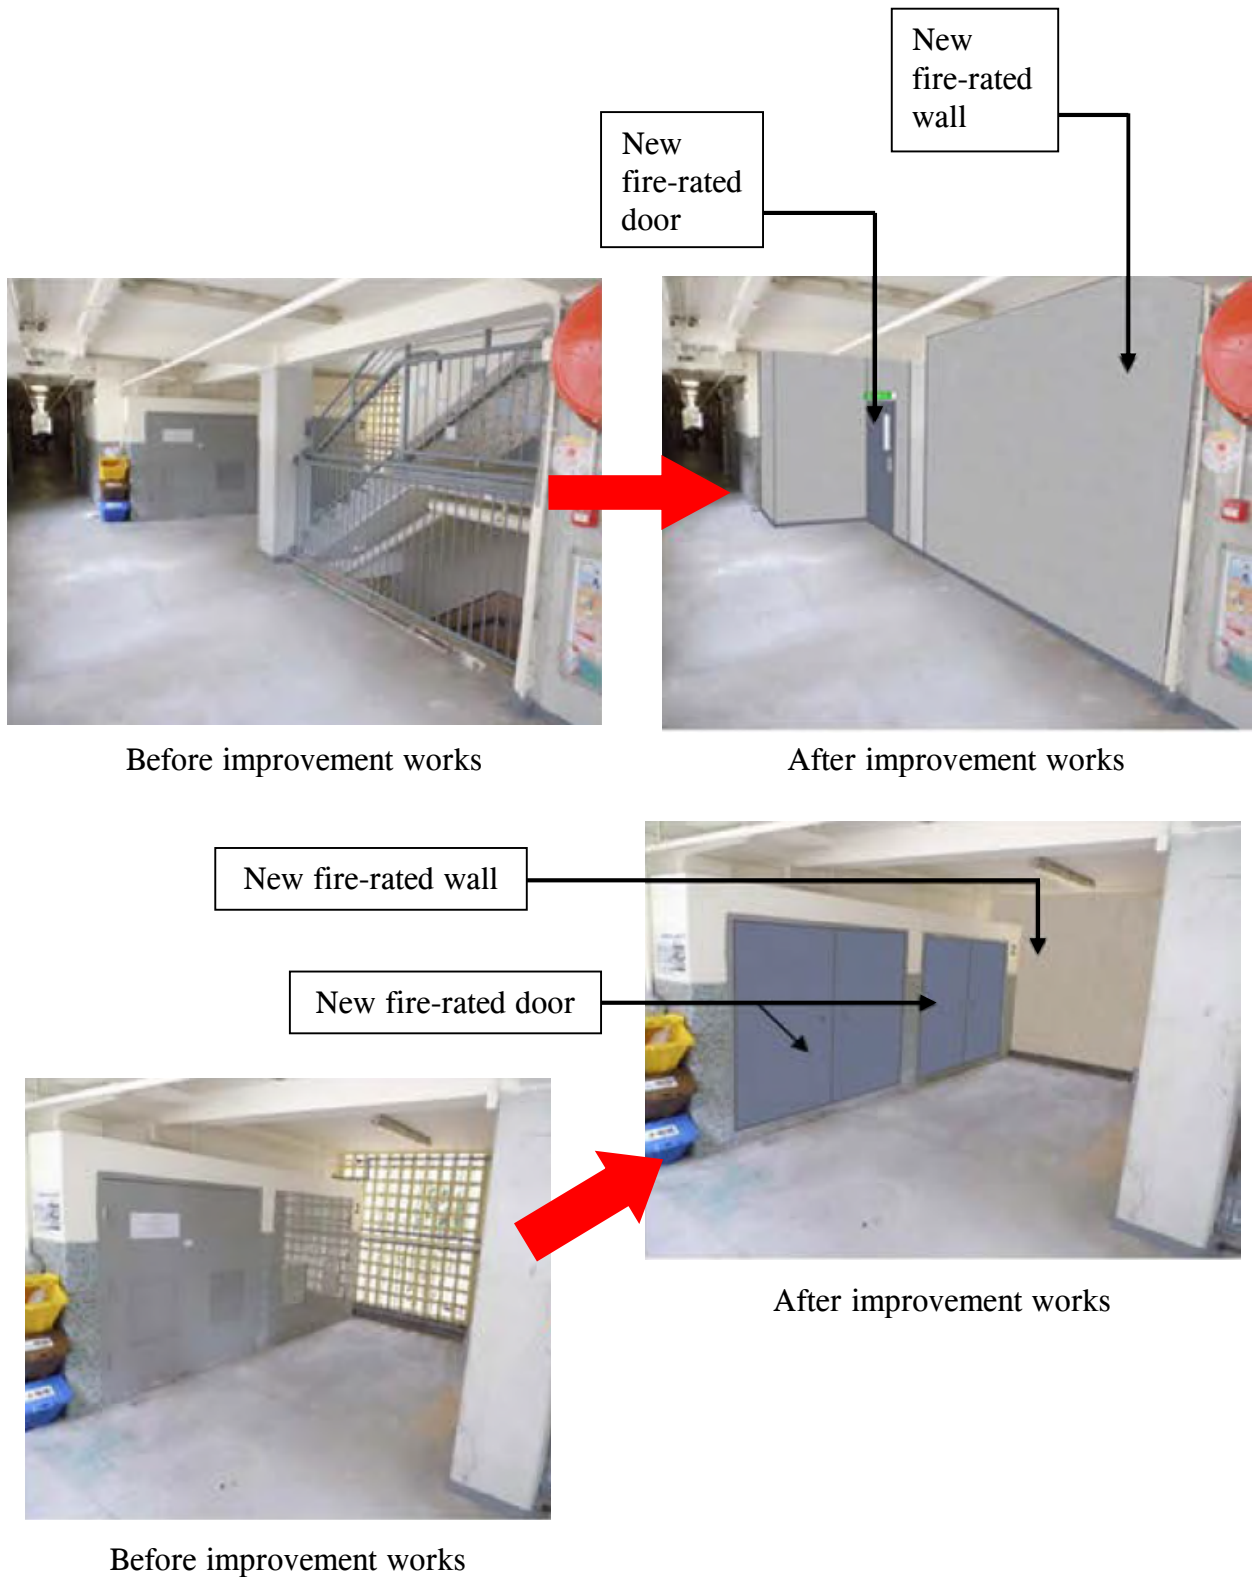
Figure 2

Illustration of fire-rated walls and fire-rated doors for staircase

The anticipated fire safety construction works included construction of fire walls and doors to protect exit staircase (see illustration in Figure 2), separating exit routes at ground floor opening for domestic and non-domestic premises, sealing up domestic flat louver openings at corridors with fire resisting boards, provision of protected lobbies for refuse rooms and installation of fire door of service ducts inside staircase enclosures. For fire service installations, the scope included the improvised sprinkler systems and other minor improvement works. Improvement proposals for Ping Shek Estate had been submitted to the BD in September 2013 and were scheduled for presentation to the Advisory Committee in April 2014. The improvement works for the two pilot estates could be executed once the comments of the Advisory Committee were addressed;
