Slope safety and landslip preventive measures

**Audit Commission
Hong Kong
20 March 2002**

SLOPE SAFETY AND LANDSLIP PREVENTIVE MEASURES

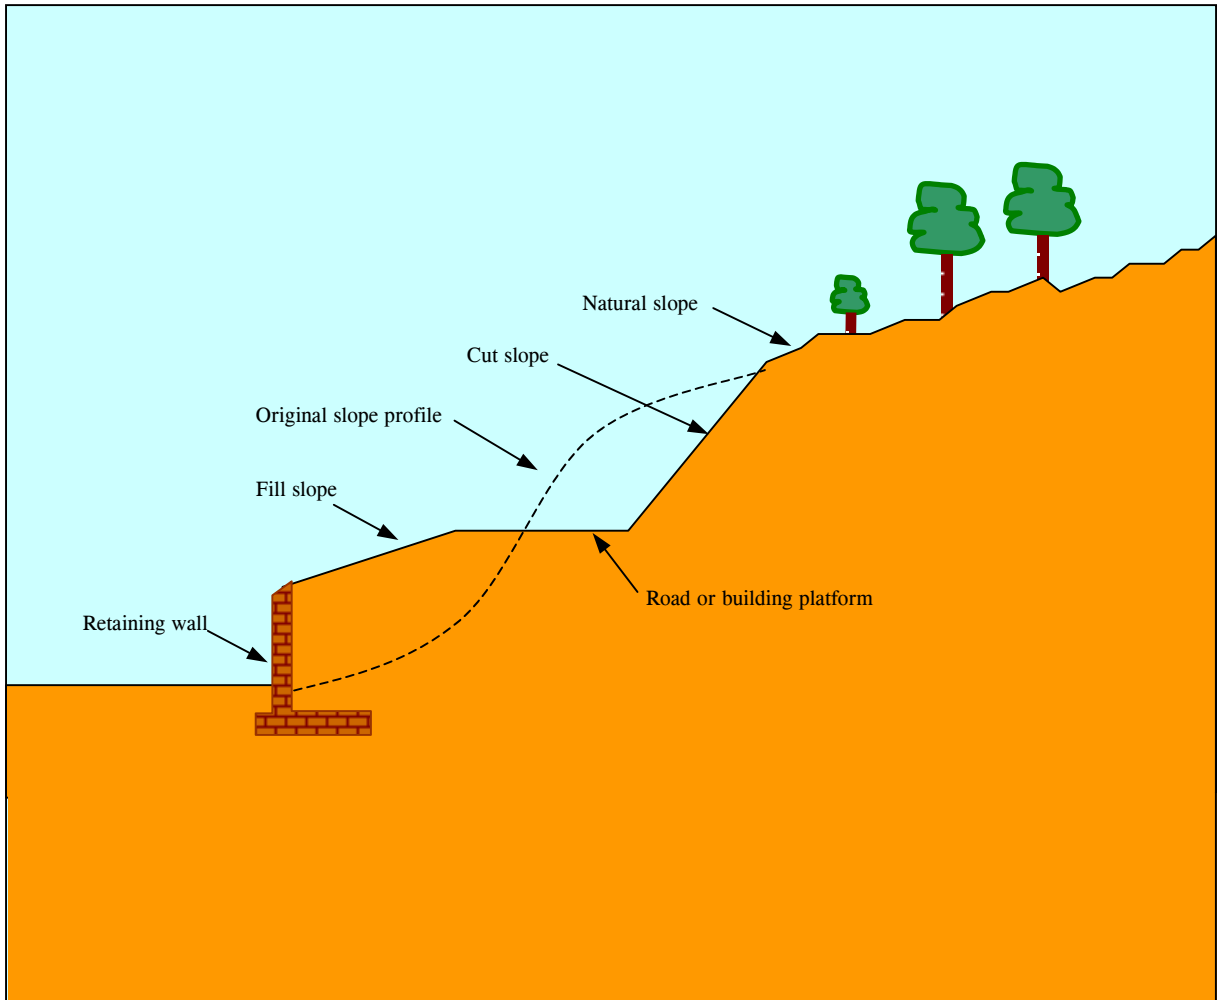
Schematic diagram showing different types of slopes
(para. 1.1 refers)

1.1 Hong Kong has a hilly terrain. Natural hillsides cover over 60% of the land area of Hong Kong. Over the years, urban development has resulted in the formation of a large number of man-made slopes. The density of man-made slopes in Hong Kong is one of the highest in the world. There are now about 54,000 man-made slopes in Hong Kong. These man-made slopes can be classified into three main types, namely cut slopes, fill slopes and retaining walls. Figure 1 on the centre pages is a schematic diagram of different types of slopes. (For a glossary of terms relating to slopes in this audit report, see Appendix I).

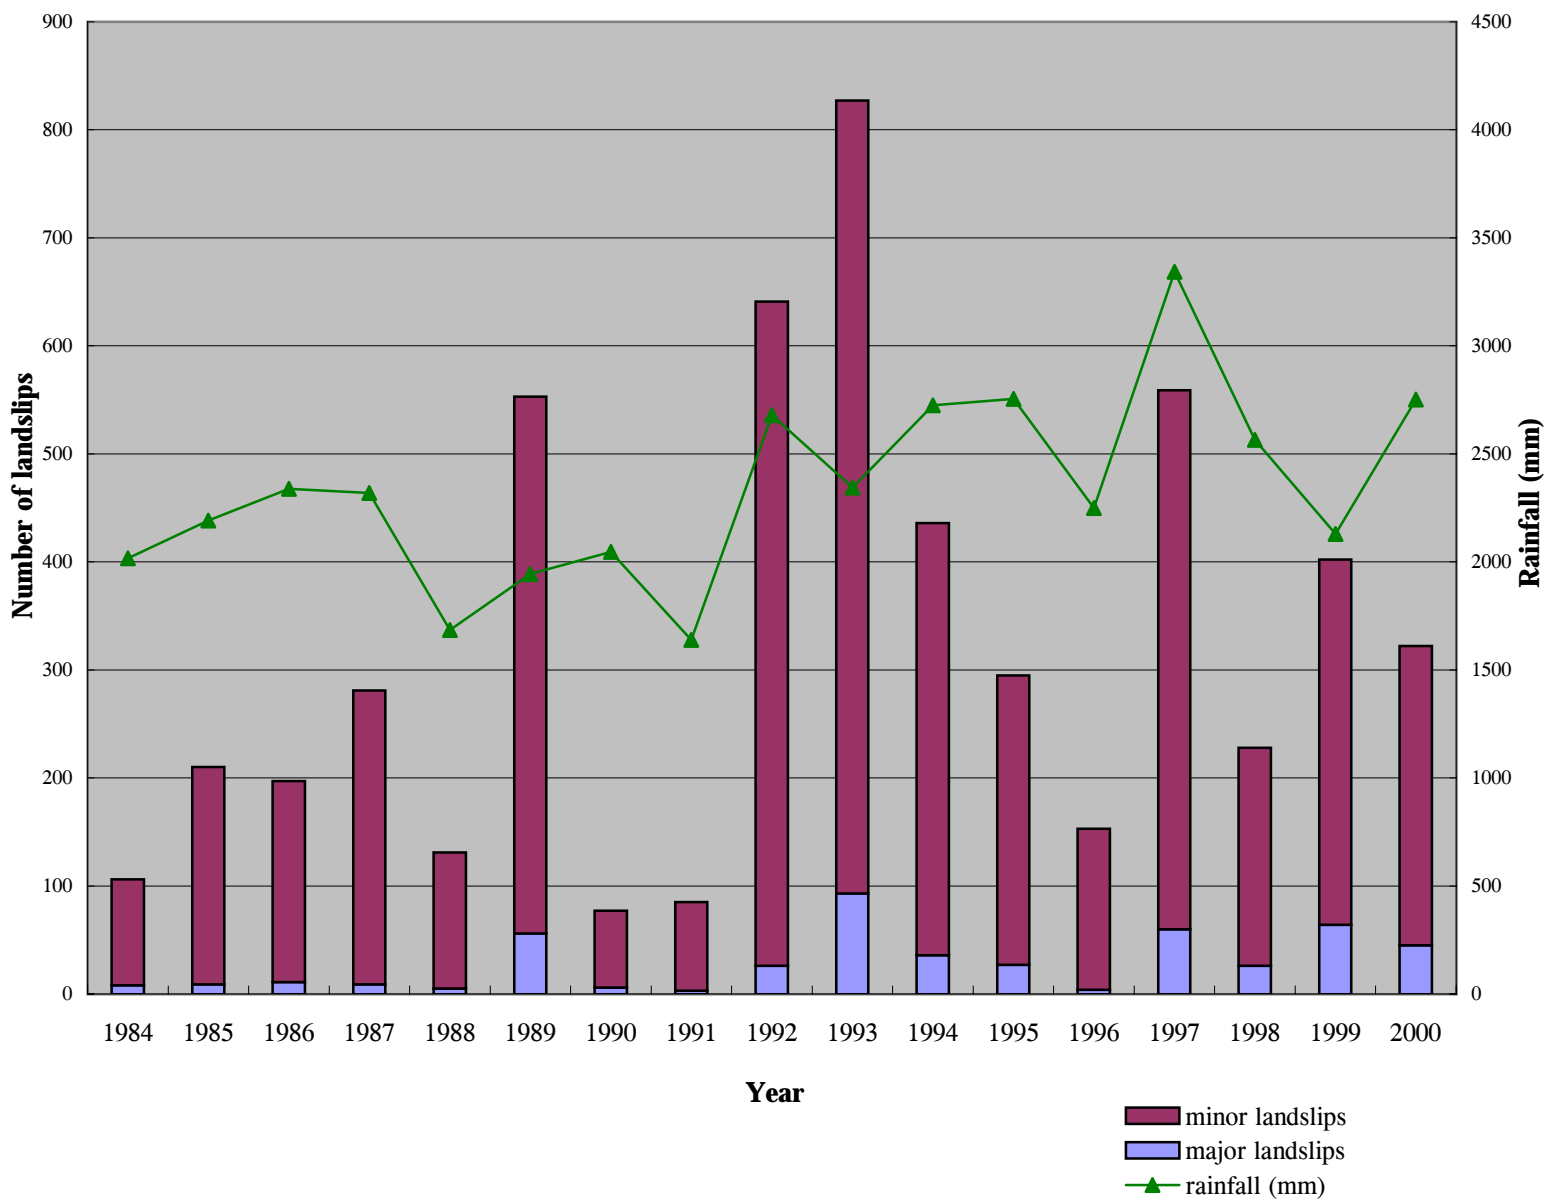
Figure 2
Number of landslips reported to the GEO
1984 to 2000
 (para. 2.3 refers)

2.3 On average, about 300 landslips are reported to the GEO a year. Figure 2 on the centre pages shows the number of landslips reported to the GEO from 1984 to 2000. Landslips can result in human casualties (i.e. fatalities and injuries) and economic losses (facilities affected, disruption to traffic and public services, etc.). Appendix A shows the number of landslips and the consequences of landslips from 1984 to 2000.

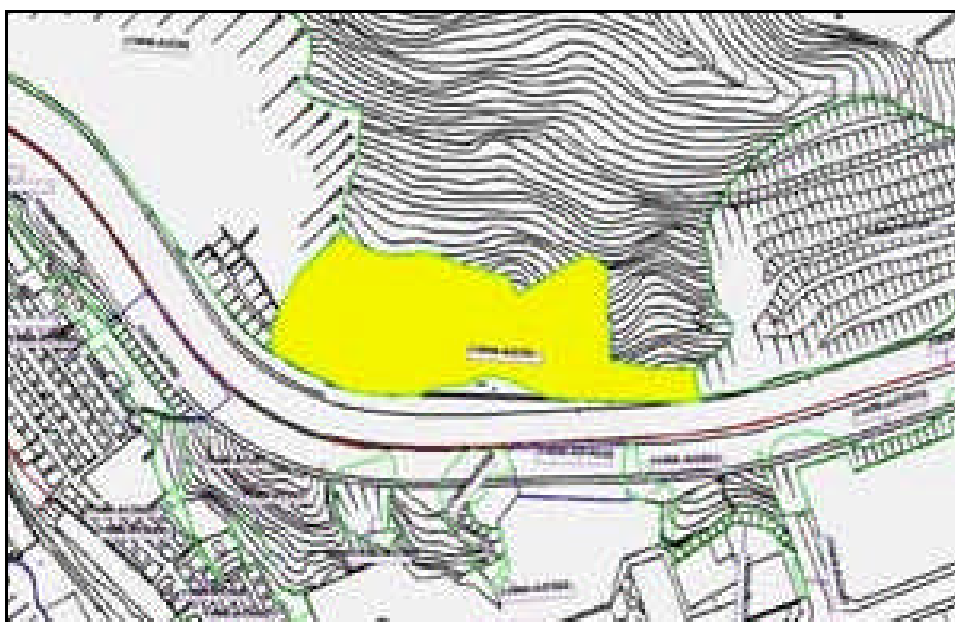
Figure 4
An example of a slope location plan in the Slope Information System
(para. 3.8 refers)

3.8 **The GEO's intention was that the New Catalogue would supersede the Old Catalogue.** During the cataloguing exercise, the GEO also conducted preliminary studies of the old slopes registered in the New Catalogue. As part of the project, the GEO developed a Slope Information System (SIS) which contained pertinent information on the slopes registered in the New Catalogue. The SIS is accessible by the public through designated computer terminals located at the GEO's office or on the Hong Kong Slope Safety Website. See Figure 3 on the centre pages. Figure 4, also on the centre pages, is an example of a slope location plan in the SIS.

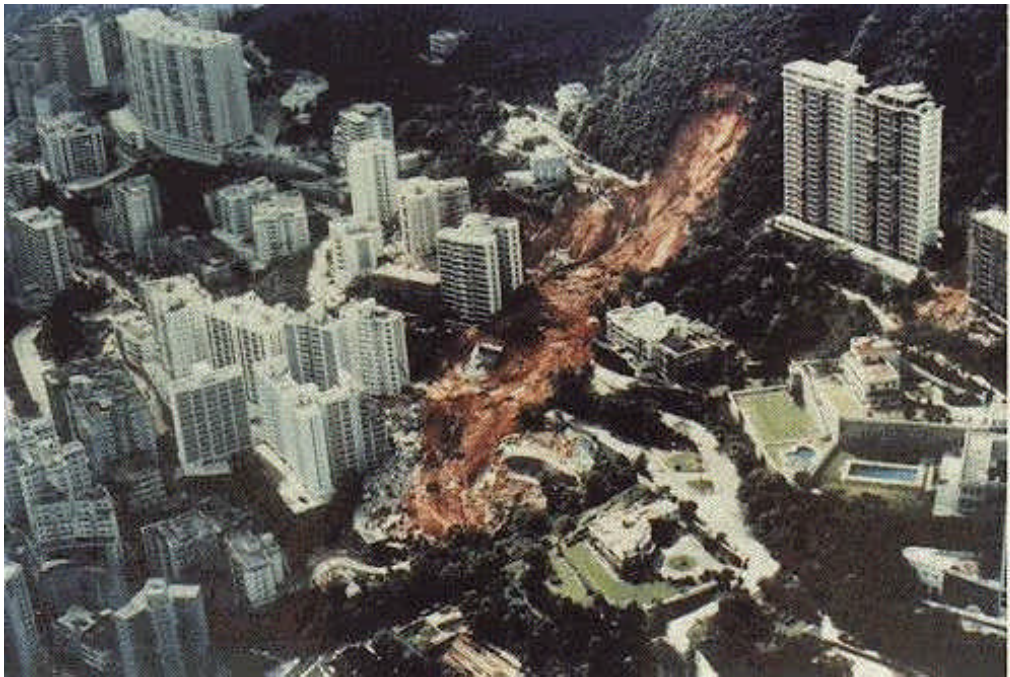
Photograph 1
A disastrous landslip in Po Shan Road, Hong Kong in 1972
(para. 1.3 refers)

1.3 The Geotechnical Engineering Office (GEO — Note 1) of the Civil Engineering Department has the overall responsibility for slope safety in Hong Kong. The GEO was established in July 1977 to improve slope safety, after a number of disastrous landslips had occurred in the 1970s (Photograph 1 on the centre pages shows a disastrous landslide in 1972). It implements a slope safety programme under the policy responsibility of the Works Bureau. Before the establishment of the GEO, there was very limited geotechnical control on slope formation both in the private and public sectors. **The slopes formed before the establishment of the GEO (in July 1977) are classified as “old slopes”.** They are largely substandard. **The slopes formed after the establishment of the GEO are subject to the GEO’s checking, and are classified as “new slopes”.**

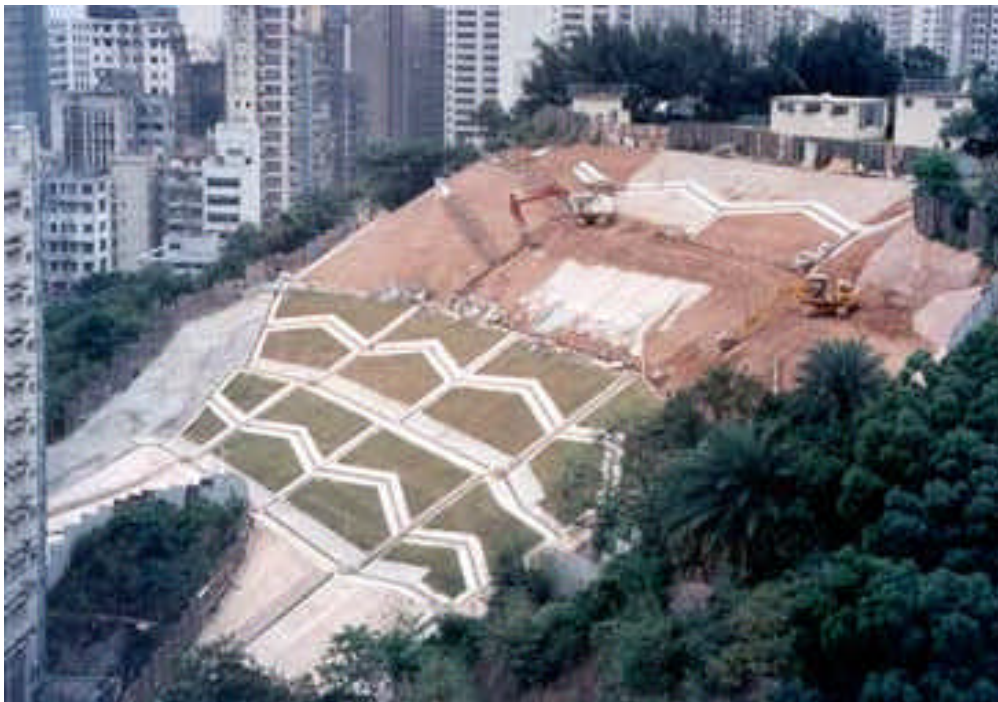
Photograph 2
Slope upgrading works in progress
(para. 1.5 refers)

1.5 Since 1977, the GEO has been checking all new slopes to ensure that they comply with the current safety standards. New slopes normally do not require upgrading but maintenance is needed to prevent their deterioration. The slopes formed before 1977 are largely substandard and require upgrading to bring them to current standards. Photograph 2 on the centre pages shows a site with slope upgrading works in progress. The Government's slope upgrading efforts are focused on old slopes, although maintenance is needed for all man-made slopes. The GEO has been carrying out the upgrading of substandard old government slopes on an ongoing basis through the Landslip Preventive Measures (LPM) Programme. The LPM Programme also includes the task of conducting safety screening of private old slopes. Under the Buildings Ordinance (Cap. 123), when a slope on privately-owned land or under private responsibility requires ground investigation or upgrading, the GEO may ask the Buildings Department to issue a Dangerous Hillside Order which requires the owner to investigate the stability of the slope and undertake any necessary landslip preventive measures. If the owner does not respond to the Order, the Government is empowered to carry out the works at the owner's expense.
