### **Upgrading and operation of Pillar Point Sewage Treatment Works**

**Audit Commission  
Hong Kong  
31 March 2021**

# UPGRADING AND OPERATION OF PILLAR POINT SEWAGE TREATMENT WORKS

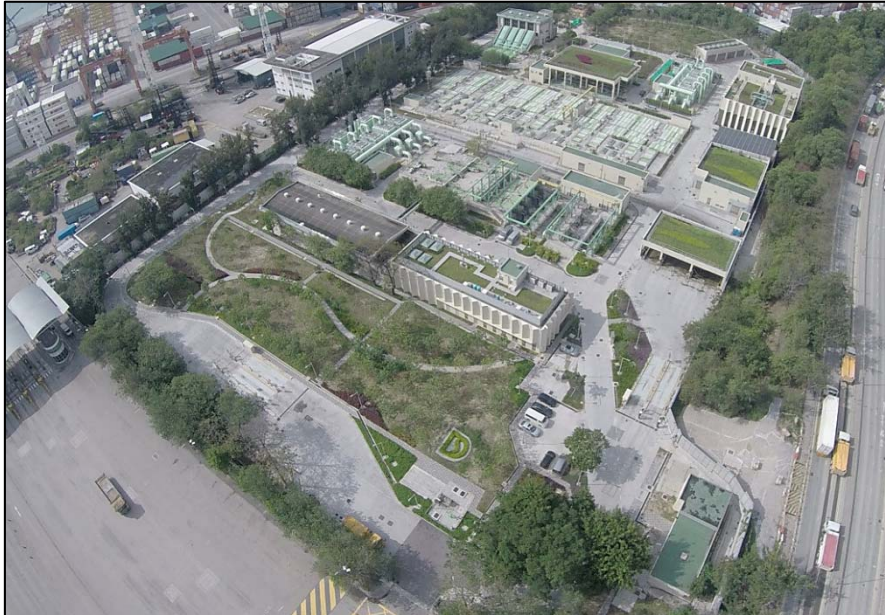
**Photograph 1**

Photograph 1 shows the upgraded PPSTW.

**Upgraded PPSTW**
